**Fire on engine n° 2 during initial climb, turn-back,
emergency landing and evacuation**

Aircraft	ATR 72- 212A registered F-OIQN
Date and time	12 January 2013 at about 03 h 30 ⁽¹⁾
Operator	Air Tahiti
Place	Tahiti Faa'a Airport (French Polynesia)
Type of flight	Public transport
Persons on board	Captain (PF), copilot (PNF), 2 cabin crew, 53 passengers
Consequences and damage	Engine n° 2 damaged
<i>Note: the following elements are based on data recorded on the FDR and the CVR, crew's and firefighter's accounts, as well as videos of the incident.</i>

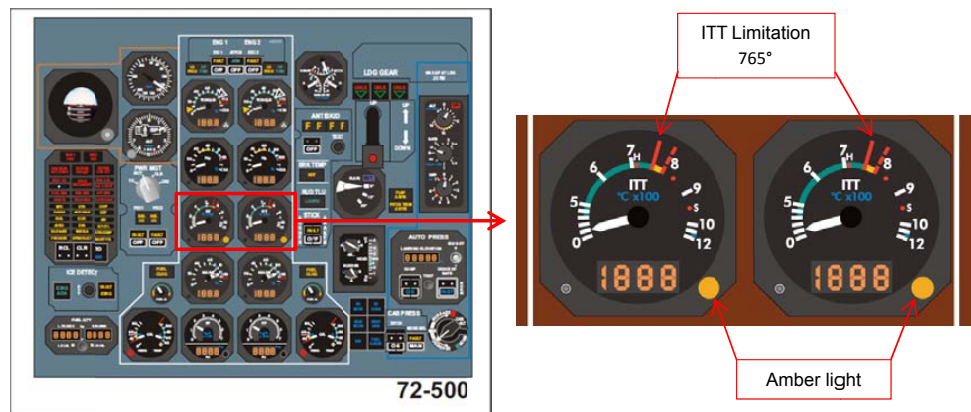
Figure 1: ITT displays

The ITT displays include a green arc up to 765 °C, then an amber arc up to 800 °C.

An ITT higher than 800 °C triggers the following:

- an amber light illuminates on the lower right of this instrument;
- an ENGINE OVERTEMP⁽⁷⁾ warning, which is inhibited⁽⁸⁾ before takeoff by the selection of the TO INHI button, and as long as the landing gear is locked down. When the triggering condition disappears during the inhibition phase, the warning is not triggered.

During the incident, the ITT exceeded 800 °C while the landing gear was locked down. The warning was not triggered because it was inhibited during the takeoff and the triggering condition had disappeared at the time of landing gear retraction.

Taking into account the number of checks to perform during the copilot's visual circuit, it can be difficult to detect these anomalies. The illumination of the amber light on the ITT display could have made detection easier but the brevity of this warning contributed to the non-detection of this failure before V1.

Since the incident, Air Tahiti has modified the takeoff procedure by including this item.

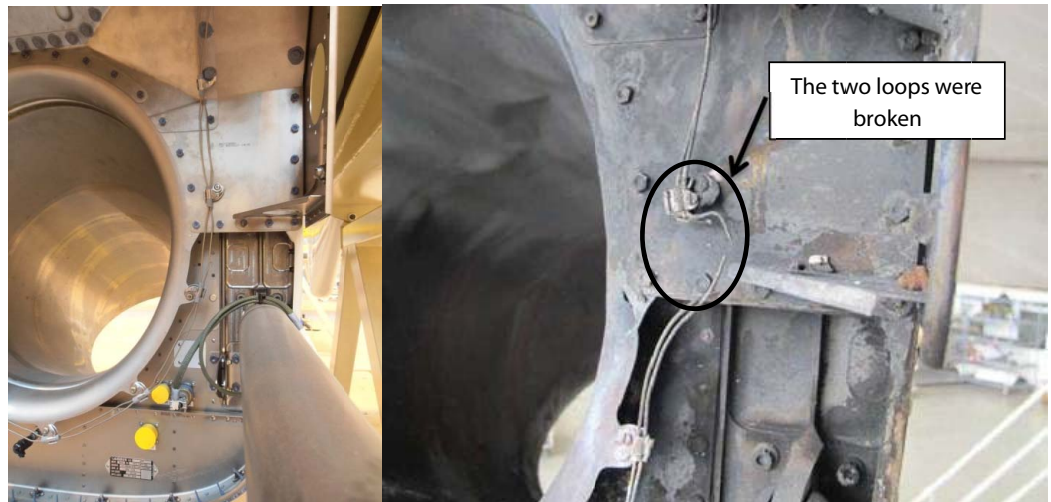
Figure 2: Fire detection system of a production aeroplane (left photo) and that of F-OIQN after the incident (right photo)

The ENG FIRE red warning light illuminates on the CAP when the temperature exceeds 258 °C on the two loops or on only one loop if the other fails⁽⁹⁾. The light remains illuminated as long as the temperature measured in the nacelle is greater than 258 °C or if a short-circuit occurs on one of the two loops.

- ❑ that the blades on two stages of the two power turbines PT1 and PT2 had failed and, more generally, that the moving parts of the turbine assembly had been destroyed (shafts and bearings);
- ❑ that at least one of the two loops in the fire detection system was in open circuit.

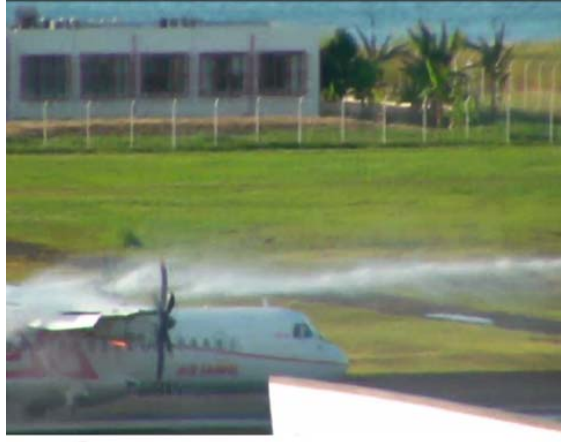
Figure 3: fire on engine n° 2 during the firefighters' intervention

A blade of a power turbine (PT1 or PT2) had probably failed generating an imbalance leading to significant vibrations that caused secondary damage, including the failure of the lubrication system that led to the engine fire through projecting oil on the hot parts.

Analysis of the amateur videos of the incident did not make it possible to determine if the engine was still on fire during the approach and landing. During the firefighters' intervention, immediately after the aeroplane stopped, a fire was clearly visible on engine n° 2.

A PT1 or PT2 blade from engine n° 2 probably failed during the takeoff roll, leading to abnormal variations in the engine parameters then a fire during the initial climb. The fire resulted from the failure of the lubrication system caused by significant vibrations that followed the blade failure.
