Serious incident to Airbus A330
registered **F-GRSQ**
on 26 December 2014
in cruise, over the Mediterranean Sea

Unavailability of the three IRSs⁽³⁾, loss of attitude and navigation data in cruise

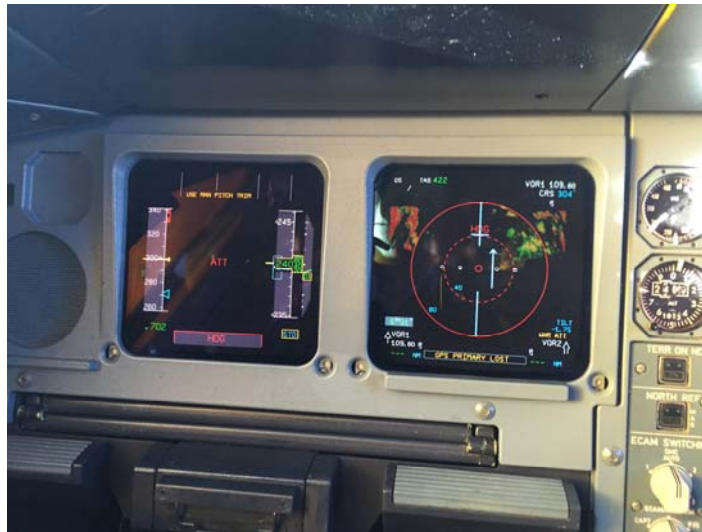
At 13:44, the internal data of each IRS recorded the message "IN FLIGHT ALIGNMENT"⁽²²⁾. The flight control law changed to direct control. The attitude data disappeared from the PFDs up to the end of the flight. The position and flight plan data was no longer available on the NDs. The crew had to use electromechanical standby instruments for the remainder of the flight without AP or A/THR. The ECAM messages still displayed in decreasing order of priority included: **F/CTL DIRECT LAW**, **NAV IR 1 FAULT**, **NAV IR 1+2 FAULT**, **NAV IR 2+3 FAULT**, **NAV IR 1+3 FAULT**, **NAV IR NOT ALIGNED**.

Figure 1: Photo taken by crew during descent to Athens

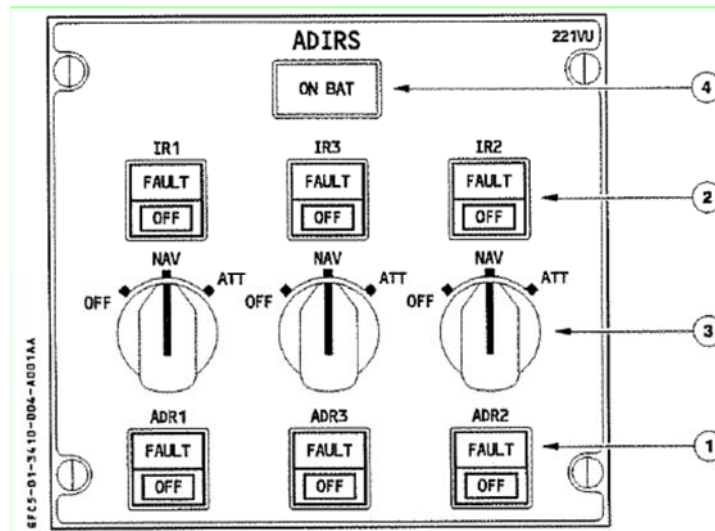
Each ADIRU includes an Air Data Reference (ADR) and an IRS. The Airbus F-GRSQ is equipped with a MSU located on the cockpit overhead panel. The MSU controls the mode discrettes to select the operational state of each ADIRU: OFF, NAV or ATT. Only crew actions on the MSU can change an ADIRU mode. The selector must first be pulled before being rotated to avoid an involuntary action with irreversible consequences.

Figure 2: MSU

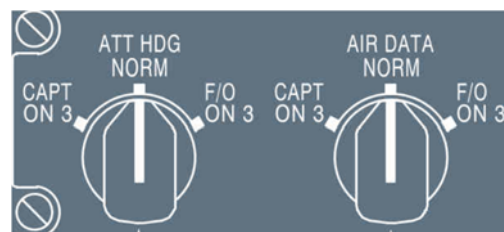
In addition, the "ATT" and "HDG" captions are respectively displayed on the PFD and the ND corresponding to the failed IRS (see figure 1). If the "ATT HDG" rotary selector (see figure 3) is set to "NORM", as in the flight of the event:

If there is a failure of IRS 1 or 2, the crew can use the "ATT HDG" rotary selector to use IRS 3 data on the left side ("CAPT ON 3") or on the right side ("F/O ON 3"). In this case, an IRS 3 fault is indicated on the side selected.

Figure 3: "ATT HDG" and "AIR DATA" rotary switches

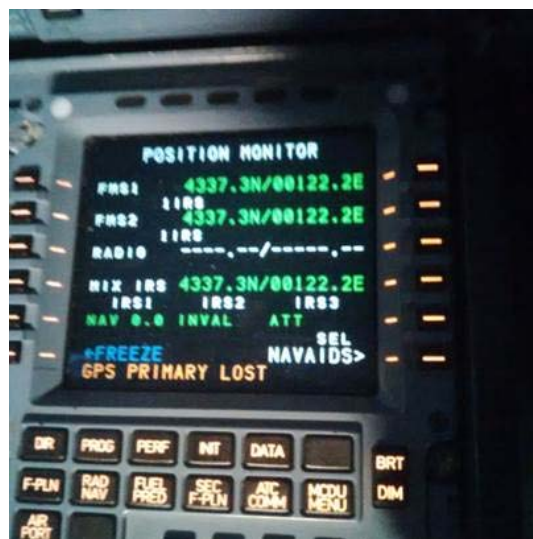
Figure 4: Example of POSITION MONITOR page. Photo taken in simulator. Note the IRS modes

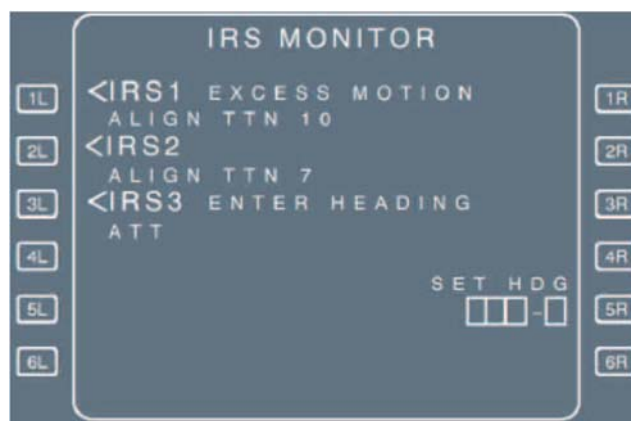
Shortly afterwards, wanting to monitor the drift of IRS 2 on the MCDU, he noted that IRS 3 was in ATT mode. No alert was displayed on the ADIRU⁽¹⁵⁾ panel. The three mode selectors were set to NAV. He explained that he saw the fields prompting the input of a heading for IRS 3 on the IRS MONITOR page of the MCDU.

Figure 5: IRS MONITOR page of MCDU taken from FCOM. Note the IRS modes and the possibility of entering a heading (SET HDG) for IRS 3.

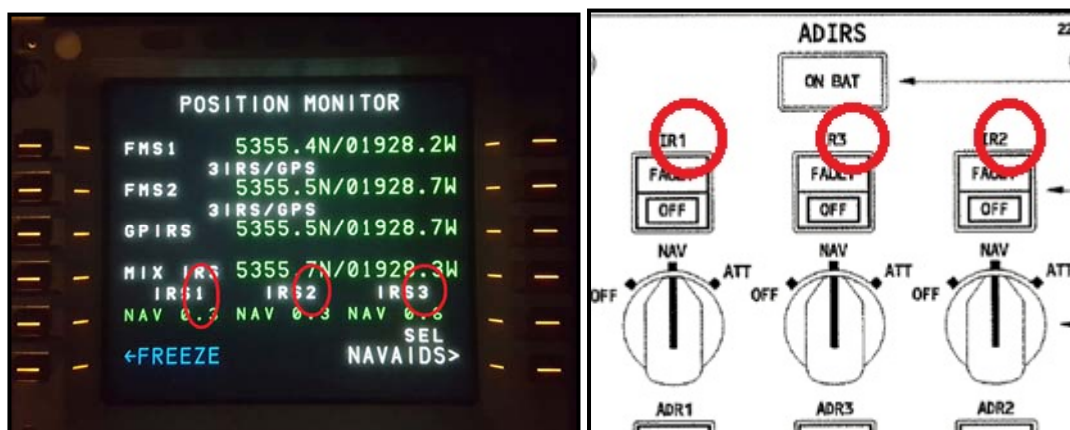
The layout of the selectors reflects the left, standby, and right assignment of the IRSs. The IRS numbers are clearly marked on the unit and this layout is recalled in training. However, it is different from the numerical order 1, 2, 3.

The presentation of the status of the IRSs on the POSITION MONITOR page of the MCDU is in numerical order 1, 2, 3, and is therefore different from the order used for the selectors.

Figure 7: Comparison of orders in which IRSs are numbered

The crew regularly consulted the POSITION MONITOR page during the flight to monitor the drift of IRS 2. They were therefore concentrated on reading the drift value in the centre and may have associated IRS 2 with this central position. For this reason, when acting on the selector, it is possible that the crew operated the middle mode selector (IRS 3) instead of the one on the right (IRS 2), bypassing the step which involves reading the IR number and the cross-check which are the counter-measures for this error.
