Accident to Fokker 27-500
registered **I-MLVT**
on 25 October 2013
during initial climb from Paris-Charles de Gaulle Airport

Loss of a propeller blade then part of the left engine during initial climb, in-flight turn back, emergency landing

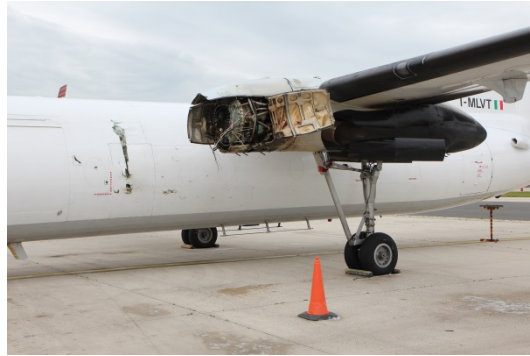
On the left side, the fuselage had a vertical hole that opened from the outside to the inside, and numerous small impacts. On the right side, it was punctured vertically, from the inside to the outside of the fuselage, with a hole of a similar size to the hole on the left fuselage. Inside the fuselage, the postal freight container, between the two puncture holes in the fuselage, was cut from side to side. The electrical cable bundles running along the fuselage side walls had been cut.

View of left side of aircraft

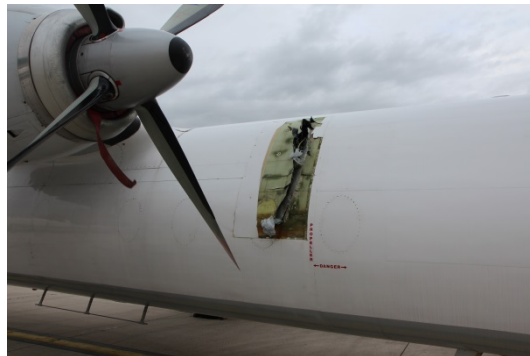
View of right side of aircraft

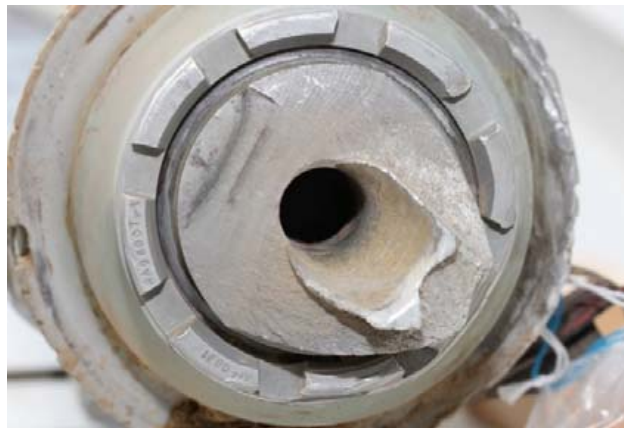
Examinations of the aircraft and blade No. 2 established that the blade separated from the left propeller and struck blade No. 1, causing it to separate from the propeller. Blade No. 2 separated from the propeller as a result of fatigue failure in its pre-load bolt, in the fillet, approximately 8.7 mm below the bolt head.

Detailed examinations with a scanning electron microscope (SEM) showed the presence of fatigue striations, confirming the presence of a crack propagation area under cyclic loading (40% of the total bolt cross-section). The high-relief area (60% of the remaining cross-sectional area) had numerous dimples, which were characteristic of a sudden ductile fracture.

Figure 2: fracture pattern on blade No.2 pre-load bolt

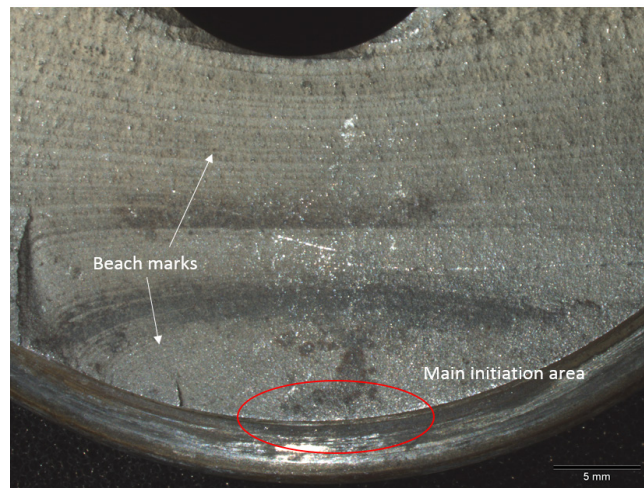
Figure 3: close-up of the fracture pattern, initiation crack area

By observing the beach marks (concentric lines at the start of propagation, visible on Figure 3), the crack initiation area could be determined; it was located on the leading edge side of the blade. The presence of two ratchet lines suggested that two secondary cracks were also initiated and propagated.

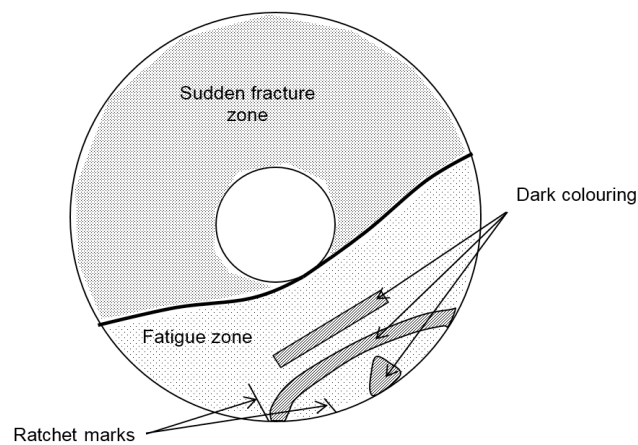
Figure 4: Fractographic description of the fracture surface of blade No. 2 pre-load bolt

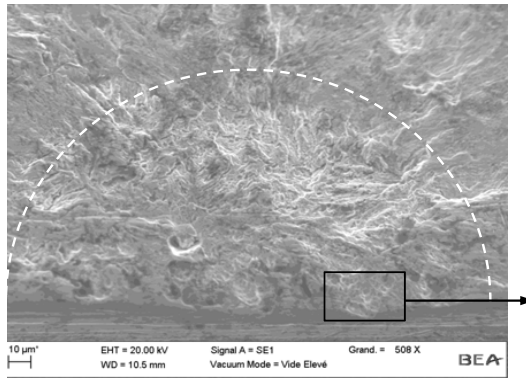
No prior damage (tool impact, machining fault, etc.), no corrosion pitting and no geometric defects were observed at the main crack initiation area.

Figure 5: morphology of the main crack initiation area

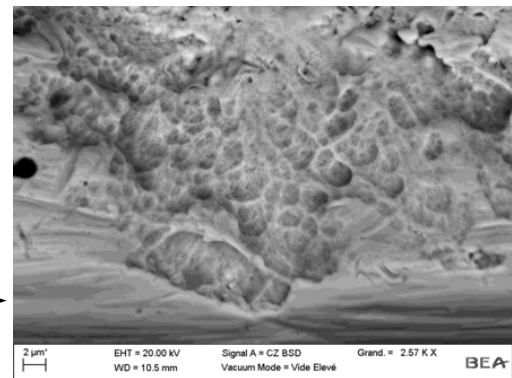
The main crack initiation area locally presented a pattern with porosities (*Figure 6*). An inclusion was also observed, 100 µm from the fracture pattern. Through chemical analysis, it was determined that it was a non-metallic manganese sulphide (MnS) inclusion.

Figure 6: porosities in the main crack initiation area (detail of Figure 5)
