# Report

Accident on Friday **28 October 2011**  
**at Toulouse Blagnac Airport (31)**  
**to the Piper PA31T**  
registered **OE-FKG**

**BEA**

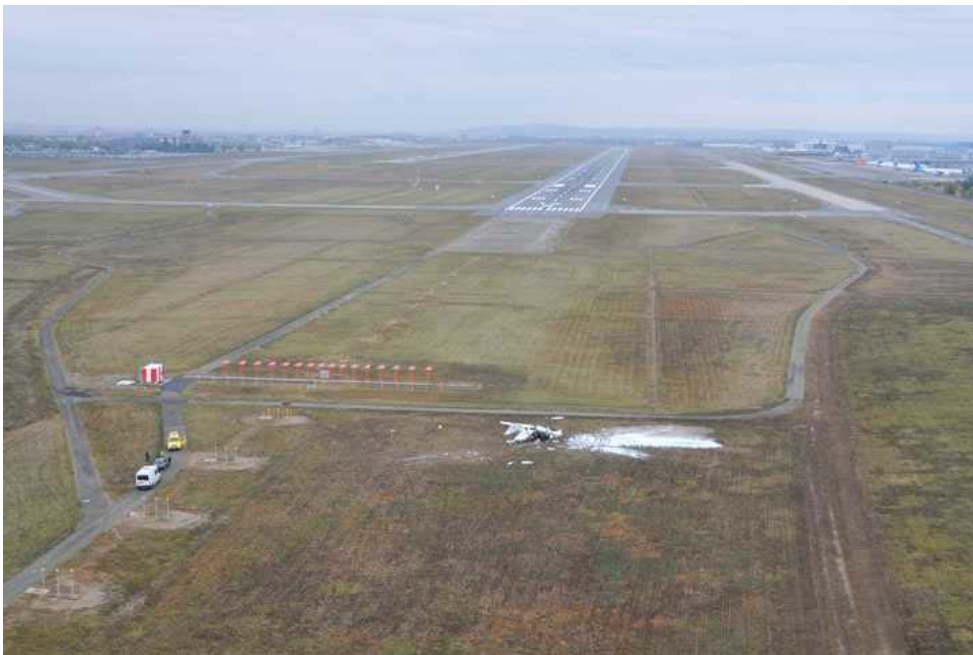
Figure 1 - accident site

The main wreckage was grouped together and partly burned. It was located about 40 metres to the right of the centre line approach lights and 640 m from the beginning of runway 14R. It came to a stop on its back on a magnetic bearing of 270°.

A fire subsequent to the impact started on the left wing (leading edge and upper wing surface) as well as on the forward part of the cabin. The instrument panel was seriously damaged by the fire.

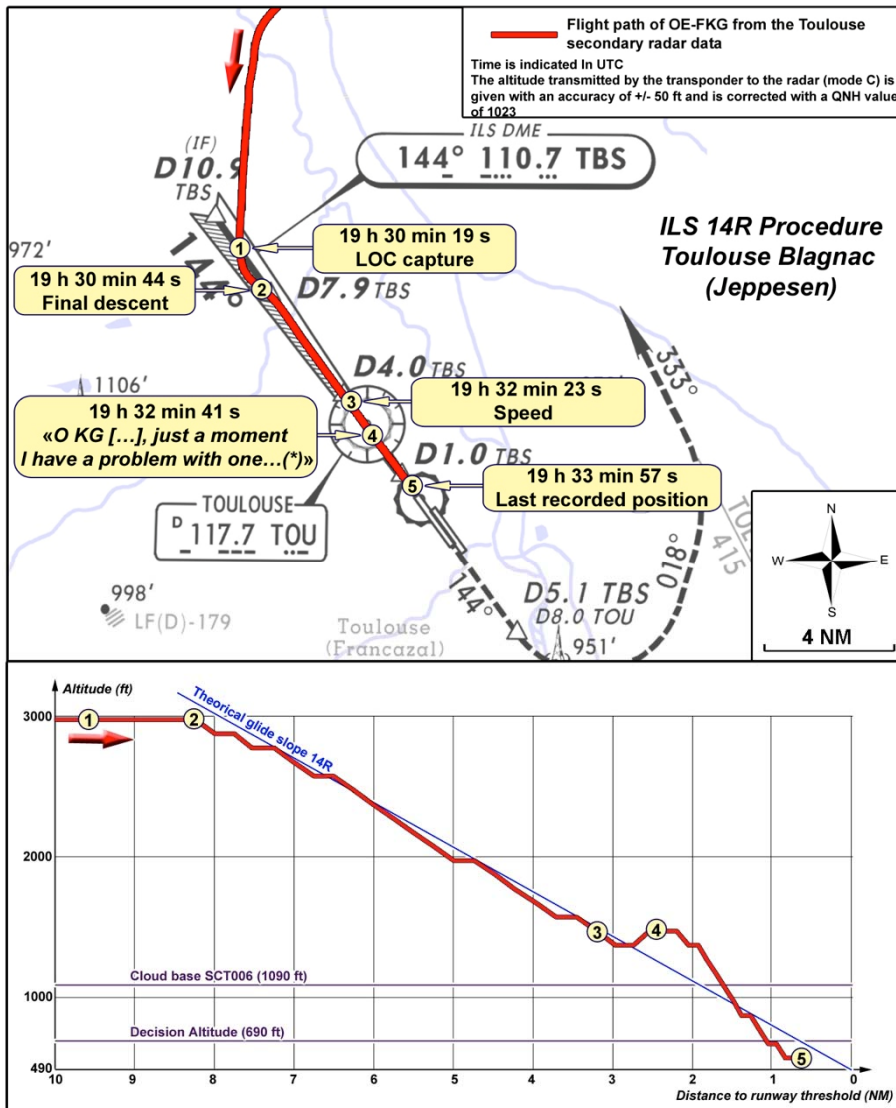
Figure 3- OE-FKG approach trajectory

At 19 h 32 min 41 s (point ④), the pilot announced "... *just a moment I have a problem with one ...(\*)...(\*)...* ". The aeroplane's descent gradient increased, it then went below the glide path.

The last radar contact was dated at 19 h 33 min 57 s at point ⑤. A final inaudible message was transmitted by the pilot.

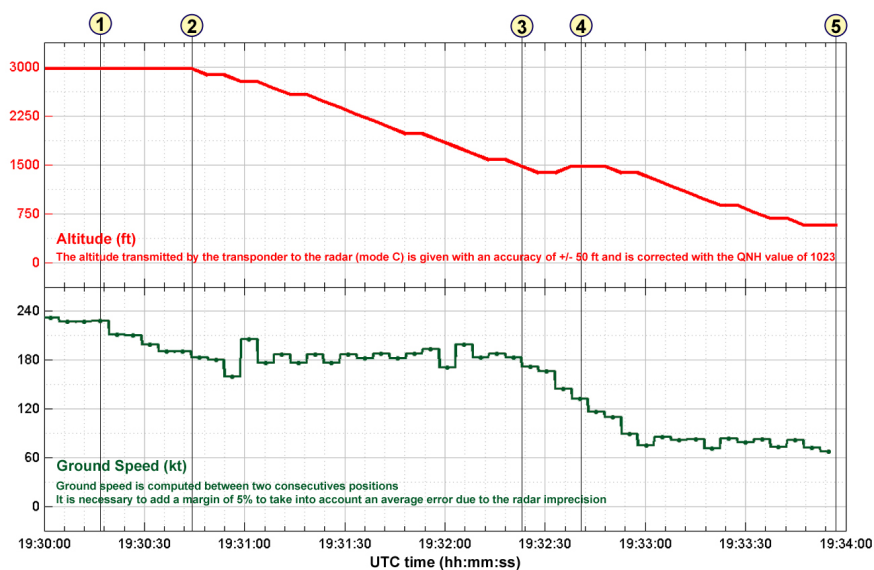
Figure 4 - OE-FKG approach flight path - Vertical profile and ground speed

Although there is no regulation on this, the stabilisation criteria for an IFR approach are generally set at 500 ft in visual flight conditions and 1,000 ft in IMC.

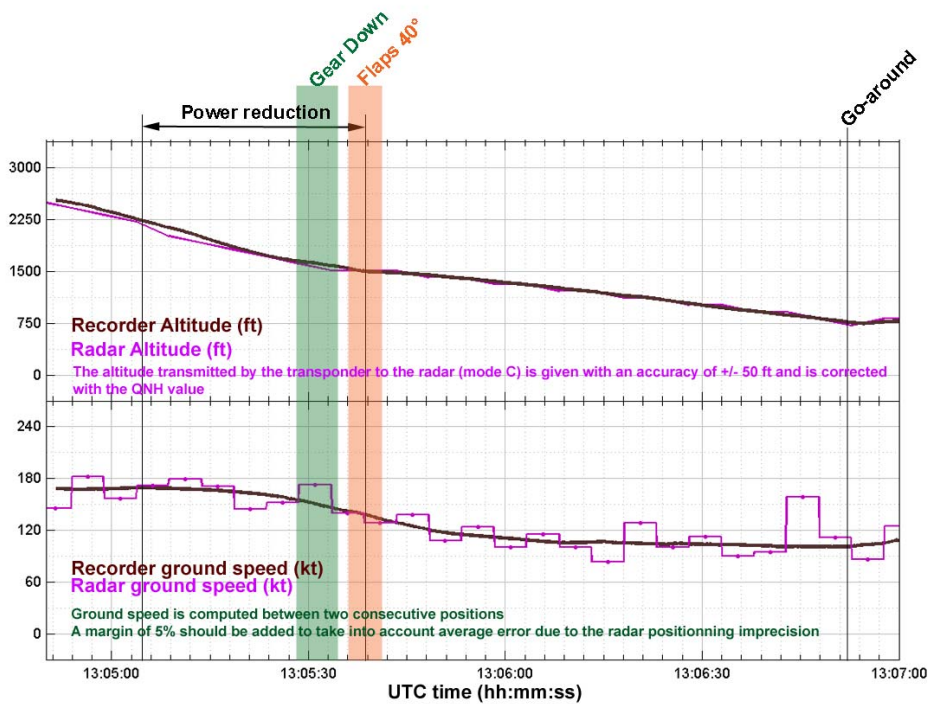
Figure 5 - First approach

The first approach showed that interception of the ILS axis, with the autopilot engaged<sup>(9)</sup> with a speed of 190 kt, did not lead to overshooting the axis.

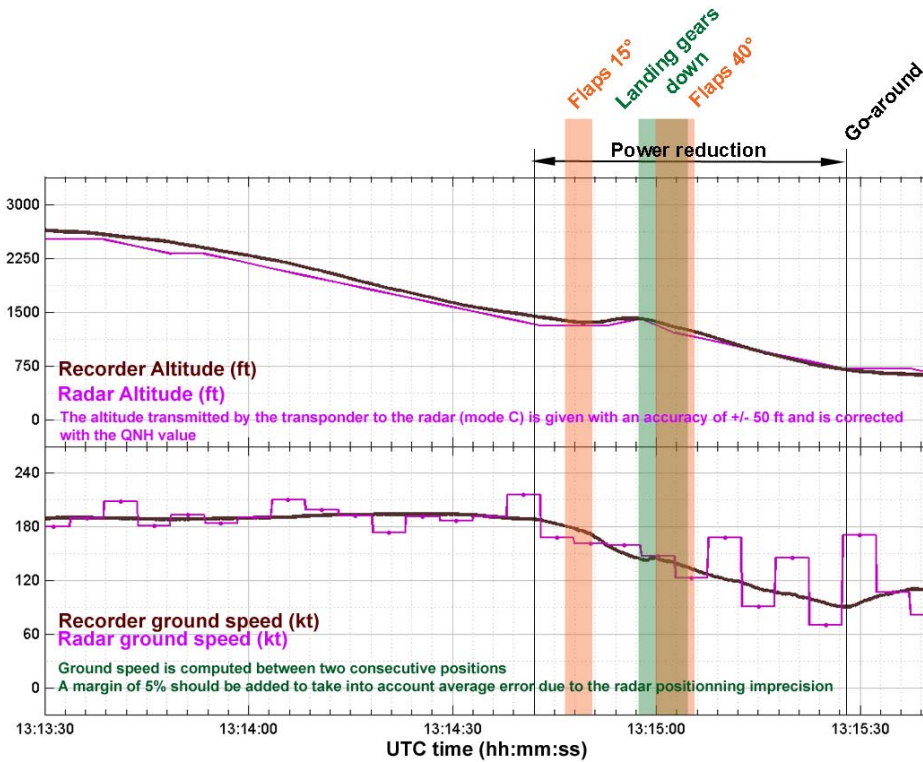
Figure 6 - Second approach

The second approach aimed to reproduce the decelerated ILS approach on the accident flight starting from interception of the ILS axis at about 190 kt and targeting a final speed of around 90 kt.

Deceleration was delayed in such a way as to intercept and follow the glide path at a speed of 185 kt. The engine power was adjusted. The decrease began 1,000 ft above ground level and the extension of drag devices was in compliance with the flight manual VFE.

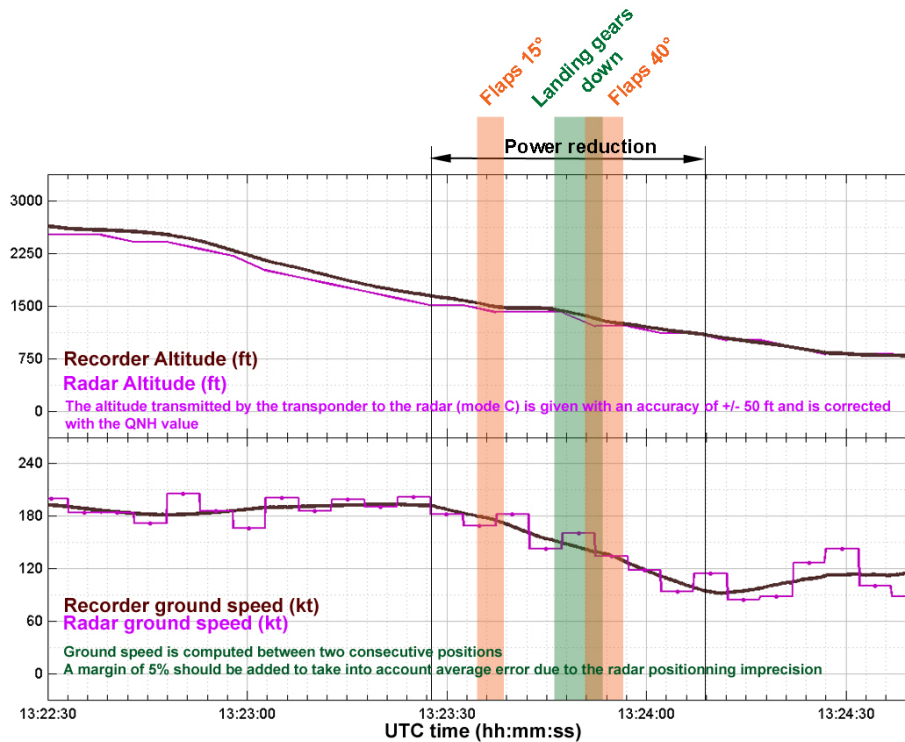
Figure 7 - Third approach

The third approach was conducted in an identical manner to the second though flying manually. A nose-down input on the trim was required to reduce control inputs effort. The deceleration phase and extension of drag devices was timed in order to compare it to the accident flight.

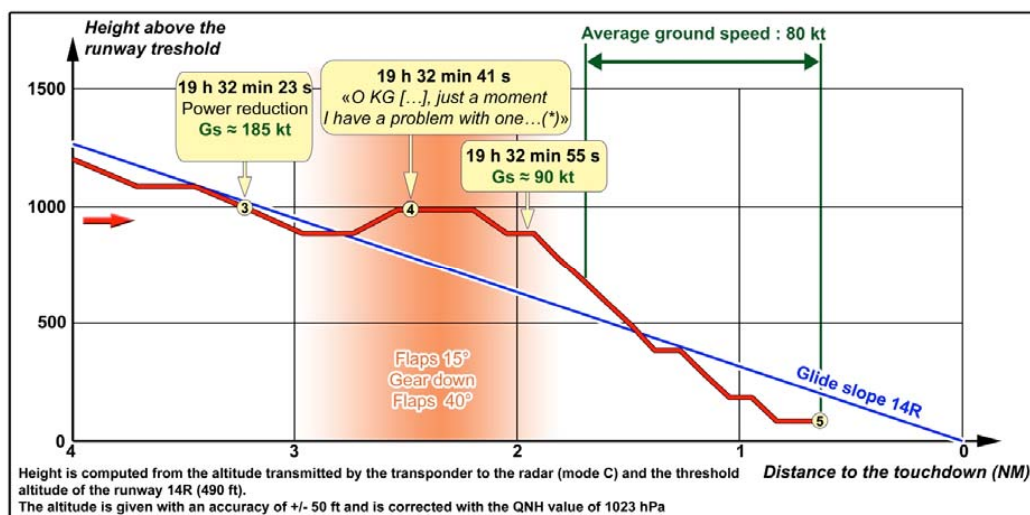
Figure 8 - Probable sequence of flap and gear extension during final approach

The approach controller asked the pilot if it was possible for him to maintain his speed. The pilot confirmed to him that he would maintain it as long as he could. He was probably influenced by this request not wanting to interfere with the airliner which was number two on approach and he decided to carry out a fast approach. This exchange took place about five minutes before interception of the localizer. His speed was about 230 kt on interception of the localizer and dropped as far as 185 kt on interception of the glide path. Decrease to the speed enabling extension of the landing gear began shortly before 1,000 ft from the ground. The pilot was at that moment in IMC conditions and, given the meteorological conditions, had probably acquired visual ground references.

This approach did not meet stabilisation criteria: extended centre line, glide slope, configuration, speed, vertical speed.

The drag induced by extending the flaps to 40 deteriorated performance and contributed to making the speed drop below that recommended by the manufacturer (113 kt). The speed decreased to 90 kt and then became lower than the VMCA approaching the stall speed.
