# INVESTIGATION REPORT

**Serious incident** to Airbus A321  
registered **TC-OBZ**  
on 26 September 2013  
during approach to  
Deauville-Normandie aerodrome  
operated by **Onur Air**

**BEA**  
Bureau d'Enquêtes et d'Analyses  
pour la sécurité de l'aviation civile

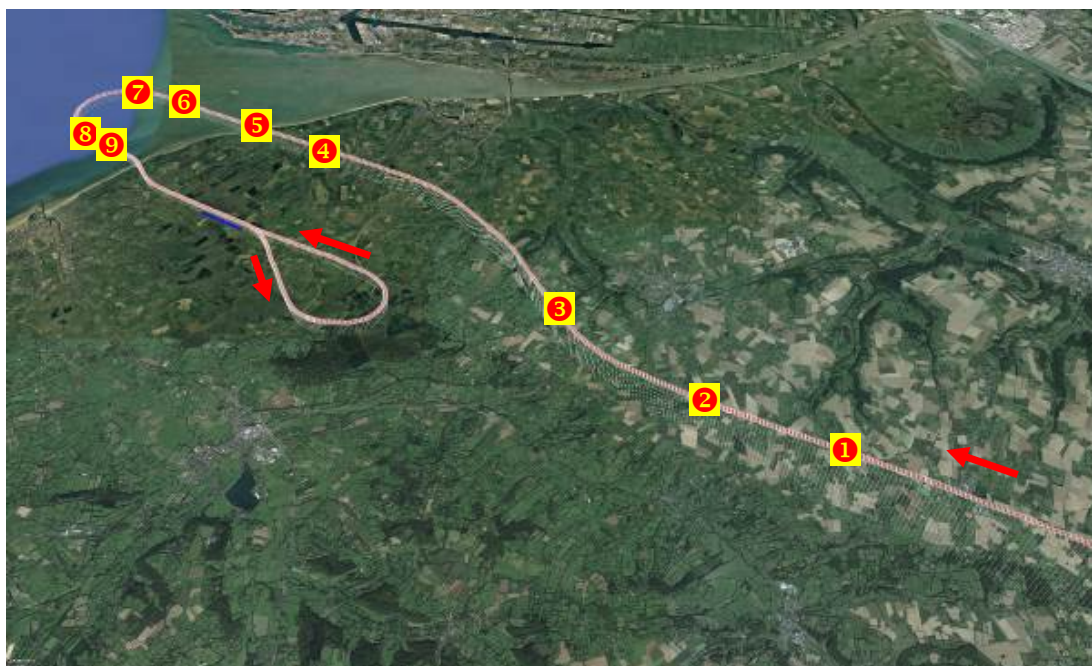
Figure 1: flight path of the incident (approach) based on QAR data

At 9:17:29 (point 6 *Figure 1 and Figure 3*), the crew was cleared to turn left to align with the runway. The aircraft was then 2.3 NM from the threshold. The crew no longer had the runway in sight but could see the surface of the sea as well as the coast. The ground spoilers were armed. A descent rate of 650 ft/min was selected (which caused the autopilot to switch to V/S mode) and the aircraft started to turn to the left with a heading of 275°. The managed speed was engaged. The flaps were extended to position 3. A descent rate of 450 ft/min was engaged and a target heading of 229 degrees was selected.

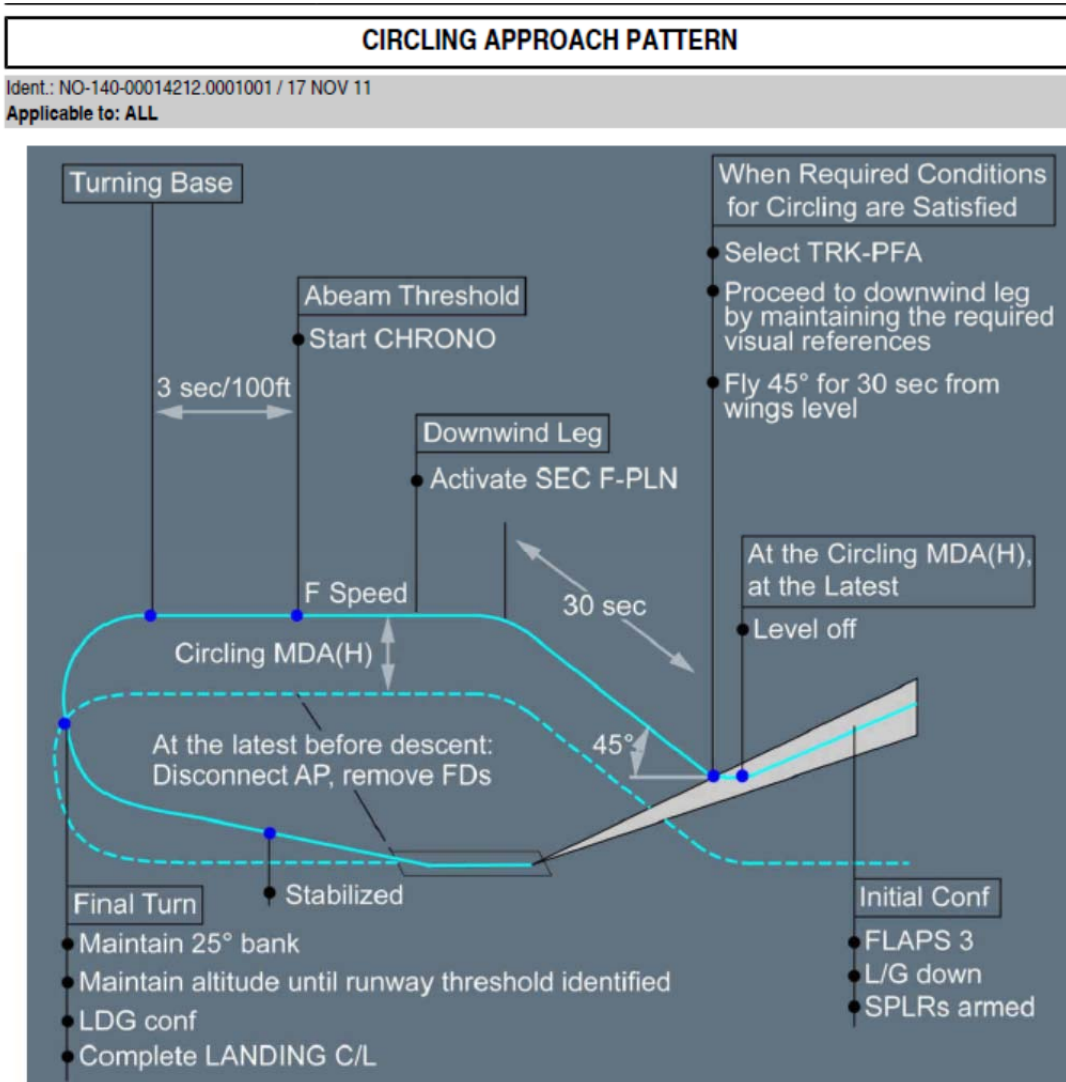
Figure 4: MVL procedure (excerpt from Onur Air FCTM)

The secondary flight plan must be completed and include the landing runway. The initial let-down must end at the latest at the MDA with the aircraft configured to flaps in position 3, landing gear down and airbrakes armed. Speed F must be entered as a FAF constraint. When beginning the turn, the crew must select TRK FPA (Bird ON), bank 45° for 30 seconds and maintain speed F. In the downwind leg the crew must activate the secondary flight plan and start CHRONO abeam the threshold. They must fly for 3 seconds for every 100 ft of height. They must then turn with a bank of 25°. When they intercept the approach slope, they must extend flaps to CONF FULL and complete the Landing Check List. The AP must be disconnected and the FDs removed before final descent.

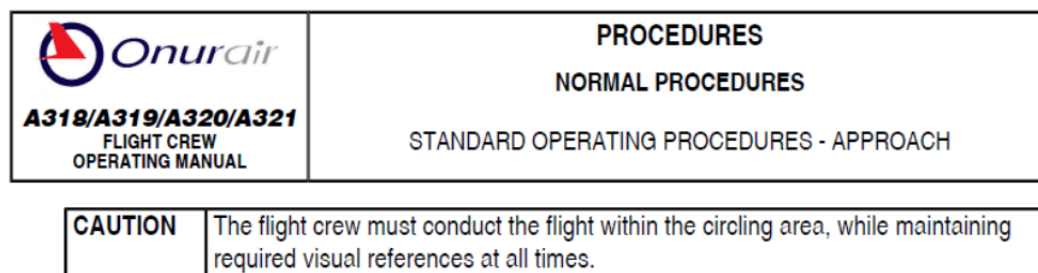
Figure 5: Circling approach caution message (Excerpt from Onur Air FCOM)

A caution specifies that the flight crew must conduct the flight within the circling area, while maintaining required visual references at all times (*cf. figure 5*).

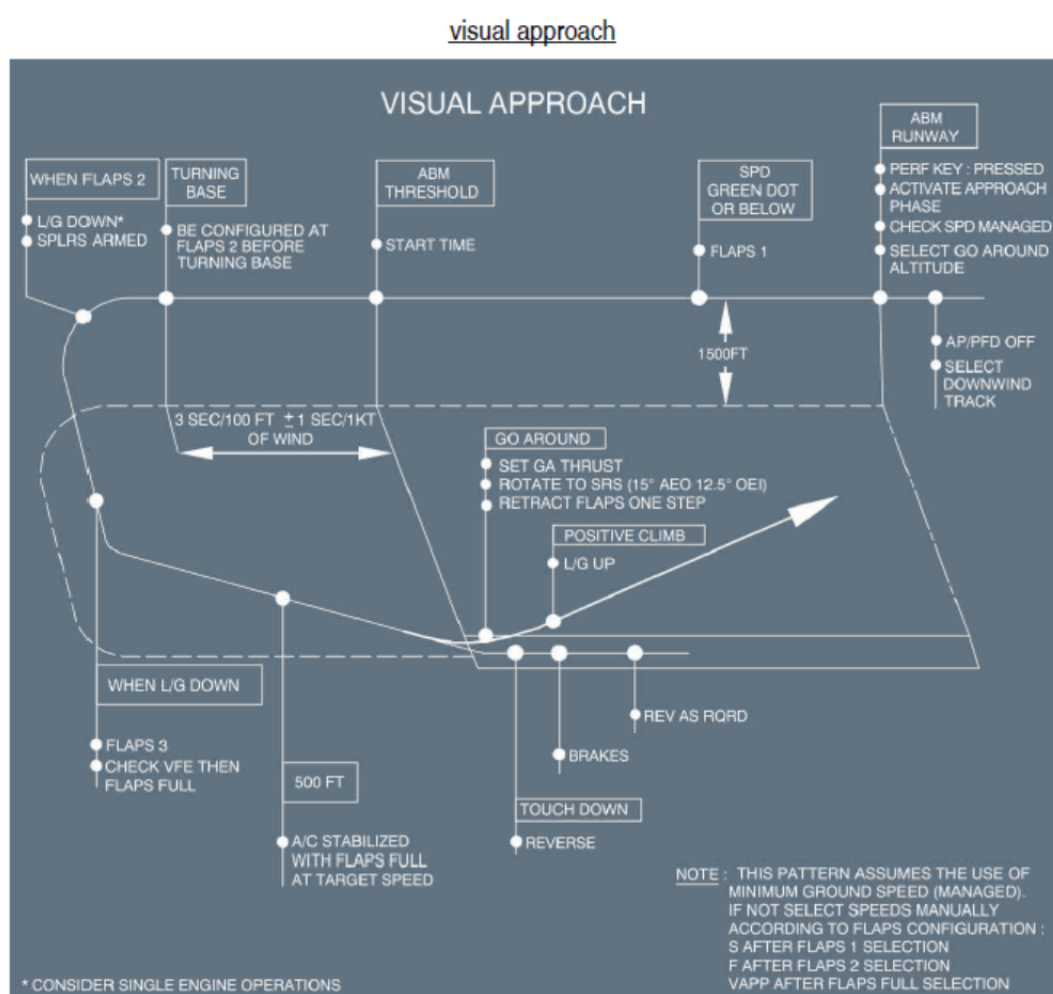
Figure 6: Visual approach procedure (excerpt from Onur Air FCTM)

The FCTM recommends banking 20° in the base turn and a rate of descent of 400 ft/min progressively increasing to 700 ft/min once established on the approach slope. Using the ND as a flight path aid in ROSE NAV mode with the scale set to 10 NM can help the pilot view the flight path.

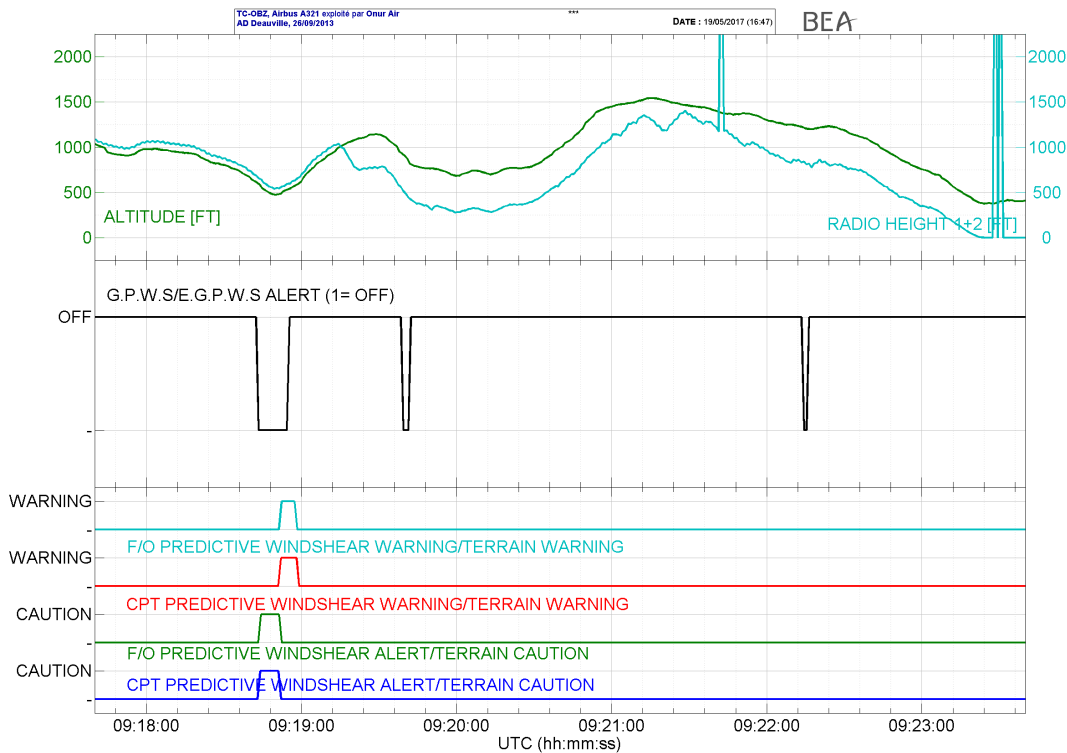
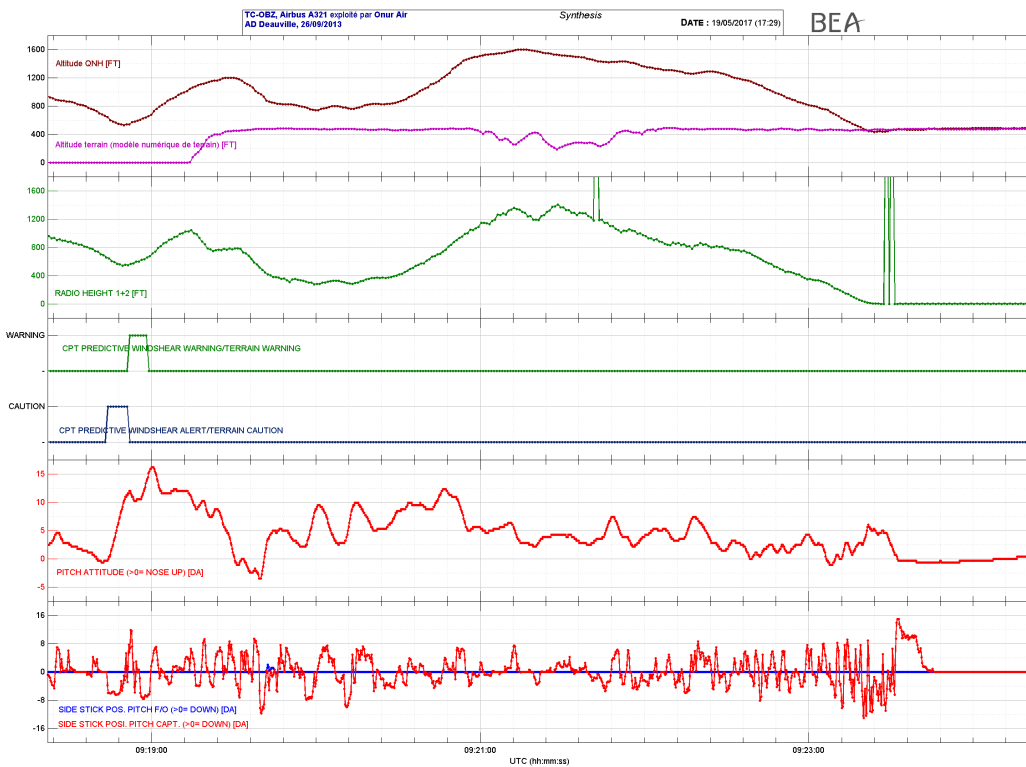
## Appendix 9 GRAPHS BASED ON QAR PARAMETERS

The curves of the event can be found in Appendix 9.
