Examination of the aircraft Examination of the left and right propellers

Accident to the Fokker - F27-500
operated by **Miniliner SRL**
registered **I-MLVT**
on 25 october 2013
at **AD Paris Charles de Gaulle (95)**

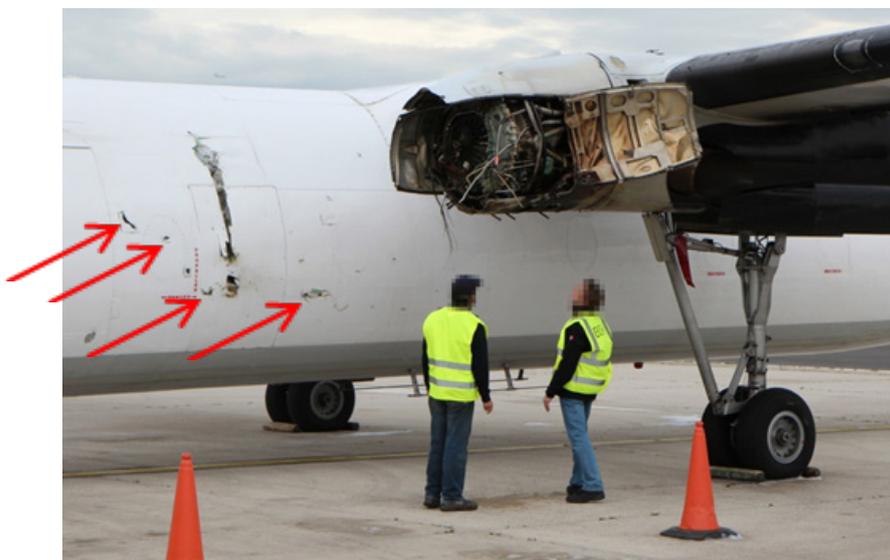
- the propeller and the left engine; the propeller was missing as was the front of the engine. Part of the left side of the engine cowling was folded backwards (figure 3);

Figure 3: Propeller missing left side - left engine damaged - opening in the fuselage and traces of impacts

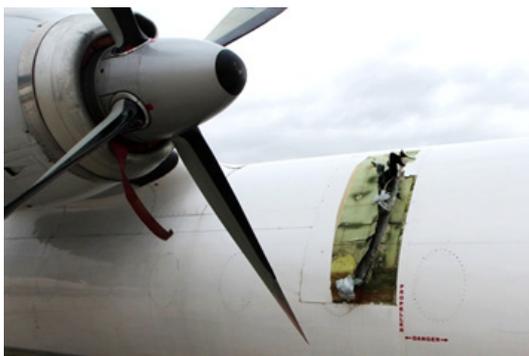
Figure 4: Opening in the fuselage, right propeller side

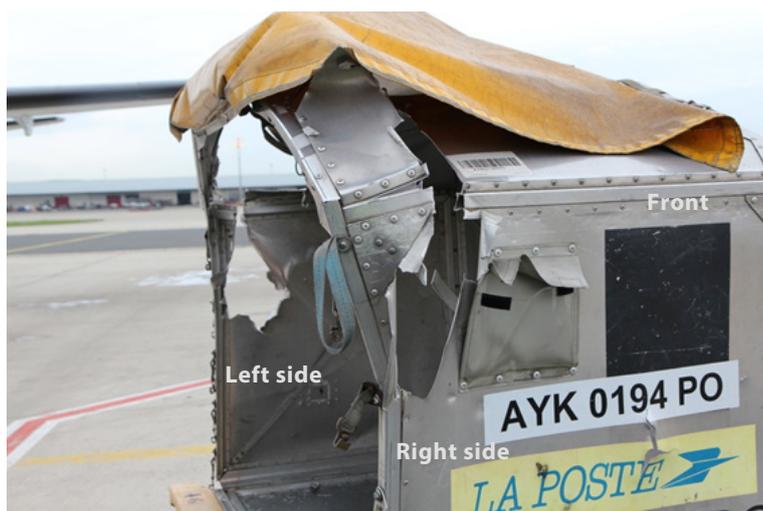
The container that was in line with the two openings at the time of the event also had perforations, the contours of which were deformed from the outside inwards on the left side, and from the inside outwards on the right side (figure 8).

Figure 8: Mail container damaged during the event

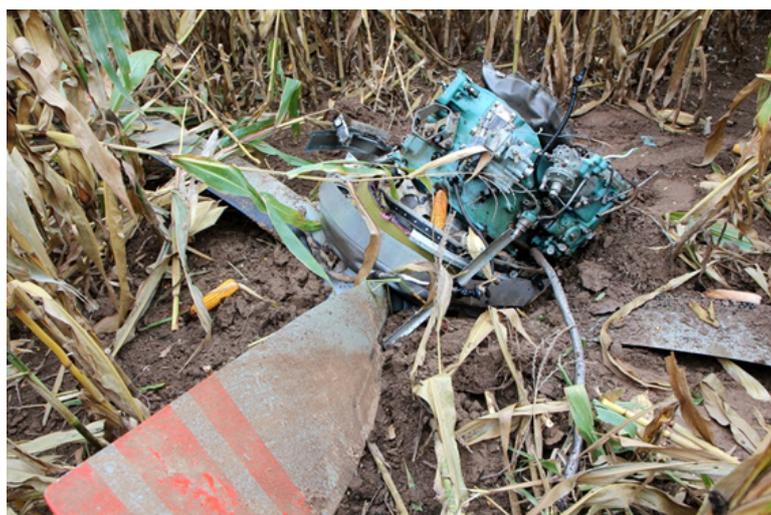
Figure 9: left propeller with blades 1, 3 and 4 and the front part of the engine

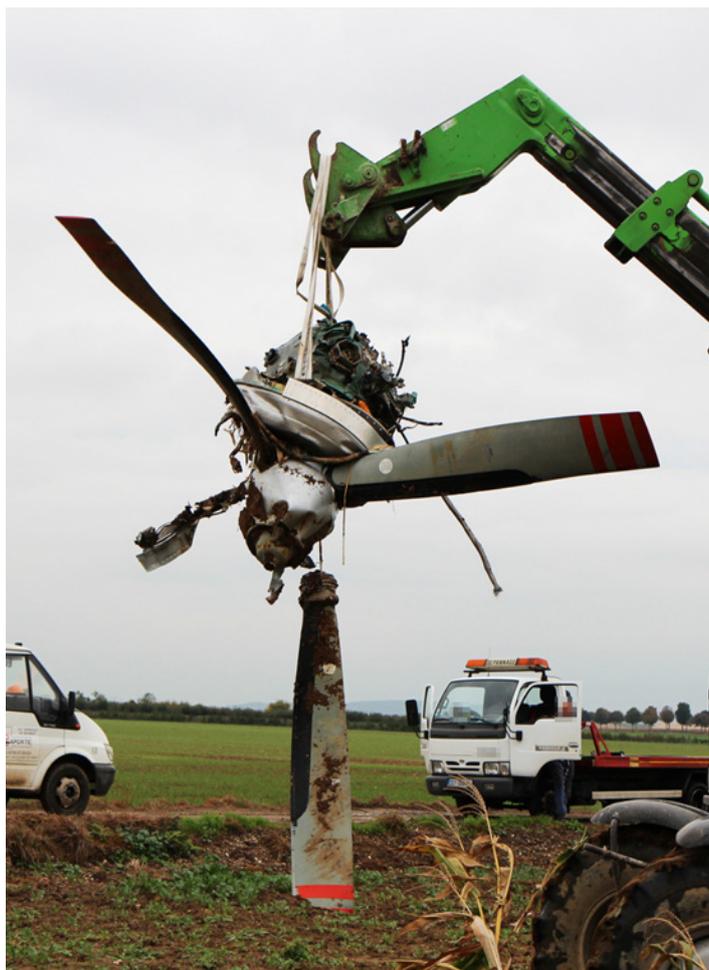
The rest of the left propeller with blades 1, 3 and 4, secured to the front of the engine and missing from the aeroplane, was also found in a field, cone towards the ground. Blade no.1 was only attached to the propeller by a de-icing system wire. Its end was broken, and part of the blade was missing (figure 10).

Figure 10: left propeller during lifting. Blade no.1 is only attached to the propeller by a de-icing system wire

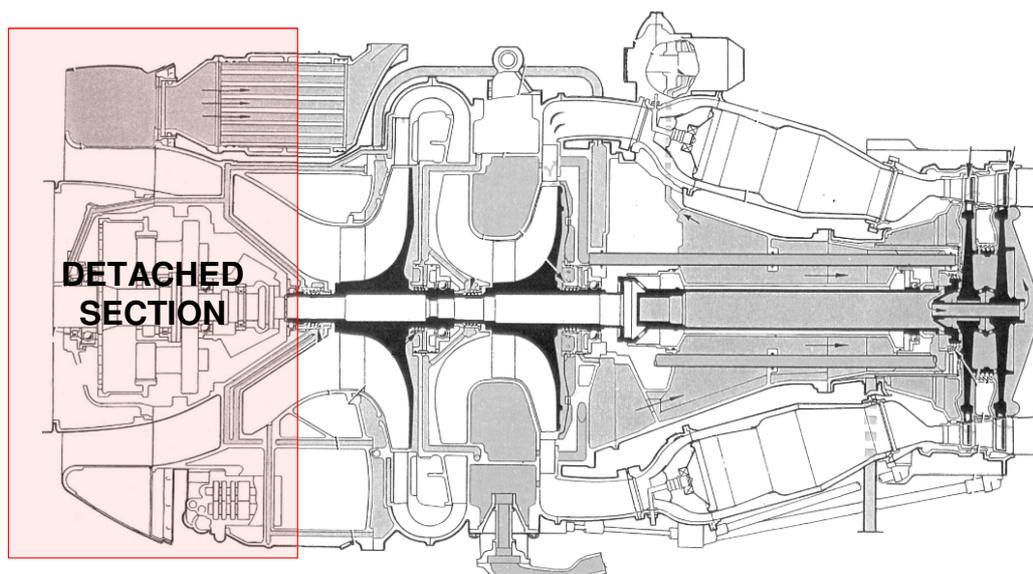
- ❑ The engine no.1, S/N 15101, was still attached to the aircraft but the front end of the engine had separated at the location immediately forward of the 1st stage compressor casing, (figure 11).
- ❑ The reduction gear drive shaft splined drive had sheared during separation of the reduction gearbox and air intake casing.
- ❑ The vanes of the first-stage centrifugal compressor showed significant damage. Traces of friction were noted on the vanes, consecutive to contact with the compressor inlet casing, and with the air intake.
- ❑ In different places on the cooling system of the engine there were black deposits, paint blisters and burns characteristic of the presence of fire.
- ❑ The engine spool was rotated using hand pressure on the 1st stage centrifugal compressor, thus indicating that the engine had not seized.

Figure 11: Sectional view of an RR Dart 532-7 engine.
In red, the separated part of engine no.1.

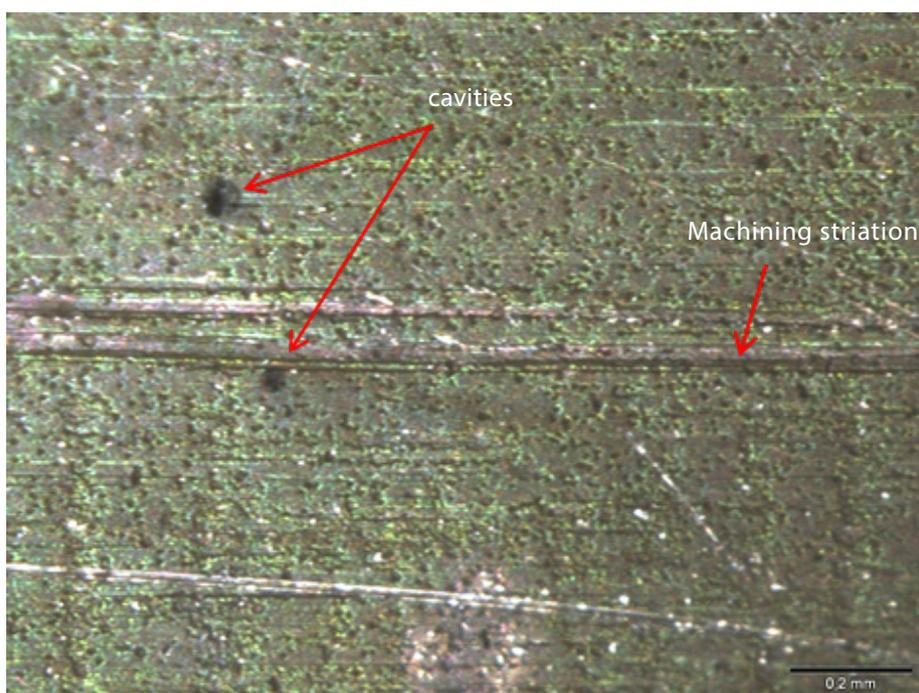
On bolt nos.1, 3 and 4, surface defects were observed by magnetic particle inspection. In most cases, the defects indicated through-cavities. More rarely, the indications revealed machining striations (figure 16).

Figure 16: through-cavities and machining striation on the side of a bolt (bolt no.1)

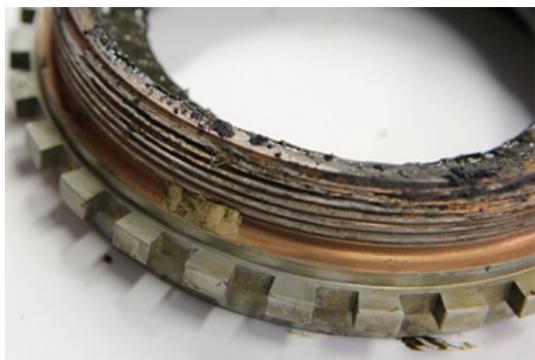
The bearing of blade no.1 was severely damaged. The external thread of the central race was torn in places (figure 20) due to the separation of blade no.1 from the hub during its collision with blade no.2 (see § 1.3.3.4) and then with the ground.

Figure 20: external thread torn, central ring

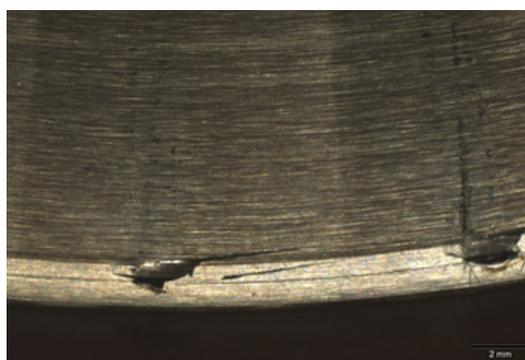
All of the outer rollers and cage were destroyed. Some of the rollers were fractured by compression forces. The raceway of the outer ring showed severe indentation. The lower race of the central ring was cracked over its entire circumference and also had severe indentations (figure 21).

The damage was consistent with the shock of blade no.1 against blade no.2 and the separation of blade no.1 from the hub.

Figure 21: cracking and indentation of the lower race of the central ring

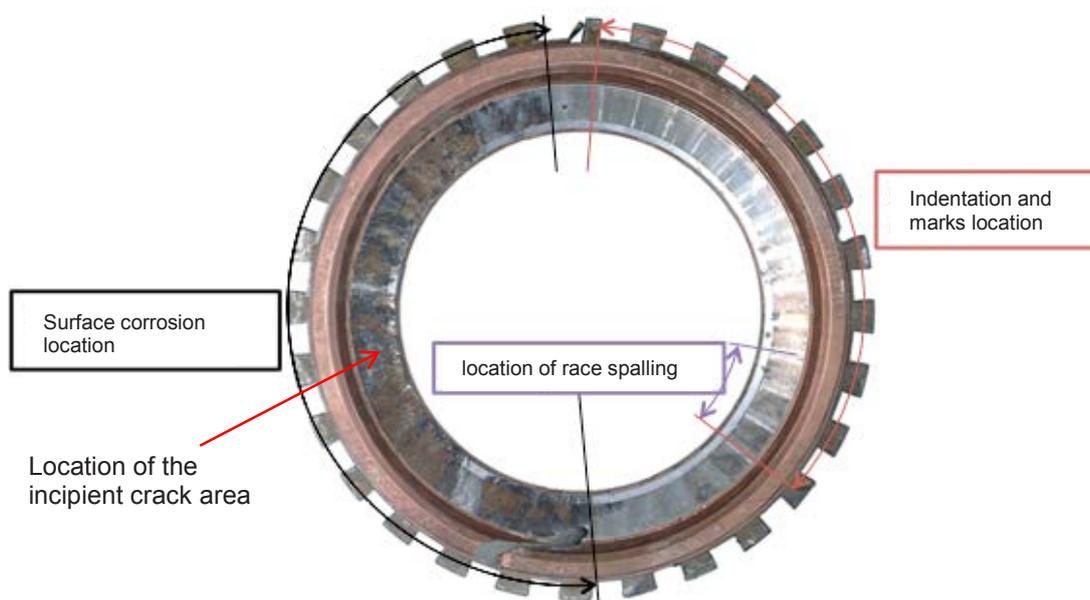
- ❑ on the central ring, outer side, several areas of surface corrosion and slight contiguous indentation marks, eccentric with respect to the normal position of the rollers on the race;
- ❑ on the lower race of the central ring, the presence of surface corrosion on approximately 180° and contiguous indentation marks spaced from the roller pitch over approximately 130° . This area was located opposite the incipient crack area of the bolt;
- ❑ on the inner rollers, traces of surface corrosion and slight indentation marks and very occasional spalling;
- ❑ on the race of the lower ring, traces of surface corrosion, and a few contiguous indentation marks;
- ❑ a fracture of one sector of the lip seal, which had propagated from the inside of the bearing to outside.

No damage prior to the event could be brought to light. The damage observed was consistent with the separation of blade no.2 and the induced loads.

Figure 22: damage found on the outside of the central ring
(Photo DGA-EP)

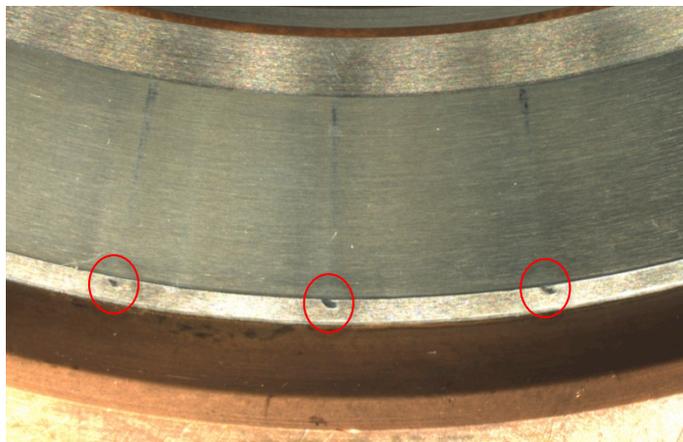
The general condition of bearing of blade no.3 was found to be correct. However, indentations were observed locally on the lower race of the central ring, outside the raceway (figure 23).

These marks may be related to the impact of the propeller with the ground.

Figure 23 : indentation of the lower race of the central ring

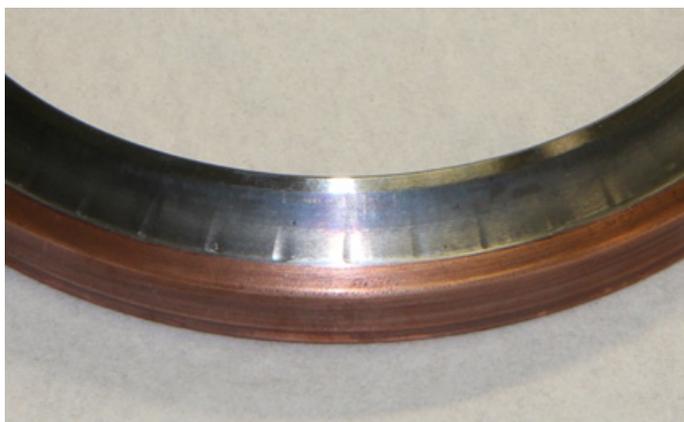
The bearing of blade no.4 had relatively large indentations (brinelling), especially on the races of the upper bearing (figure 24). According to the manufacturer's representative, an aeroplane cannot fly if the bearing of one of its propeller blades has brinelling of this size, which would cause problems controlling the propeller pitch. The marks were therefore more likely to be consecutive to the event, in particular to the shock of the propeller with the ground.

Figure 24: Severe brinelling and traces of blooming on the raceway of the outer ring

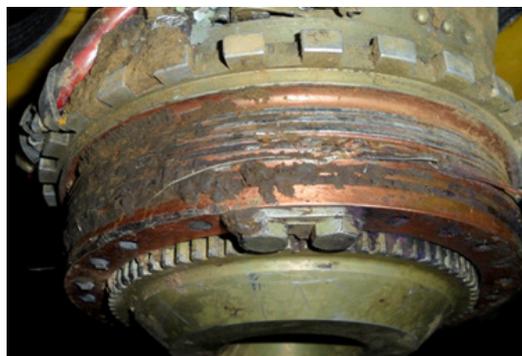
The first observations showed that the thread used to attach the blade in the hub was damaged (see §1.3.3.3.1- Bearing of blade no.1 - figure 25 and Figure 26).

Figure 26: root of blade no.1 - damaged thread

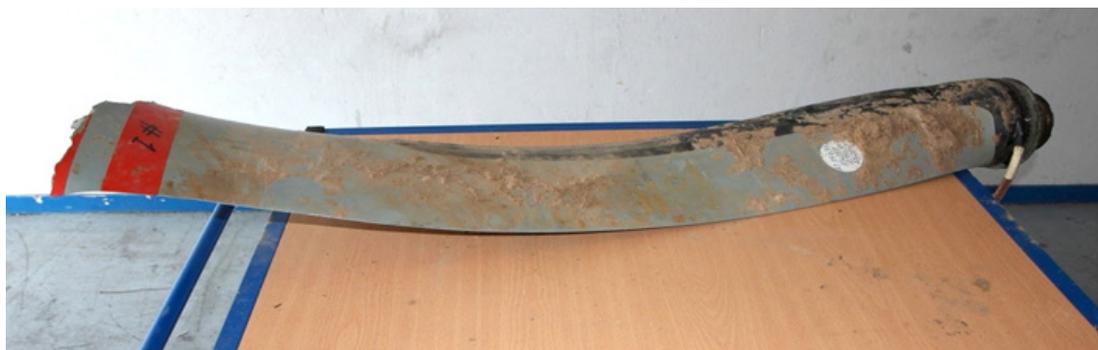
Figure 27: bending and twisting deformation of blade no.1

The blade has been subject to bending and twisting deformation, and its tip (approximately 150 to 200 mm in length) was missing (figure 27). The fracture of the blade tip was sudden and ductile in nature (granular fracture surface). The clean appearance of the fracture was noted (no earth). There were unusual marks near the fracture area, on the pressure side (figure 28). These marks indicated that blade no.1 hit blade no.2 after the latter broke. This was because the marks corresponded to an impact with the serration of a blade root (figure 29). In addition the serration of blade no.2 was damaged and the geometric matching of the serration with the marks of blade no.1 confirmed this hypothesis (figure 30). The deformations of blade no.1 and the fracture of the tip were therefore consecutive to this impact. An illustrative diagram of the sequence is proposed in figure 31.

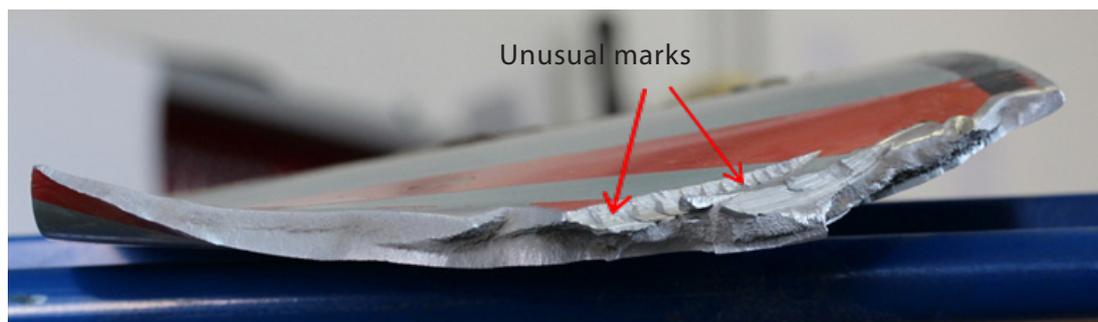
Figure 28: fracture zone at the tip of blade no.1 and unusual marks

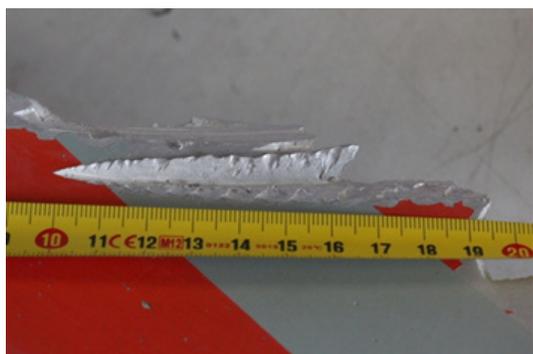
Figure 29: marking of the pressure face of blade no.1 in the vicinity of the fracture

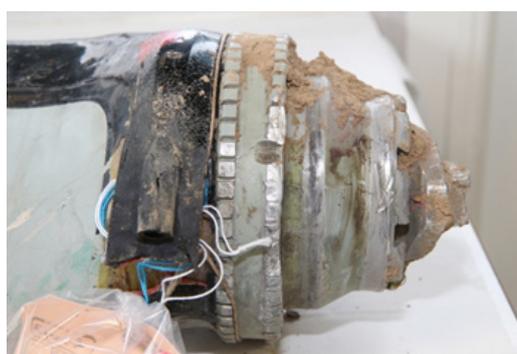
Figure 30: damaged serration at the root of blade no.2

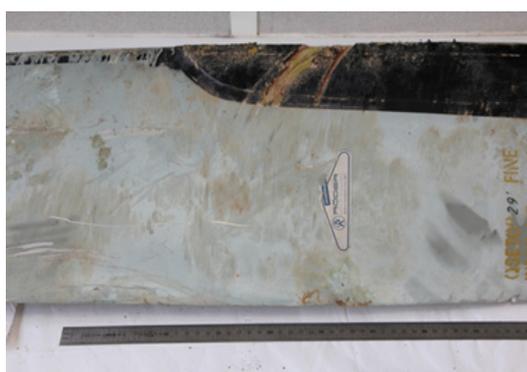
Blade no.2 was found in a field (figure 1). The blade tip was slightly bent towards the pressure side. The leading edge was damaged in several places (figure 32). One part of the damage was particularly pronounced, its shape being curved. It extended from the leading edge to the pressure side and the upper surface. The end of the leading edge was bent towards the rear (figure 36).

Figure 32: severe damage on the leading edge

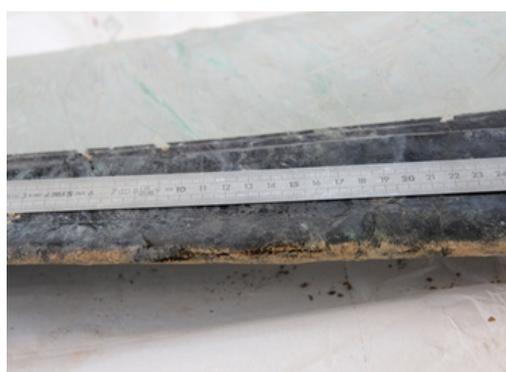
Figure 33: radial cracks in the elastomer of the de-icing system

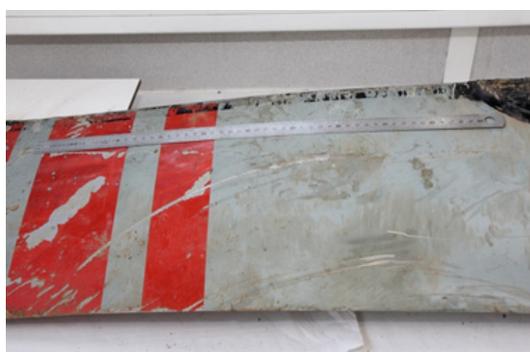
Figure 34: curved scratches on the upper surface

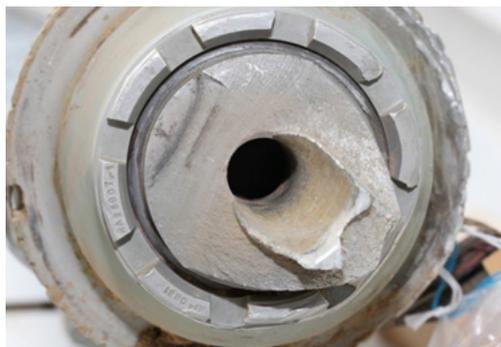
Figure 37: fracture surface of the preload bolt showing signs of fatigue

The fracture surface of the preload bolt (figure 37) was extracted from the blade by cutting then cleaned with ethanol. The fracture surface was located 8.7 mm under the bolt head (figure 38) in the fillet.

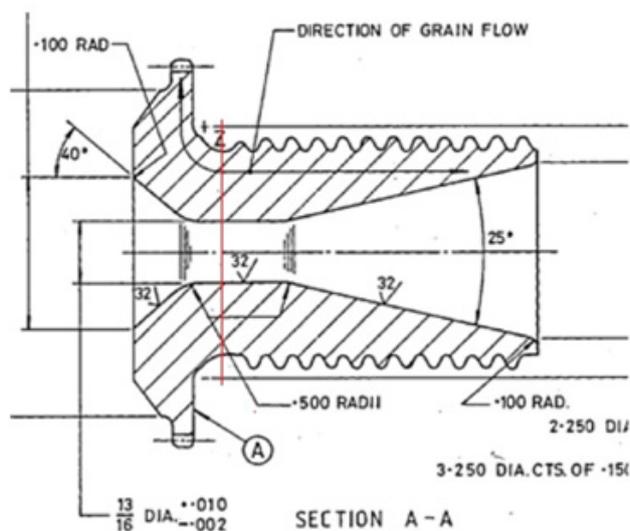
Figure 38: fracture section of the bolt (in red)

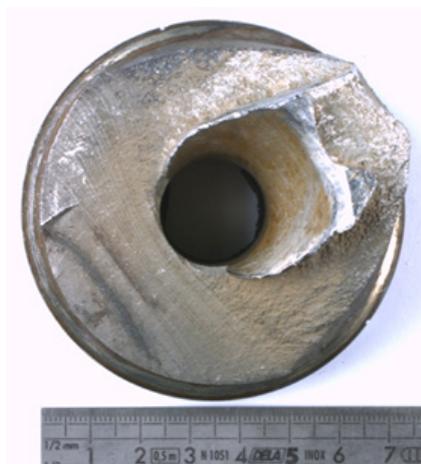
Figure 39: fracture surface of preload bolt no.2

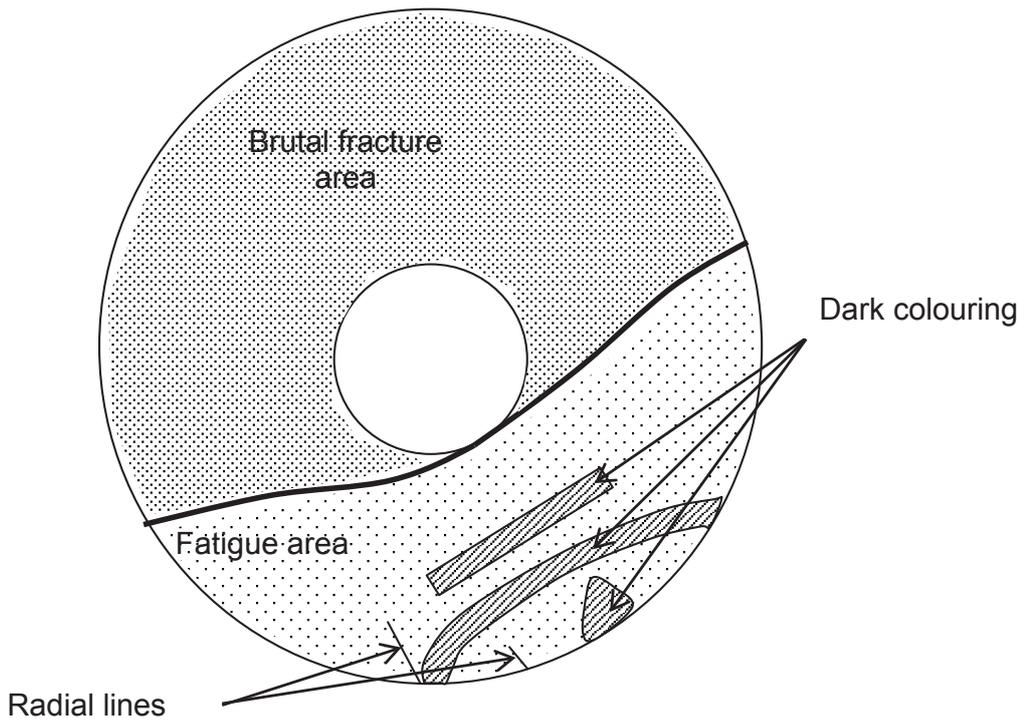
- ❑ 40 beach marks could be counted between the incipient crack (line concentricity area) and the first dark area, covering 70% of the area. Of the remaining 30%, close to the initiation area, the information was degraded by the openings and re-closings of the crack;
- ❑ 15 beach marks could be counted between the two areas of dark colour;
- ❑ 25 beach marks could be counted between the second area of dark colour and final fracture zone.

Figure 41: fractographic description of the fracture surface of the preload bolt of blade no.2

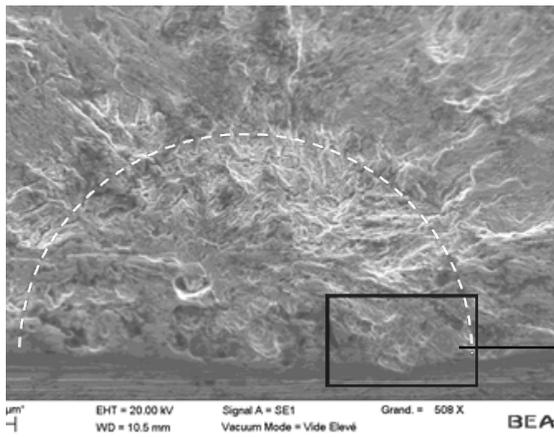
SEM observations of area A1 highlighted a main crack initiation area, the morphology of which differed from the rest of the fracture surface (figure 47). The main crack initiation area, approximately covering a semi-circle of 100 µm in diameter, had a fracture surface with local porosities (figure 48). Traces of cadmium were also visible locally.

Figure 47: morphology of the main crack initiation area

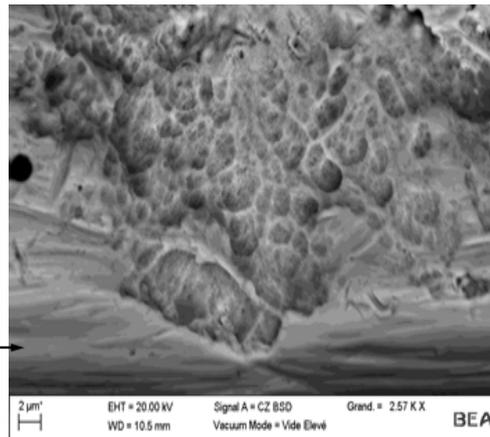
Figure 48: porosities in the main crack initiation area (detail of Figure 47)

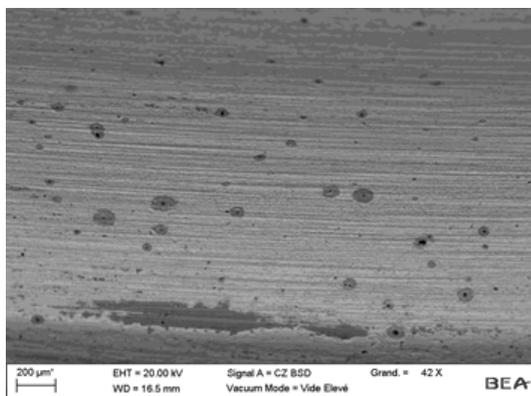
Figure 49: through-cavities on the side of the bolt

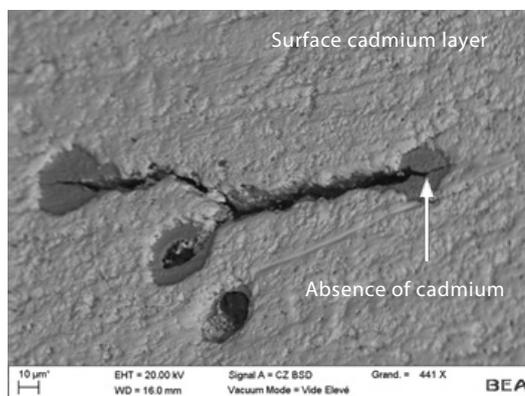
Figure 50: cavities and crack on the side of the bolt

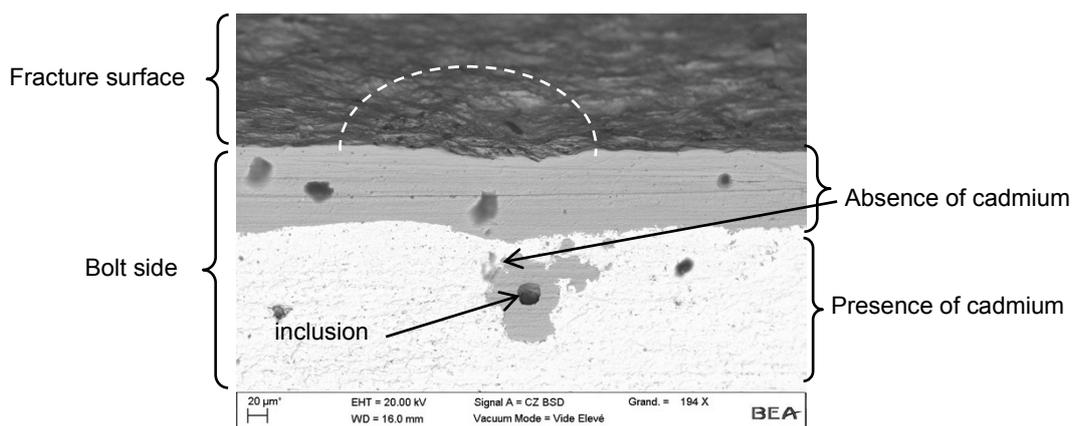
Figure 51: inclusion visible on the side, approximately 100 µm from the fracture surface

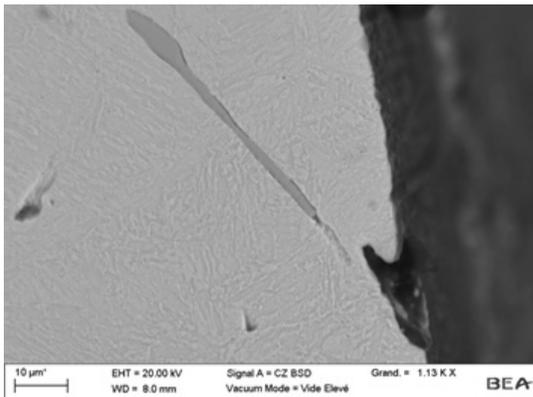
Figure 57: filiform manganese sulphide and surface cavity

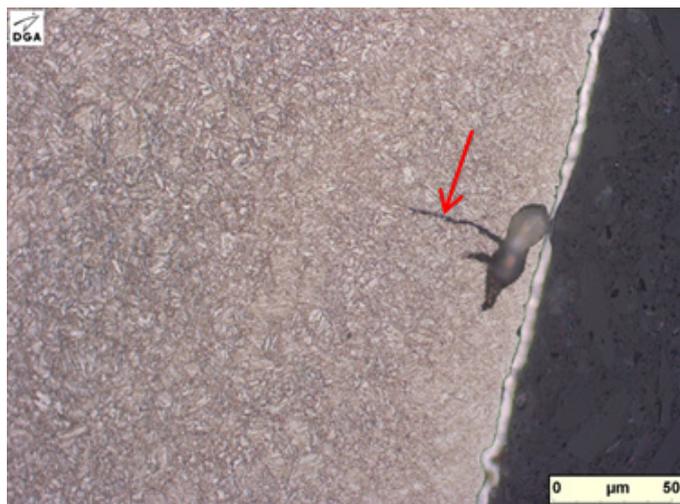
Figure 69: crack initiated in a surface cavity (detail of the box Figure 68) - Photo DGA-EP

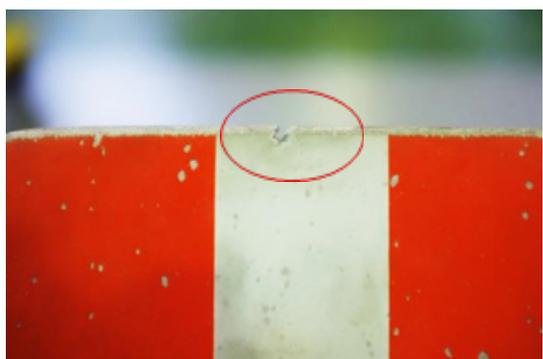
Figure 71: impact traces on the blade no.1

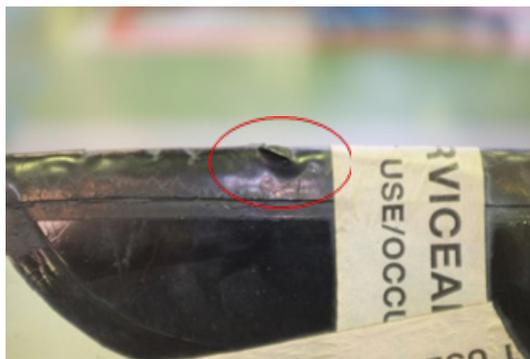
Figure 72: damage to the de-icing system of blade no.2

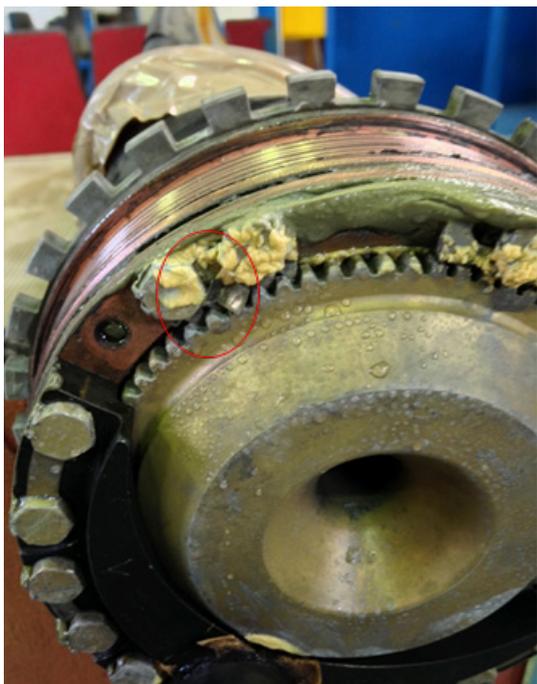
Figure 73: shim found outside the bearing/bolt assembly - traces of moisture

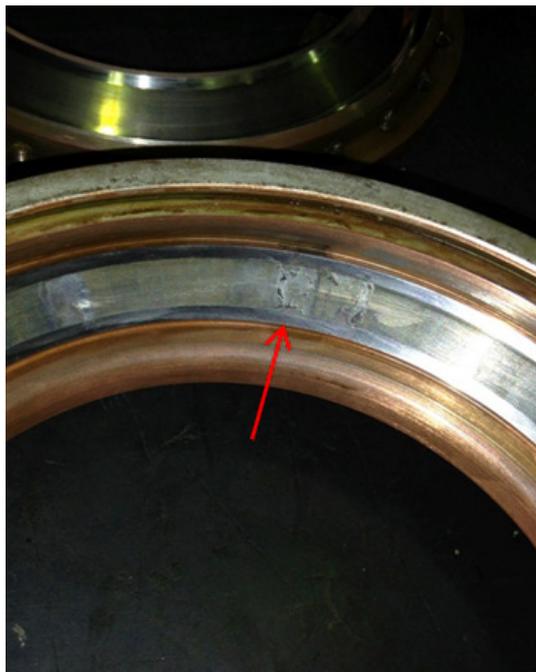
Figure 74: corrosion visible on one of the raceways

The seal was found twisted, allowing moisture to penetrate the bearing, and grease to escape. This resulted in the emergence of severe corrosion pits on the bearing raceways, resulting in a significant loss of the bearing pre-load. Stress in service on the preload bolts was thus significantly increased, causing the fatigue failure of the bolt in the fillet radius under the bolt head.

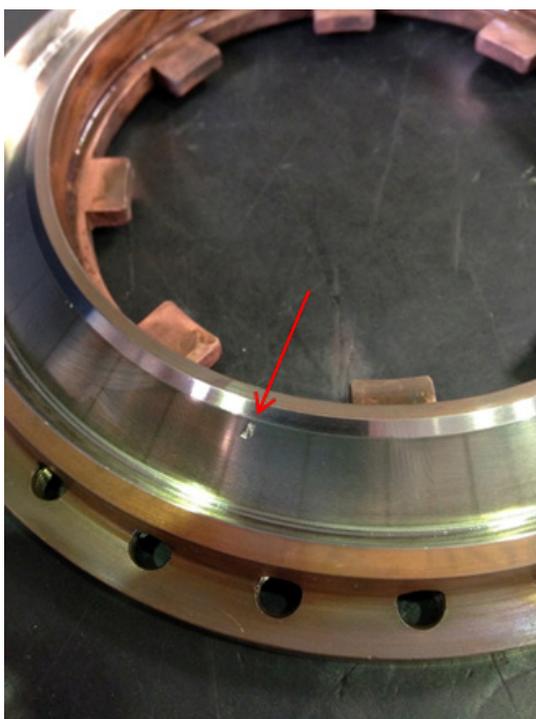
Figure 75: damage to the race of bearing no.2
