Accident to the TECNAM - P92 S ECHO
identified **01VA**
on 30 September 2021
at Saint-Rambert-d'Albon

Time	Around 18:25 ¹
Operator	Private
Type of flight	Local
Persons on board	Pilot and passenger
Consequences and damage	Pilot and passenger fatally injured, microlight destroyed
This is a courtesy translation by the BEA of the Final Report on the Safety Investigation published in October 2022. As accurate as the translation may be, the original text in French is the work of reference.

Reduction in engine power in initial climb, right turn, stall

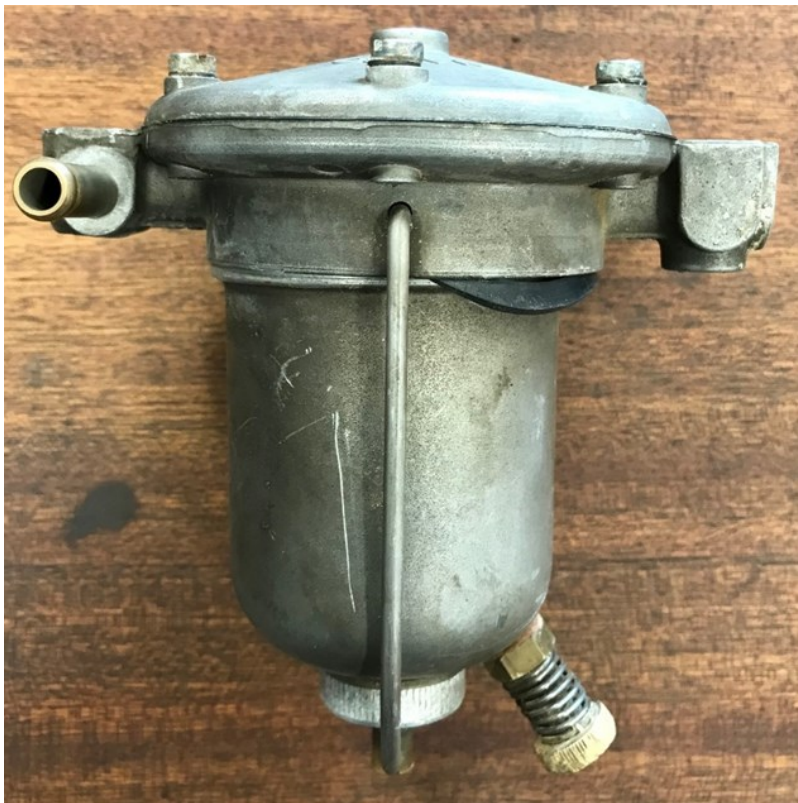
- The tab that locks the wiring harness plug to the fuel injection electronic control unit (ECU) was found broken with the plug disconnected. When this plug is disconnected, the engine immediately shuts down. Given the damage observed to the wiring harness, the tab breakage and the plug disconnection most likely occurred during the collision with the ground.
- The seal between the top of the filter and the strainer was pinched and protruded outside the filter. In this configuration, a substantial fuel leakage occurs when the filter strainer fills. A test was carried out by the BEA to determine the flow rate of this fuel leak. With no pumps (by gravity), the leakage was 1.4 to 1.5 l/min, i.e. an average of 90 l/h. With the pumps running, the leakage was 0.2 to 0.3 l/min, i.e. an average of 15 l/h.

Figure 2: fuel filter, with pinched seal (source: BEA)

According to the manufacturer of the injection kit, an air leak on the part of the system between the fuel filter and the surge tank⁵ may have a major impact on engine operation. Taking into account the pump's output, if air is sucked in, an engine malfunction may occur very quickly. This malfunction would result in a considerable loss of power, combined with strong vibrations and a possible knocking phenomenon.

When the engine upper cowling is removed for the pre-flight inspection, it is possible to see and access the fuel filter attached to the firewall. As a consequence, the seal pinching could have been detected. Given the flow rate of the leak observed during the tests carried out by the BEA (1.4 to 1.5 l/min with the pump stopped), the pilot should have noticed the flow of fuel at the time of bleeding, or he should at least have detected a strong smell of fuel during the pre-flight inspection. If the pilot only opened the valves at start-up and closed them again just after the engine shut-down, he had no way of visually detecting the leak during the pre-flight inspection. Only a calculation of the average consumption over the last flight(s) could have warned him.

The pilot carried out a local flight of around 46 min. A fuel leak during the flight due to the incorrect positioning of the fuel strainer seal meant that the fuel tanks progressively drained in an abnormal way (average engine consumption plus leak). In initial climb, the engine power decreased. The pilot turned right. During the turn, the microlight stalled and collided with the ground.

If the fuel strainer seal had been incorrectly positioned during a previous flight, the pilot would have been able to detect the consequences. However, the latter did not report any abnormal engine operation or over-consumption of fuel. It is therefore very likely that the fuel strainer was opened and its seal incorrectly repositioned prior to the accident flight, either during the pre-flight inspection or following the penultimate flight.
