**Accident** to the Autogyro Calidus  
identified **02AHO**  
on Saturday 30 September 2023  
at Mardeuil

<b>Time</b>	Around 17:10 <sup>1</sup>
<b>Operator</b>	Private
<b>Type of flight</b>	Local
<b>Persons on board</b>	Pilot and one passenger
<b>Consequences and damage</b>	Passenger fatally injured, pilot injured, gyroplane destroyed

## Collision with a power line during low-height flight

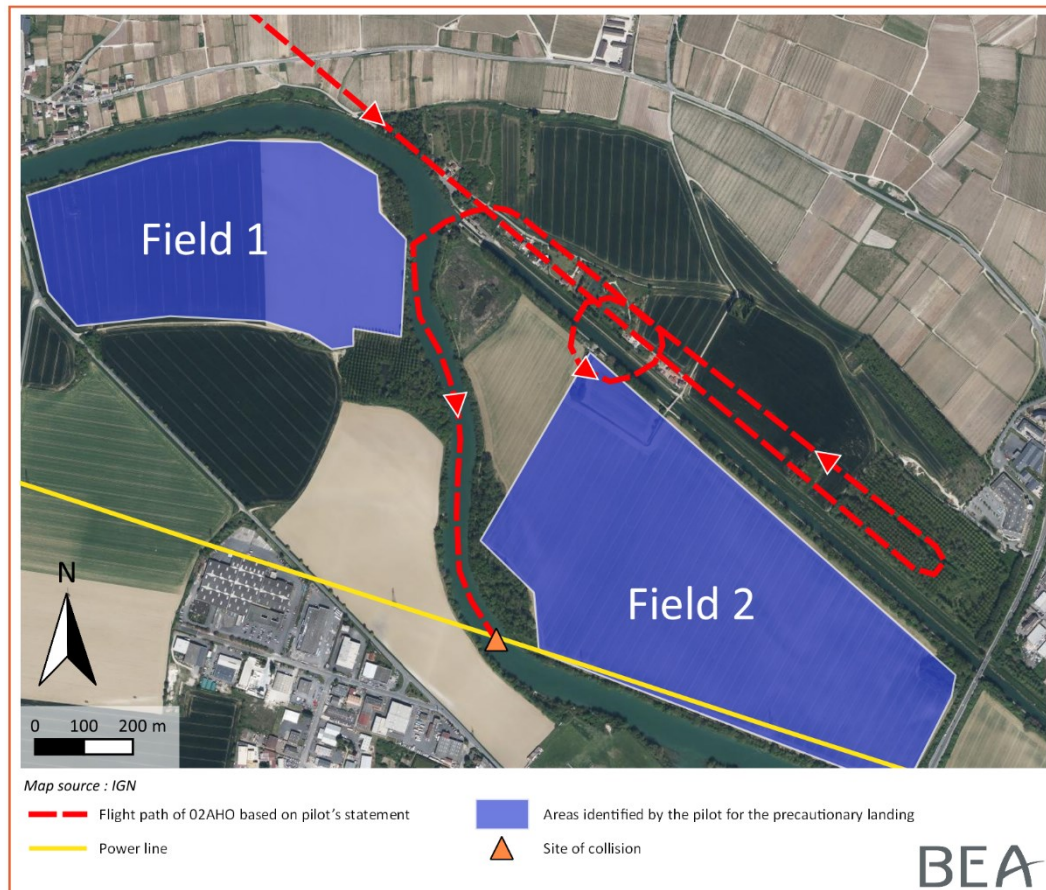
The gyroplane was lying in the middle of the Marne, at around 30 m from a high-voltage power line. One of the power line cables had been severed by the gyroplane's rotor.

Figure 1: aerial view of accident site

A few minutes later, when the pilot was flying over the Marne at a low height, the microlight collided with a power line that the pilot had seen too late.

The investigation was not able to understand the reasons which led the pilot to fly 150 ft overhead the middle of the Marne, at high speed when he had doubts about the operation of the engine. Indeed, the flight path taken by the pilot was not such that a safe precautionary landing could be carried out.

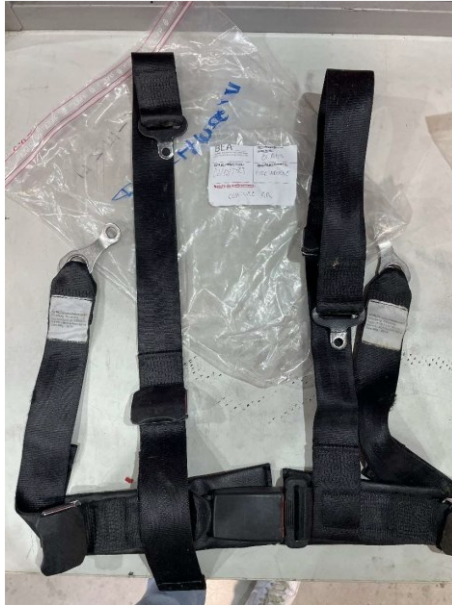
The body of the passenger in the rear seat was found in the wreckage, with the harness fastened. Additional examinations carried out on the pilot's and passenger's harnesses found that the release system was functional. However, if traction is applied to the safety buckle and if a small amount of pressure is applied to the release button, the spring tab may not release the tongue.

Figure 2: view of rear passenger's fastening system (source: BEA)
