**Accident to the LEOPOLD DIDIER - Pti'Tavion
identified 03AEG
on Thursday 18 July 2024
at Isle-Saint-Georges**

This is a courtesy translation by the BEA of the Final Report on the Safety Investigation. As accurate as the translation may be, the original text in French is the work of reference.

Mid-air rupture of a wing, loss of control, collision with ground, in instruction

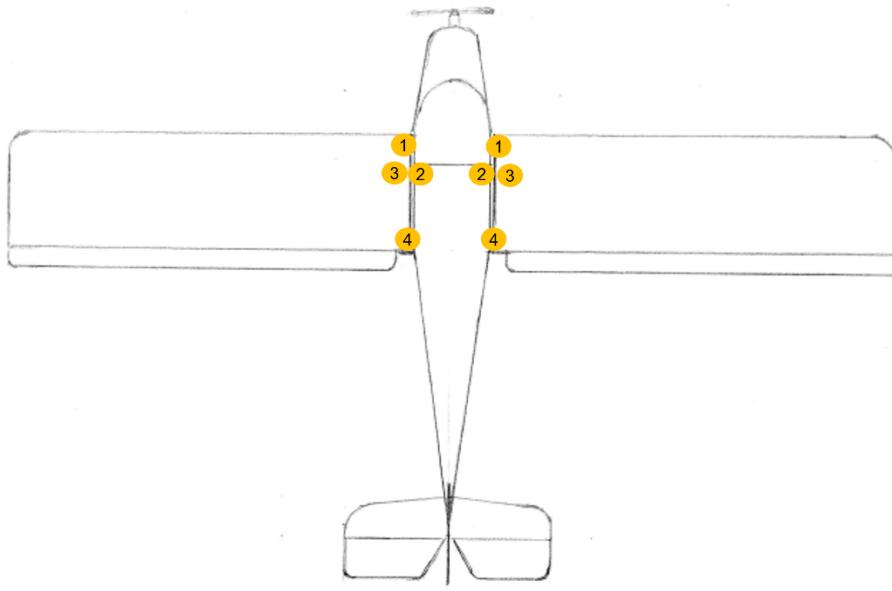
*Figure 3: diagram showing position of wing fastening points to fuselage, top view
(source: technical file for the Pti'tavion VI prototype; BEA annotations)*

All the fastening points of the left wing were found and examined by the BEA. The damage observed on these components was most likely the result of the impact with the ground or the intervention by the emergency responders. This damage did not indicate any defect in the wing's fastening to the fuselage.

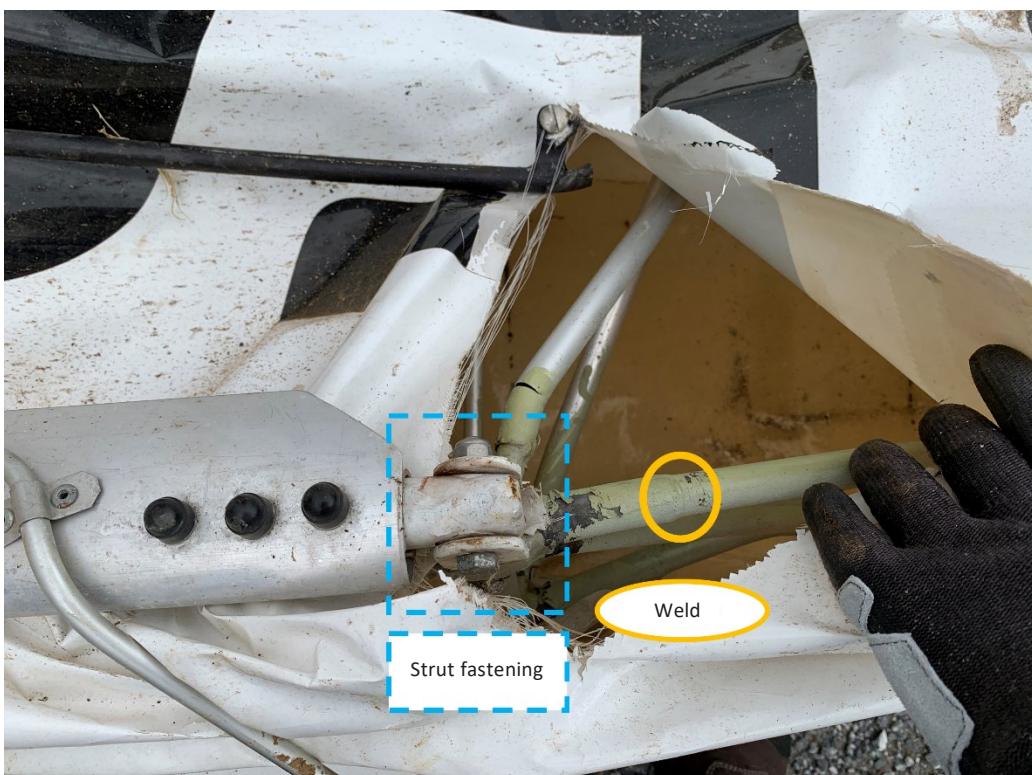
A weld, associated with a reduction in the diameter of the steel tubes forming the front spar, was observed on the right wing of 03AEG.

Figure 5: reduction in diameter of forward spar observed on 03AEG (source: BEA)

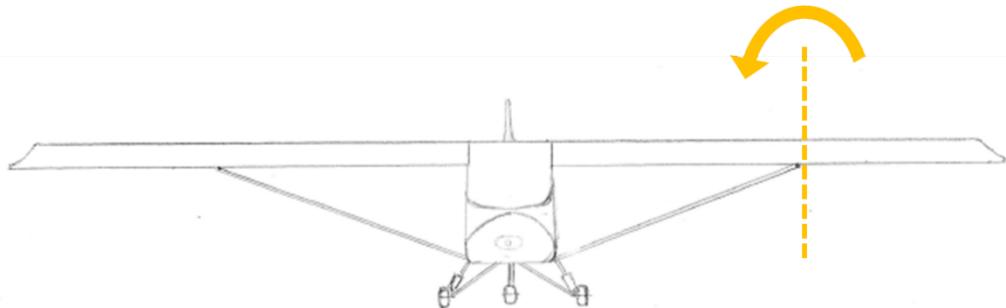
The left wing was complete, but part of it was folded upwards, bent along a line located slightly after the strut fastenings in the direction of the wing tip (see **Figure 6**). Signs of soil were visible on the lower surface of the half of the wing on the root side and on the upper surface of the half of the wing on the tip side.

Based on the signs of soil on the wings and the very different damage observed between the right and left wings, the left wing most probably ruptured in flight, unlike the right wing.

Figure 6: diagram showing the line of bending of the left wing (yellow dashes)
(source: technical file for the Pti'tavion VI prototype; BEA annotations)

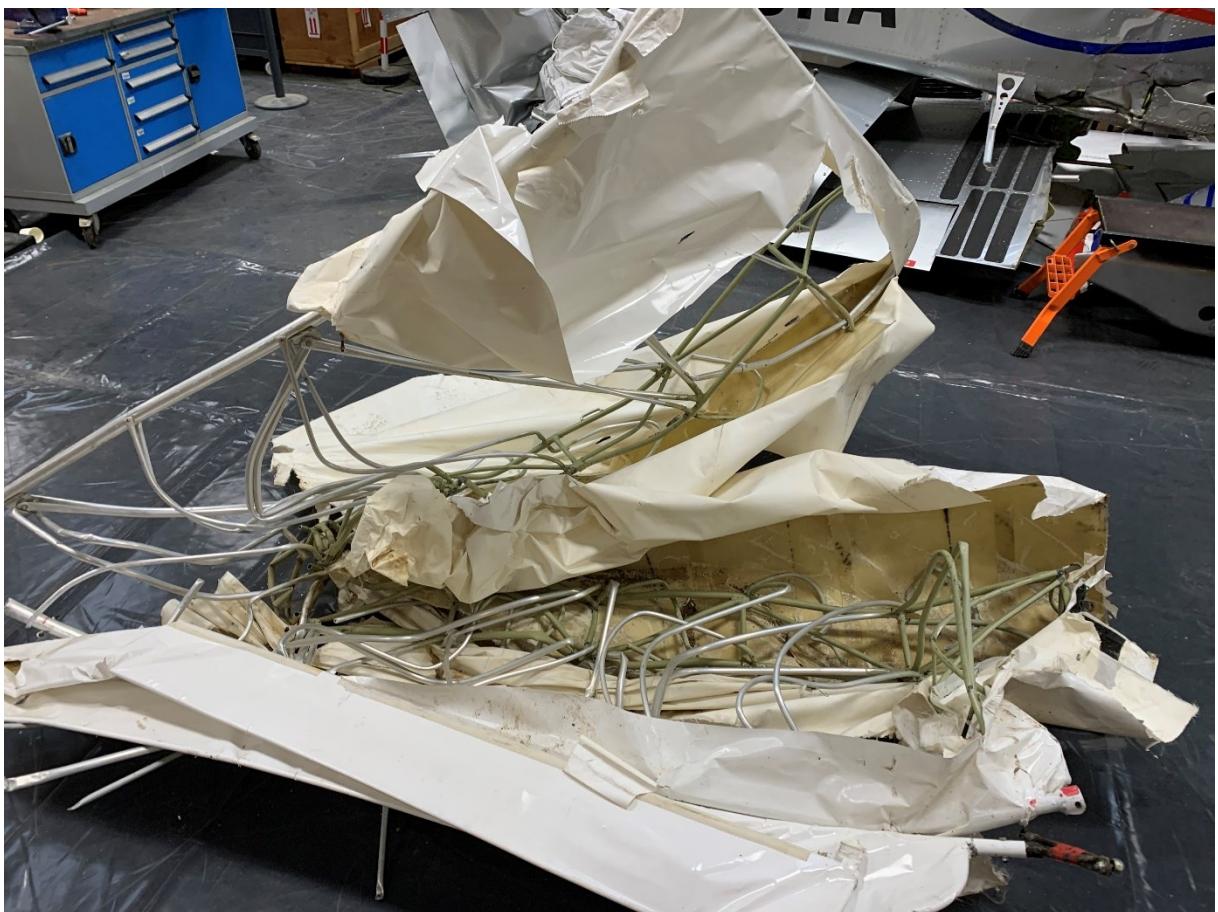
Figure 7: view of left wing of 03AEG with partial separation of aircraft fabric (source: BEA)

The structure of the left wing was examined, and no signs of fatigue were observed. In particular, all the ruptures observed where the wing had bent exhibited a fracture face characteristic of a sudden failure and were thus most likely due to the exceedance of the maximum permissible load on the wing structure before impact with the ground.

A few minutes into the flight, the left wing of the microlight ruptured close to the strut fastenings. It is probable that the bending damage and the sudden ruptures observed were due to the exceedance of the maximum permissible load on the wing structure. The BEA was not able to determine if this rupture was the result of high load factors, a weakness in the wing structure or a combination of these two factors.

- a bulletin addressed to all Pti'tavion and DIDL owners informing them of the accident to 03AEG and recommending they avoid any situation that could lead to high load factors;
- an airworthiness directive prohibiting flights with paying passengers on Pti'tavion and DIDL aircraft.
