Accident to the Aerospool WT9 Dynamic
identified **04FO**
on Sunday 11 August 2024
at Eschbach (Bas-Rhin)

Loss of control, collision with ground, in instruction

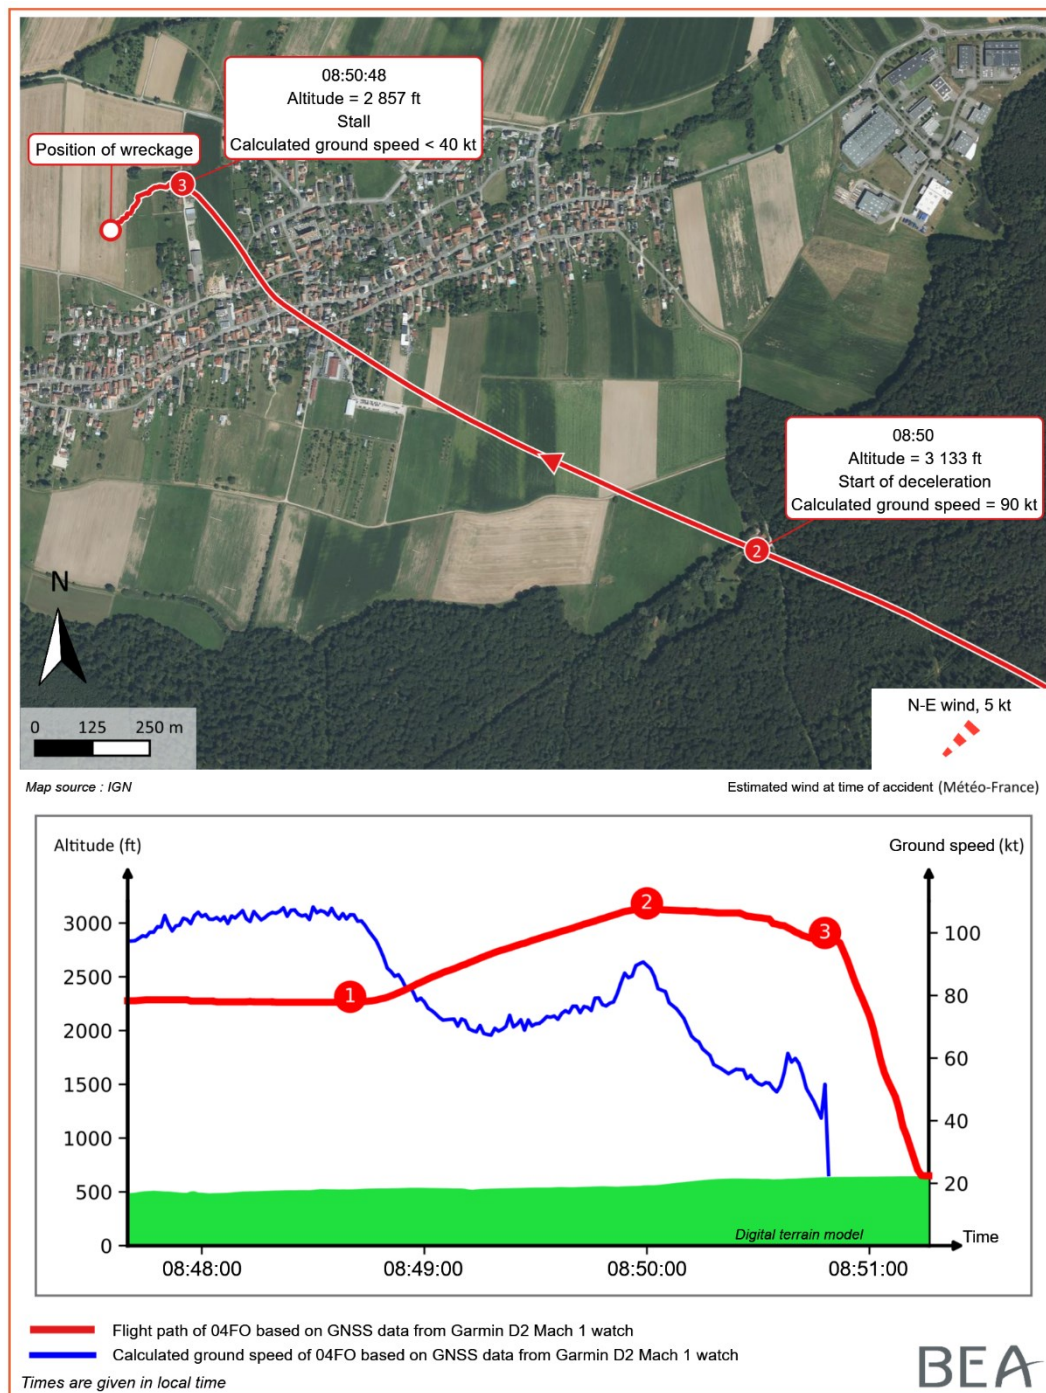
Figure 2: end of flight path of 04FO

The recorded path indicated a sudden decrease in altitude up to the collision with the ground.

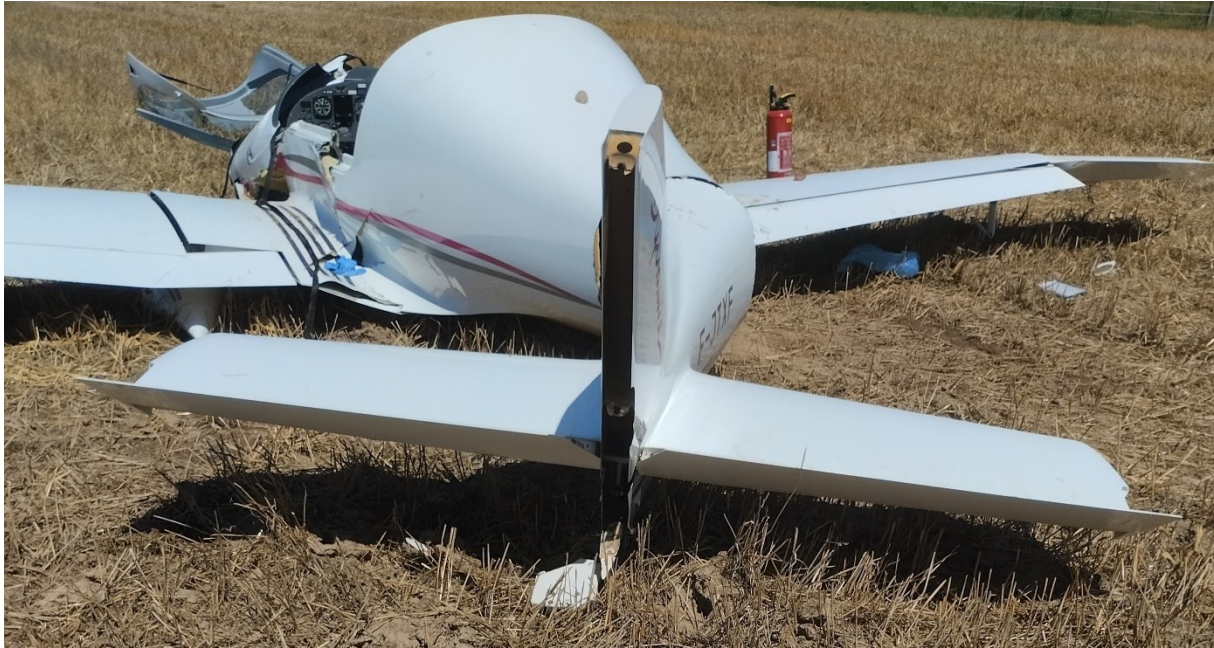
Figure 3: rupture of the rear section of the fuselage (Source: BEA)

The rear section of the fuselage was cut and showing a leftward deviation from the fuselage axis. The landing gears were substantially bent upwards. All of the observations made indicated that the aircraft collided with the ground with a slightly nose-down attitude, in a left-hand rotation, with almost zero horizontal speed and high vertical energy. These observations were consistent with a left-hand spin up to the collision with the ground.

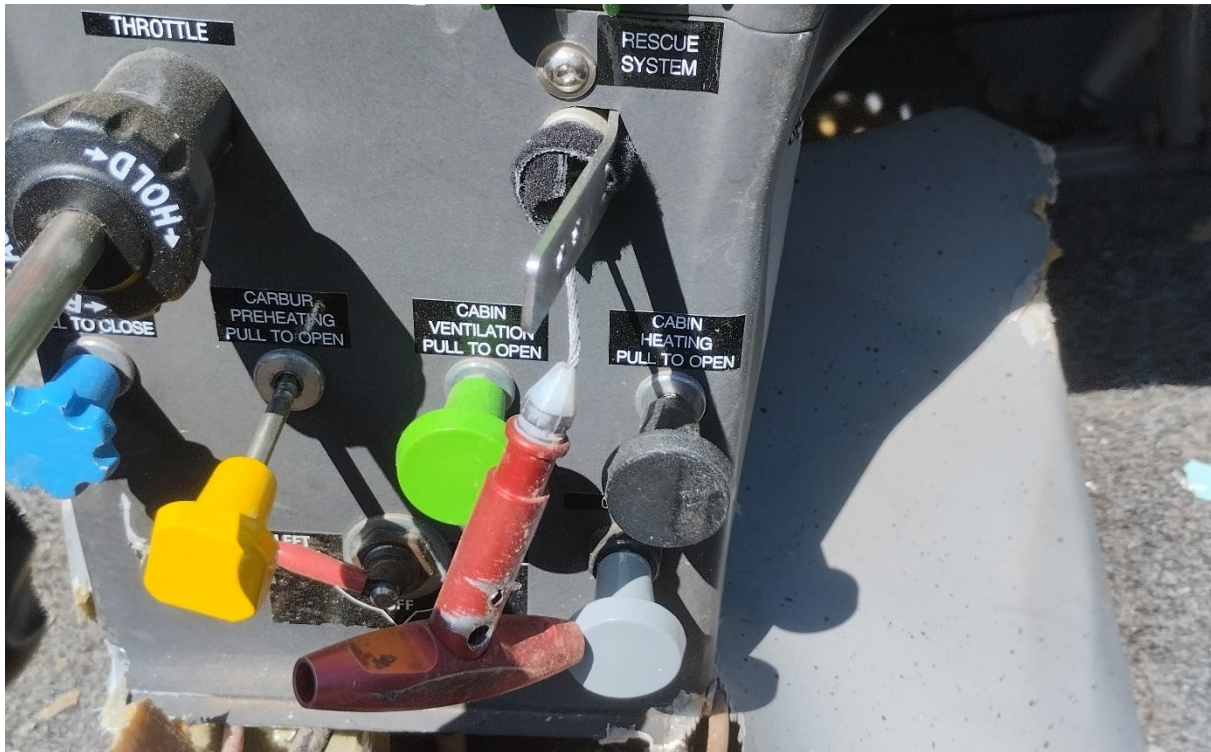
The airframe parachute was found not fully deployed, a part of it still being in its container. The parachute housing door, which was ejected when the parachute came out, was found in the immediate vicinity of the wreckage. The parachute control handle was in the pulled position: one of the pilots very probably activated it. The statements (see para. 2.2) and these observations indicated that this input was probably made at a late stage and at a height that was too low for the parachute to have time to deploy, inflate and slow down the fall of the aircraft.

Figure 4: position of the airframe parachute handle after the accident (Source: BEA)

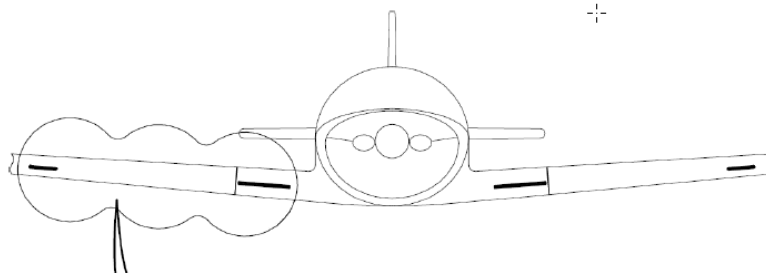
04FO was built in 2012 and was not equipped with stall strips.

Figure 5: stall strip installation drawing (Source: Aerospool)

The installation of stall strips is possible on the WT9 microlight built before 2018 through the implementation of a [Service Bulletin \(ZBWT9 31A / 2024\)](#). This Service Bulletin, initially classified as “optional”, was reclassified as “highly recommended” by the manufacturer in September 2024, following the accident to 04FO. However, at the time of publication of this report, it had not been made mandatory by an airworthiness directive.

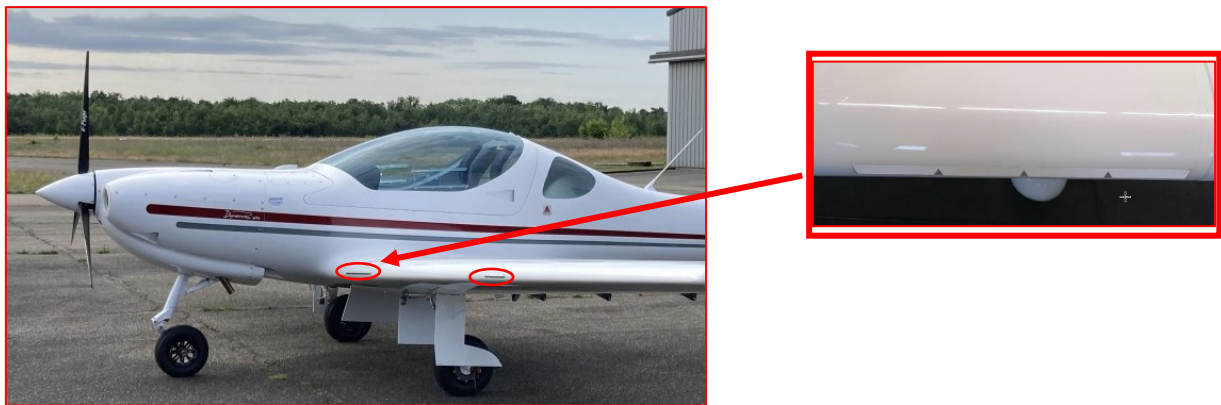
Figure 6: stall strips on a WT9 microlight (Source: Finesse Max)

- the absence of stall strips on the microlight. These aerodynamic devices designed to improve the stall behaviour of the microlight, reduce the risk of roll, and therefore, of entry into a spin. This risk increases if the entry into a roll is not countered early enough or if the pilot makes inappropriate inputs, such as a maintained nose-up input or inputs on the ailerons that would induce a differential drag contributing to the entry into a spin.
