Accident to the G1 Aviation G1 SPYL-XL-R ULS (P)
identified **04IF**
on Saturday 4 February 2023
at Salignac (Alpes-de-Haute-Provence)

**Distortion of both wings in flight in rough air, loss of control,
activation of the airframe parachute, in instruction**

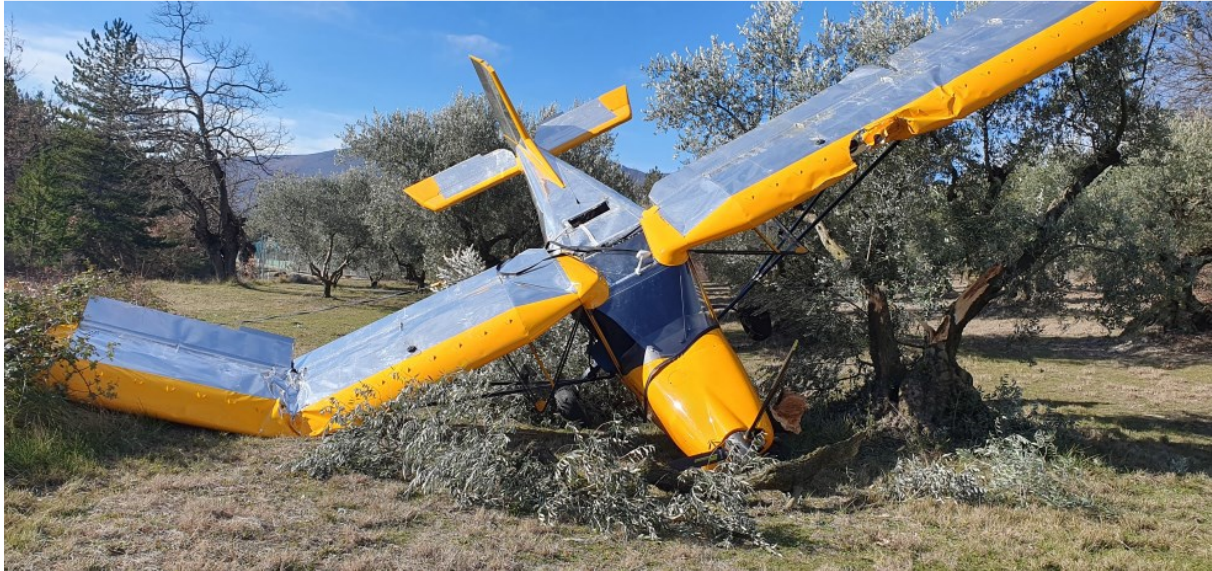
Figure 2: position of the microlight after the accident (Source: pilot in the left seat)

The accident site was located in a field of olive trees at an altitude of 1,750 ft (see **Figure 2**).

- an upward bend in the centre of the right wing between the aileron and the flap, extending from the leading edge to the trailing edge;
- a depression of the leading edge in the centre of the left wing;
- distortions on the left-wing upper skin between the aileron and the flap and at the junction with the fuselage;
- distortions on both sides of the fuselage, aft of the cockpit;
- a break in the windshield with its right-hand side missing.

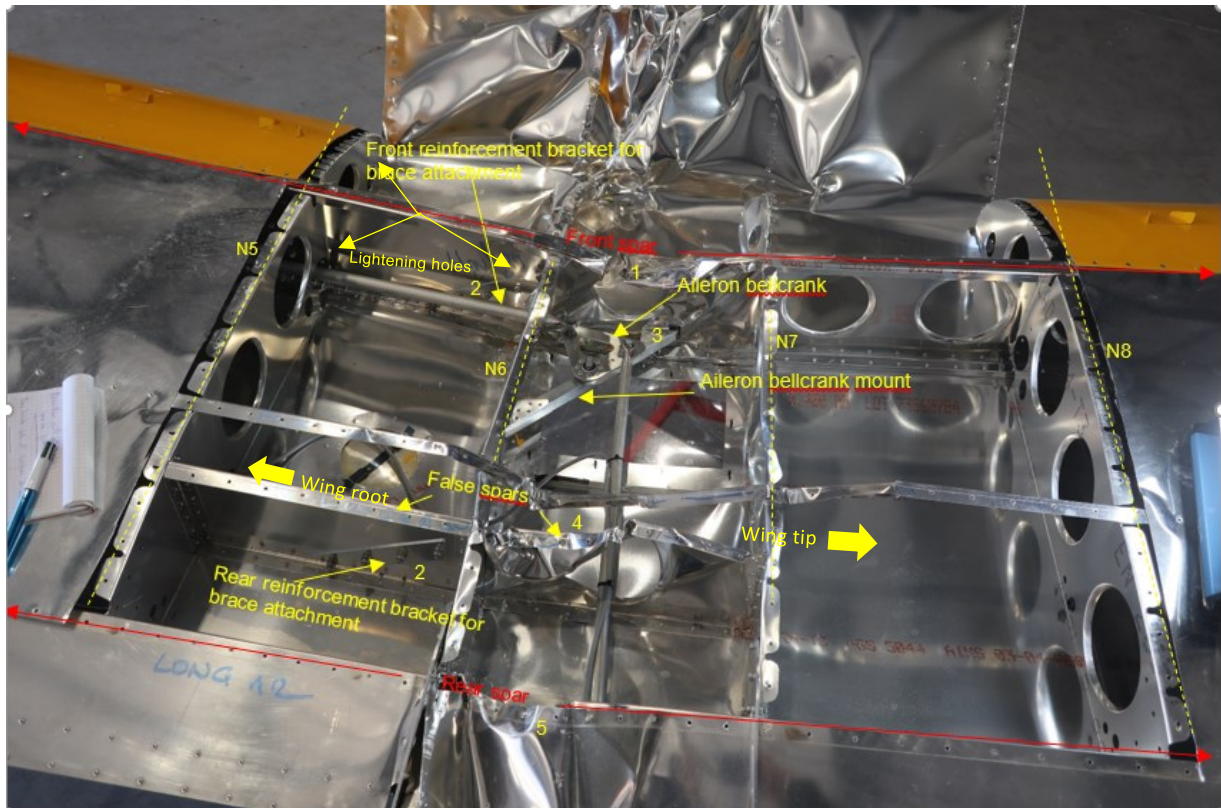
Figure 4: general view of right wing damage between rear ribs No 6 and 7 (front ribs No 8 and 9) (Source: BEA)

Visual examination of the right-wing internal structure revealed the following (see **Figure 4**):

- local fracture of the upper part of the front spar under compressive/bending stresses;
- no distortion in line with the stiffeners of the brace upper fasteners;
- fractured rivets at the angle fastening the aileron bellcrank mounting bracket, in a front-to-rear movement;
- fracture of the right false spar under compressive/bending stresses;

- distortion of the rear spar under compressive/bending stresses, along with local tears in the spar web. All of this damage, substantial in line with the lightening holes in the spars (front, rear and false spars), did not restrict the movements of the aileron control rods and the aileron;
- distortion of rear ribs No 6 and 7 (front ribs No 8 and 9). This distortion was the result of the forces undergone by the spars under compression/bending (see **Figure 4**).

Part of the fracture face of the front spar was observed using a Scanning Electron Microscope (SEM) at the BEA's laboratory. This examination showed that the failure was of a sudden nature due to overload, and no prior damage (corrosion, fatigue) was observed.

Following the tests conducted in June 2025, pending the definition by G1 AVIATION of a stiffening solution for G1 microlights having a single spar with a sheet thickness of 0.8 mm and additional checks for other G1 microlights, the DSAC issued an airworthiness directive¹⁷ imposing restriction of the flight envelope - in particular the restriction of the maximum speed in rough air to 110 km/h - as well as restrictions relating to commercial activities.

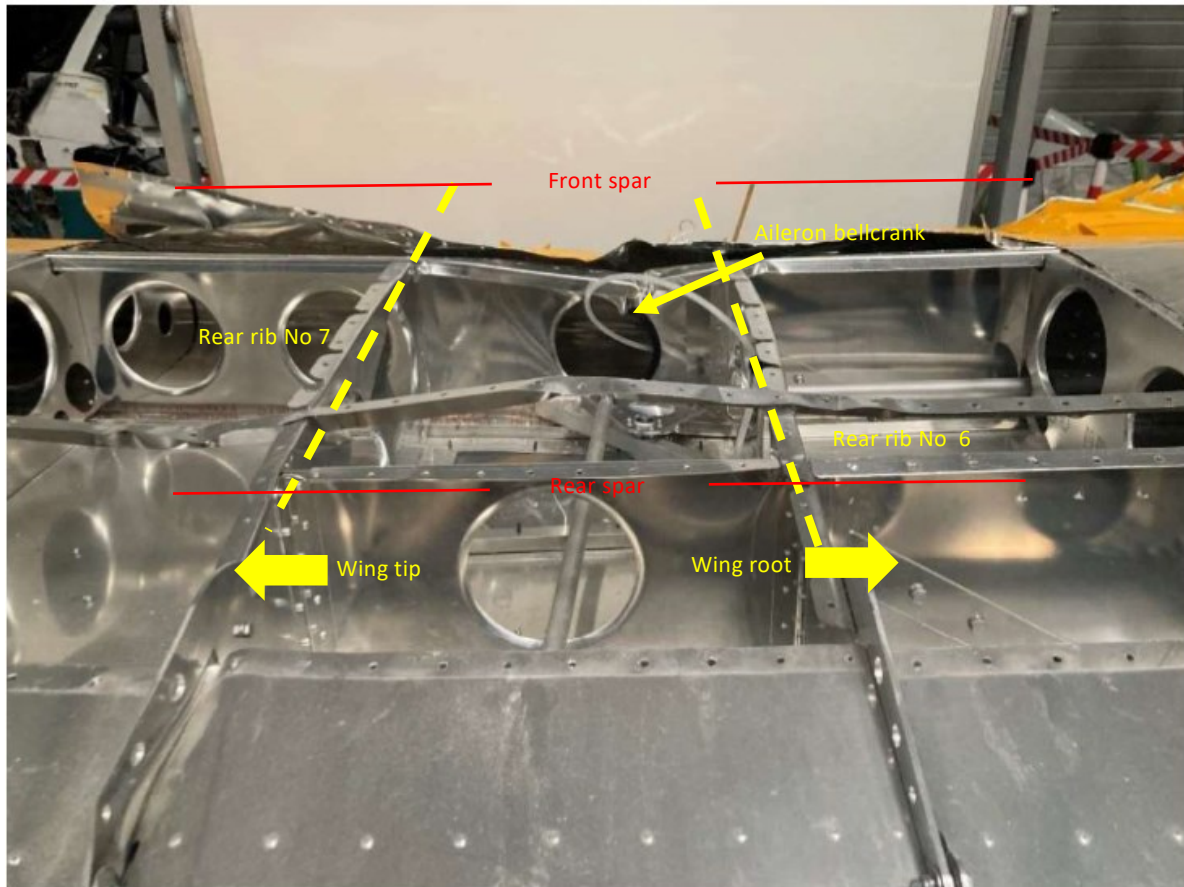
Figure 5: left wing folding (Source: BEA)

During the visual examination at the BEA, the rivets of part of the left-wing upper skin were removed. Visual examination of the left-wing internal structure showed damage similar to that observed on the right wing, but less pronounced (see **Figure 5**). No further examination was performed on this wing.
