Accident to the AEROS LTD - Skyranger
identified **12DM**
on 8 March 2022
at Aix-Les Milles aerodrome (Bouches-du-Rhône)

Time	Around 15:00 ¹
Operator	Private
Type of flight	Test flight
Persons on board	Pilot and passenger
Consequences and damage	Pilot fatally injured, passenger severely injured, microlight destroyed

Loss of control in initial climb, collision with ground

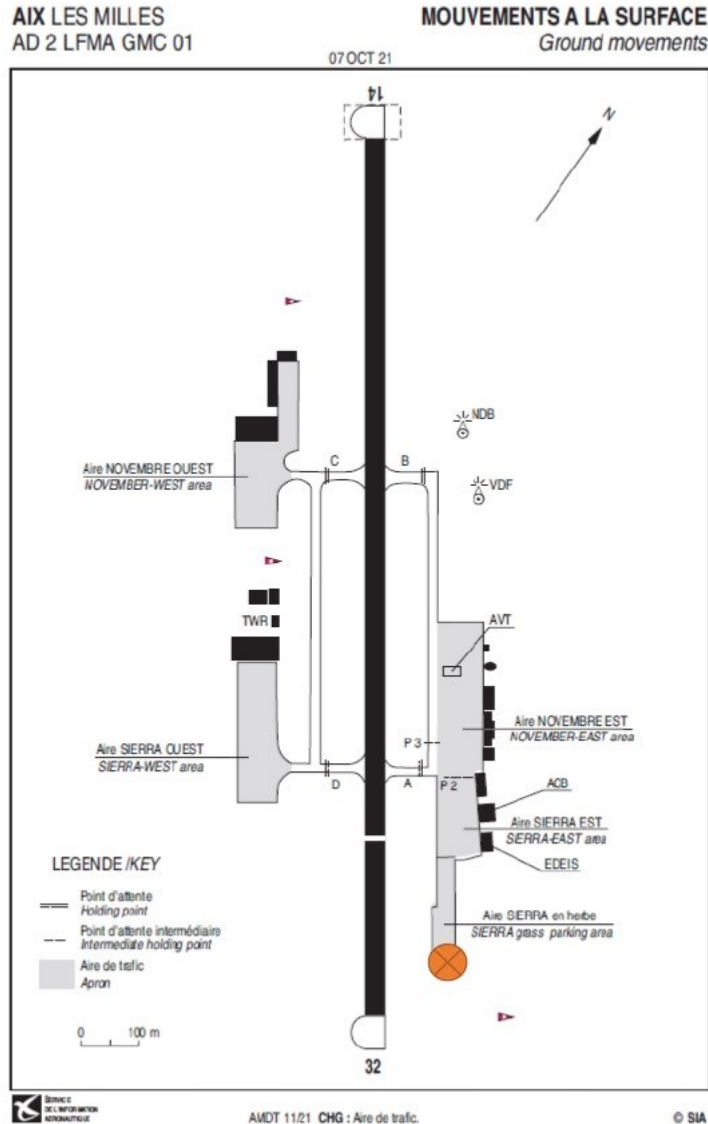
Aix-Les Milles aerodrome has a paved runway 14-32. Four taxiways (A, B, C and D) located between the thresholds on either side of the runway lead to it. The Take-Off Distance Available (TODA) and the Accelerate Stop Distance Available (ASDA) for runway 14 is 1,504 m. From stop position C, the take-off distance available on runway 14 is approximately 925 m. The location of the point of impact is represented by a cross on the aerodrome VAC chart (see Figure 3).

Figure 3: Aix-Les Milles aerodrome VAC chart (Source: AIS, BEA annotation)

Lastly, flight tests involve risks due to their specific nature. They should therefore be carried out with increased safety margins. In this accident, it would have been better to plan to use the entire runway take-off distance available, to avoid taking off with a crosswind component and to plan to climb to a height high enough to allow the emergency parachute to deploy in the event of an emergency, rather than carrying out a low-height runway circuit as announced by the pilot before take-off.
