Accident to the SUPER GUÉPARD 912 ULS
identified **12HP**
on Saturday 30 September 2023
at Dragey-Ronthon

Time	Around 20:50 ¹
Operator	Private
Type of flight	Cross country
Persons on board	Pilot
Consequences and damage	Pilot fatally injured, microlight destroyed

**Get-home-itis, fuel exhaustion, activation of airframe
parachute at low height, collision with ground, at night**

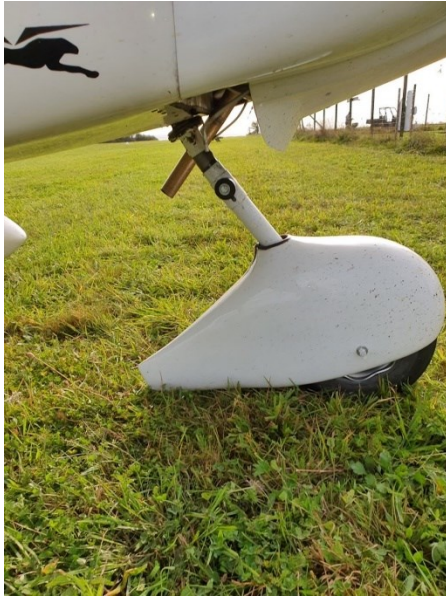
On Friday 29 September, at around 16:30, the pilot, accompanied by his wife, landed at Dragey microlight base² to meet up with members of his family. After landing, he observed that the nose gear strut was deformed (see **Figure 1**). He contacted Aeroservices, the manufacturer of the microlight, to find out if it would be possible to repair the landing gear the next day at Villefranche-de-Rouergue aerodrome, where the manufacturer was based. The appointment was fixed for Saturday 30 September at around noon.

Figure 1: photo taken by the pilot after landing at Dragey microlight base
(Source: Aeroservices)

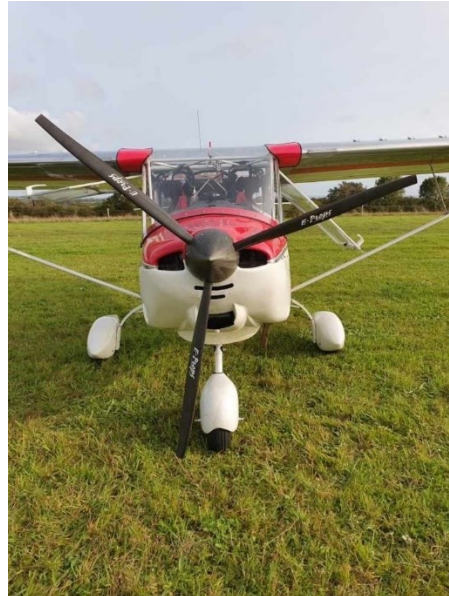
The next day, the pilot took off at 08:20. After landing at Villefranche-de-Rouergue aerodrome at 11:45, the pilot replenished the microlight's fuel tanks before finding the Aeroservices person contacted the day before. The latter started repairing the landing gear after lunch and observed that the main landing gear also needed repair work (see **Figure 2**).

Figure 2: photo taken by the pilot after landing at Dragey microlight base
(Source: Aeroservices)

On completion of the repair work on the main landing gear, the pilot took off from Villefranche-de-Rouergue aerodrome at 17:00 to return to Dragey microlight base. He climbed to 7,500 ft before descending to 4,500 ft and then 3,000 ft which he reached at 20:00, when west of Angers. The pilot indicated in an SMS message sent to his daughter that he expected to arrive at Dragey microlight base 30 minutes later. The pilot continued the descent. Radar contact was lost at 20:13, five minutes after the start of the aeronautical night, when the microlight descended through 1,500 ft, 4 NM south-west of Laval-Entrammes aerodrome³.

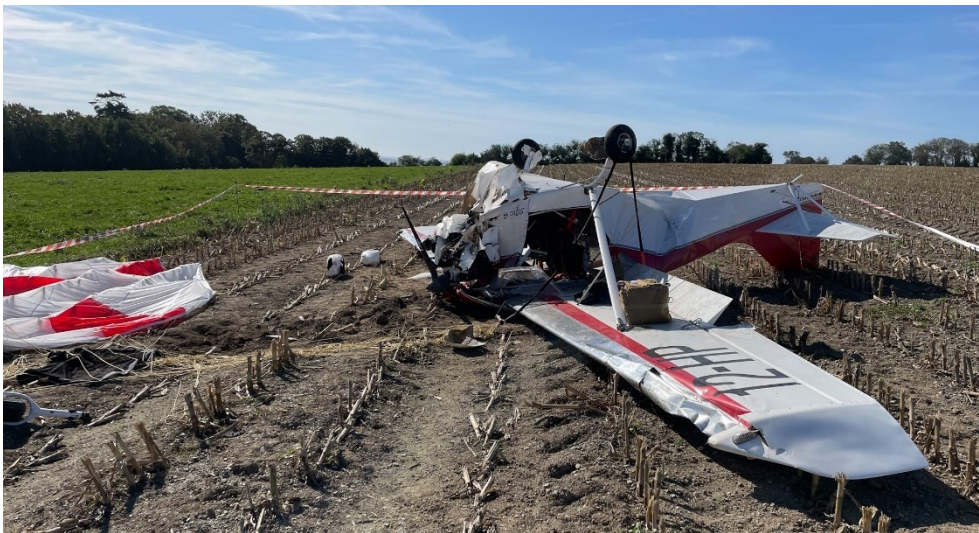
The microlight was lying inverted in a field of cut corn, around 750 m south of the runway of Dragey microlight base, probably at the end of the RH downwind leg for runway 04. The microlight wreckage was grouped together and oriented on a 250° flight path. The propeller and the front part of the cockpit were substantially damaged. The wings were in place and the tail plane had very little damage. The microlight had collided with the ground with a nose-down attitude and a nearly-zero bank before turning over onto its back (see **Figure 5**).

Figure 5: site and wreckage (Source: BEA)

The flight controls were continuous and functional. The flaps were in the landing configuration. Only one of the three propeller blades⁵ had broken, probably during the collision with the ground. The presence of a torque limiter between the Rotax engine and the propeller meant that it was not possible to determine the level of power delivered by the engine at the time of impact with the ground.

Less than one litre of fuel was found in the two microlight fuel tanks. Signs of fluid on the ground underneath the microlight were limited and did not indicate a major fuel leak. Two soft jerrycans each holding 20 l were present on board the microlight. The first jerrycan contained no fuel (no odour) and there were a few remaining centilitres in the second.

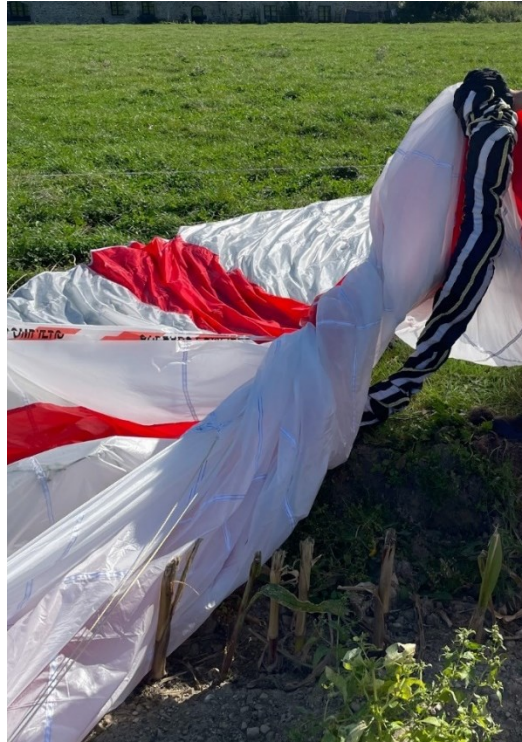
The parachute was activated in flight. It was not completely deployed which suggested that it was activated at an insufficient height (see Figure 6) during the last runway circuit.

Figure 6: part of parachute not deployed (Source: BEA)

The pilot carried out three missed approaches very probably due to him not having sight of the runway. During the fourth runway circuit, the engine shut down due to fuel starvation. The pilot then activated the airframe parachute at a height that was too low to allow its complete deployment.
