**Accident** to the HUMBERT AVIATION - Tétrás  
identified **21AJD**  
on 21 August 2021  
at Courcelles (Doubs)

<b>Time</b>	Around 11:15 <sup>1</sup>
<b>Operator</b>	Private
<b>Type of flight</b>	Cross country
<b>Persons on board</b>	Pilot
<b>Consequences and damage</b>	Pilot fatally injured, fixed-wing microlight destroyed

## **Collision with a power line and then ground during low-height flight**

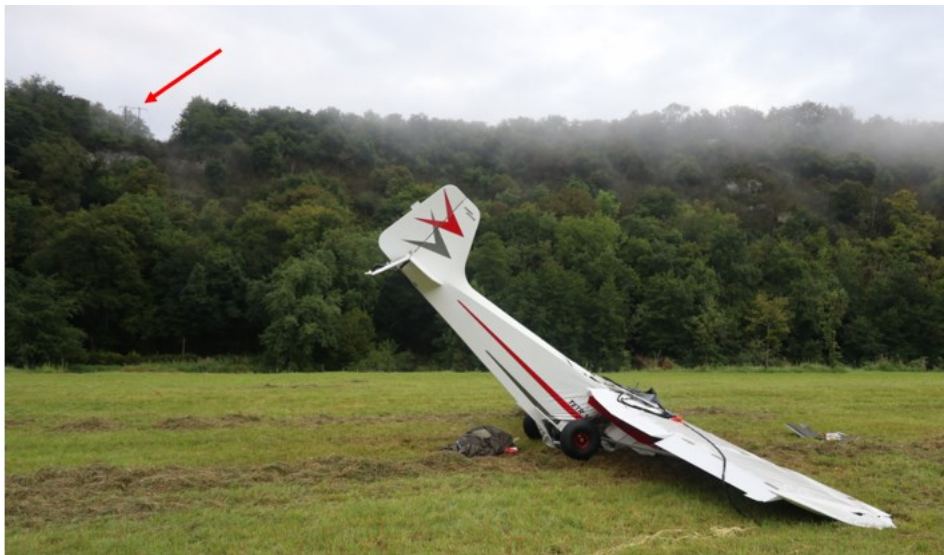
On the BEA's arrival at the site, the wreckage was lying in a field, it was complete and grouped together. No impact or rub marks were visible on the ground in the area around the wreckage.

The microlight was situated at around 60 m from a 20 kV power line. This power line was made up of three parallel cables, the two most easterly cables had been severed by the aircraft. The portion of the line which had been severed was suspended between two 12 m-tall pylons: one to the north on top of a small ridge around 50 m high overlooking the Loue, and one to the south, just behind a hedge of trees at the edge of the field in which the wreckage was laying.

*Figure 1: wreckage with ridge in background (source: BEA)  
The red arrow indicates the north pylon.*

The microlight hit the power line cables with its main landing gear and then struck the ground with a high nose-down pitch, the wings level and substantial energy. No technical anomaly prior to the power line strike was observed. The airframe parachute was activated by explosive experts.

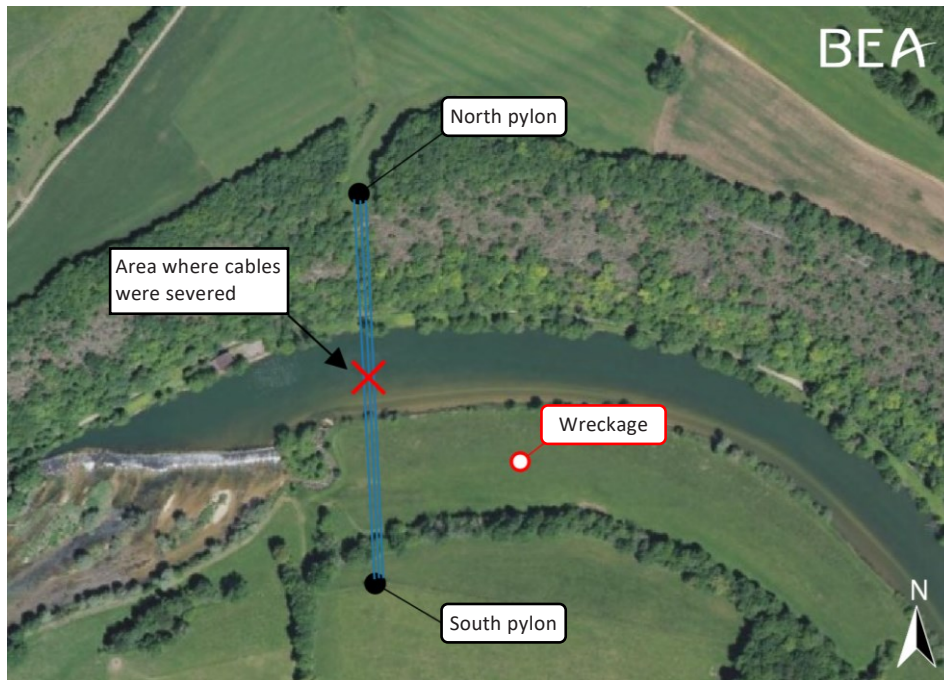
The height of the cables where they pass over the Loue is between 17 and 20 m.

Figure 2: configuration of power line and position of wreckage (source: BEA)

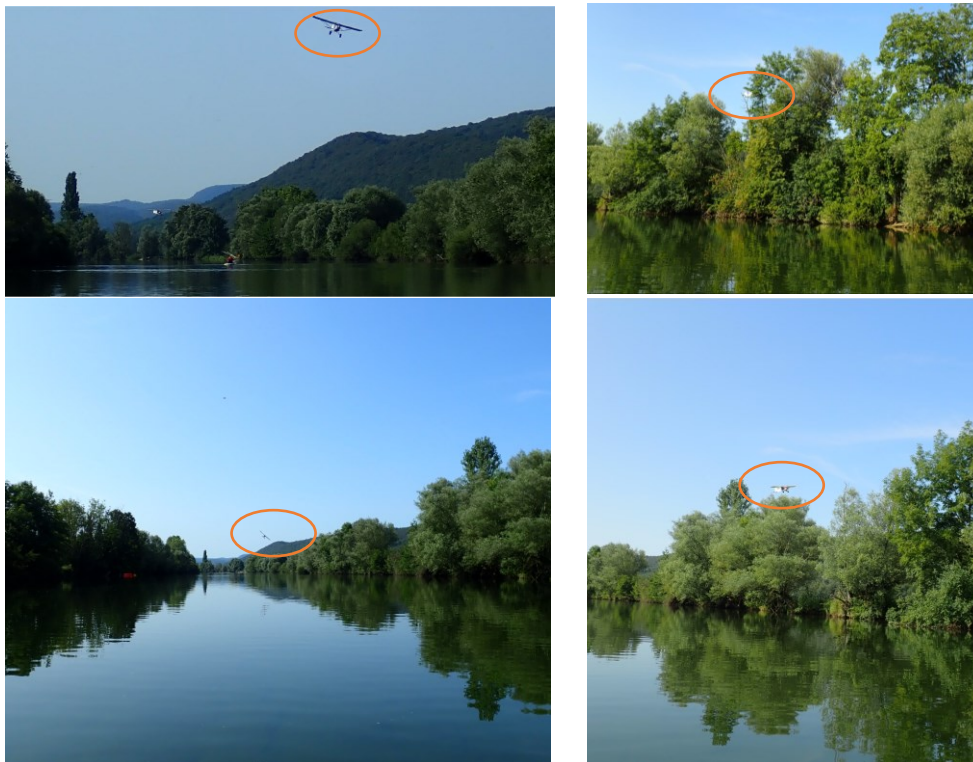
The witnesses took a series of photos. The aircraft flew over the river at 10:25. The witnesses remained on the Loue until 11:30 and did not hear or see any other aircraft fly past after that<sup>2</sup>.

Figure 4: photos taken by witnesses in position 1 on Figure 3

<sup>2</sup> All of the elements analysed in these photos confirmed that they effectively showed the flight of the microlight group during which the accident to 21AJD occurred.

Differences can be seen between the statements from the eyewitnesses and the pilots concerning the flight height and space between aircraft. The photographs back up the eyewitness accounts.

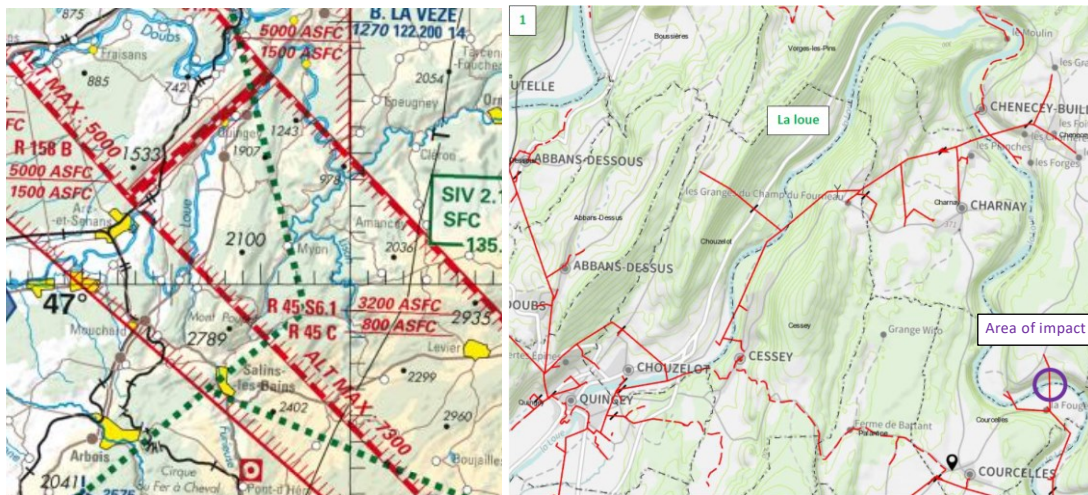
Figure 5: location of electrical power lines  
(sources: on left, IGN/ICAO map scale 1:500,000, on right Enedis)

Only the very high voltage electrical power lines are indicated on the IGN/ICAO aeronautical charts to a scale of 1:500,000 with the following key: T—Power line of 225 kV and more (height can exceed 150 ft). On the flight path taken by 21AJD, only one power line is shown on the aeronautical chart to the east of the accident site. On the other hand, the survey provided by Enedis in the scope of the investigation showed numerous sections of medium-voltage power line overhanging the Loue.

When preparing the flight, the medium voltage power line at a height of around 60 ft could not be identified. These power lines were not signalled. The minimum flight heights specified by the regulations ensure that these obstacles are cleared by a large margin. The height at which the various aircraft were flying implied reduced safety margins with respect to the different power lines. It was not possible to determine from the statements if the pilot had identified this risk beforehand.
