Accident to the AIR CREATION BioniX² 13 SKYPPER 912 S
identified **21ANN**
on Thursday 5 October 2023
at Vignoles

Time	Around 18:15 ¹
Operator	Aéroclub de Bourgogne
Type of flight	Sightseeing flight, commercial
Persons on board	Pilot, passenger
Consequences and damage	Pilot fatally injured, passenger seriously injured, microlight destroyed

Unnecessary manoeuvres for the management of the flight, tumbling, rupture of wing, collision with ground, during a local flight for remuneration

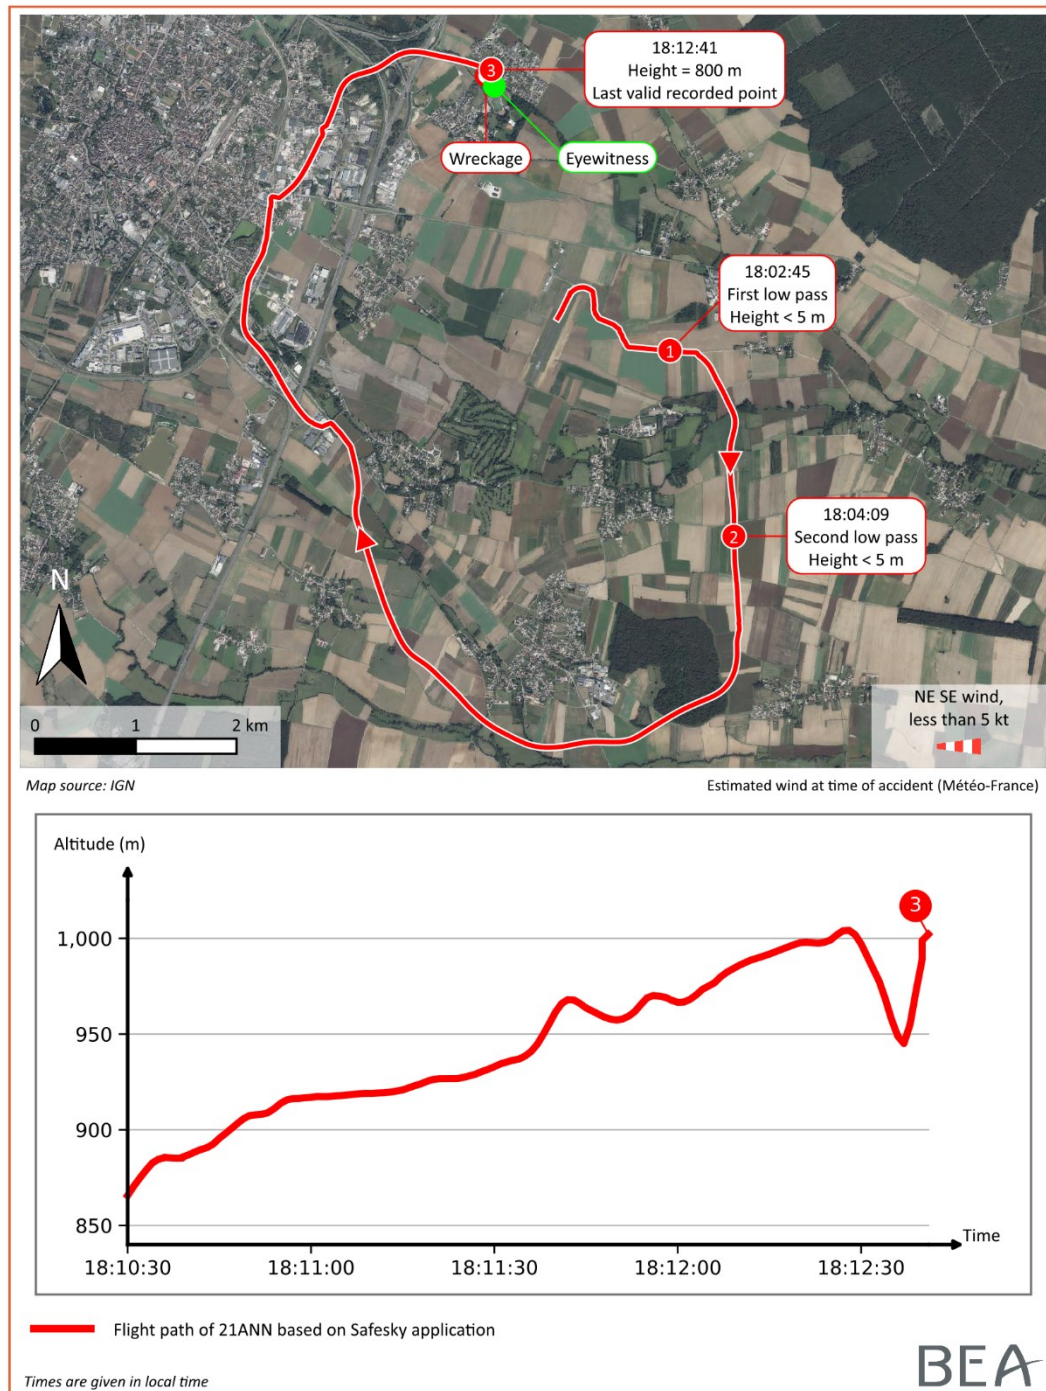
The passenger had been gifted a revenue sightseeing flight in a flex-wing microlight. The pilot, accompanied by the passenger, took off at around 18:00 from runway 02² at Beaune - Challanges aerodrome. He first climbed to a height of around 75 m, then made an initial low pass over a field, less than 5 m from the ground (see **Figure 1**, point ①). He then climbed to a height of around 40 m and performed a second low pass (point ②). After climbing to a height of about 800 m, he descended approximately 50 m and reached a ground speed of about 125 km/h, then carried out a pull-out. The last valid point (point ③) was recorded at the end of this pull-out, at 18:12:41. The ground speed at this point was around 40 km/h and the height around 800 m. The pilot then lost control of the microlight, which turned over, ejecting the pilot from his seat. The wing broke, and the microlight continued to fall, colliding with the ground.

Figure 1: flight path of flex-wing

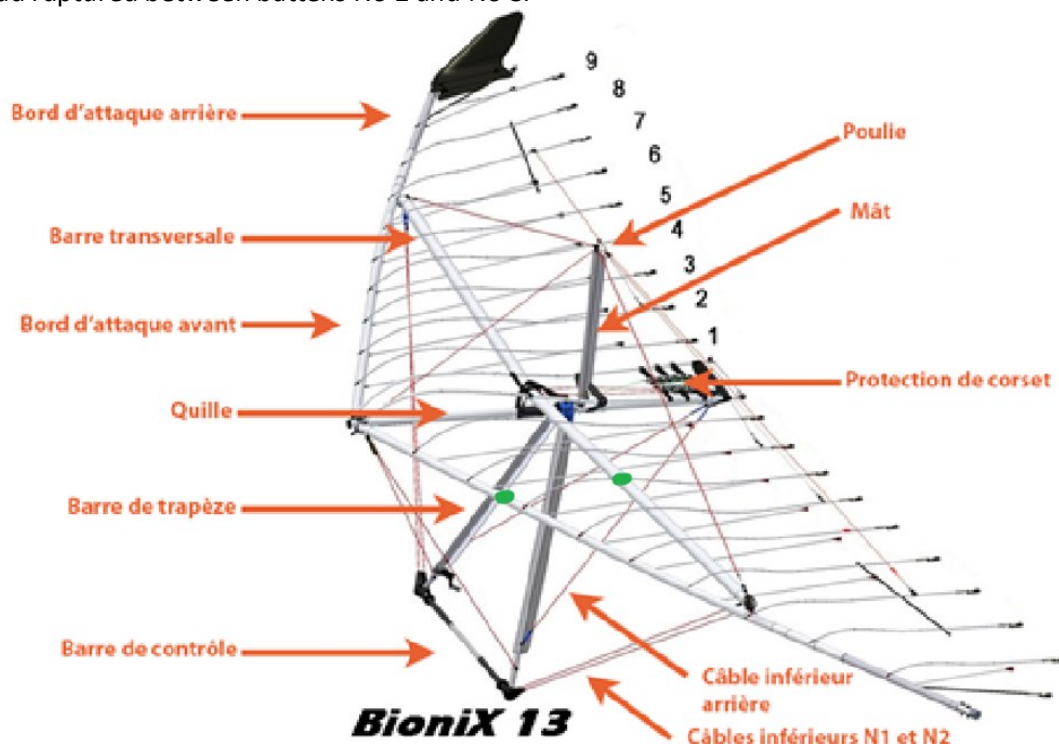
The wreckage was located in a garden at around two kilometres from the aerodrome. The wing was bent in two on its upper surface. On the LH side of the wing, the forward leading edge and the crossbar had ruptured between battens No 2 and No 3.

Figure 2: general diagram of the wing, position of ruptures in green (source: Air Création)

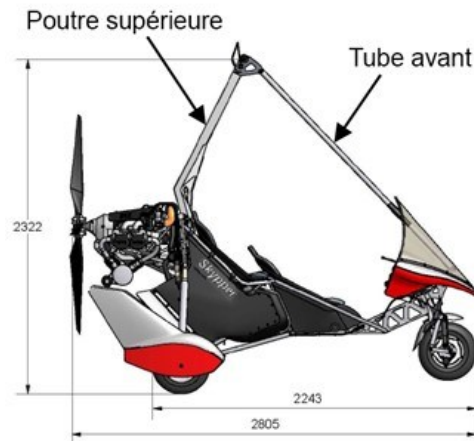
The LH side of the trike was substantially damaged, in particular the LH landing gear (wheel, triangle, damper). The upper beam of the trike and the forward tube attaching plates had ruptured. Due to these ruptures, the wing was only connected to the trike by the safety strap (see **Figure 6**).

Figure 3: general diagram of trike (source: Air Création)

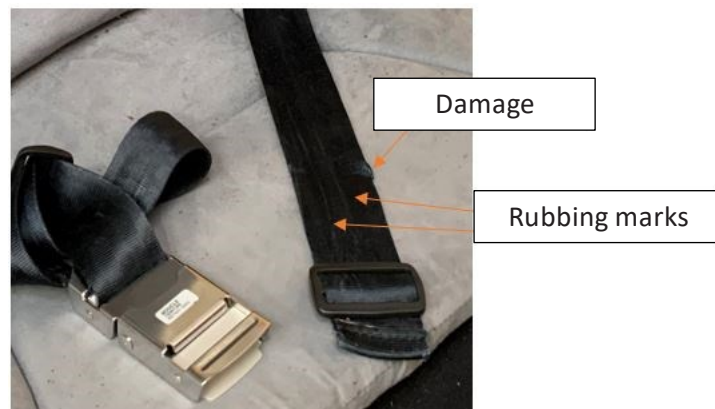
The lap strap of the pilot's belt was found separated from the female buckle. The male and female buckles were connected. There were parallel rubbing marks and a damage mark perpendicular to the strap. According to the owner, these marks were not present before the accident. This would seem to indicate that the strap had slipped, freeing itself from the buckle. The plastic loop was found at the end of the strap (see **Figure 4**). This position is not compatible with a strap passed through the buckle. The loop was probably moved to the end of the strap when it slipped. It was not possible to determine the lap strap setting. The shoulder strap was wound in its reel at the rear of the seats and showed no marks.

Figure 4: lap straps of pilot's belt: on LH side, male and female parts of buckle connected together, on RH side, strap separated from female buckle (source: BEA)

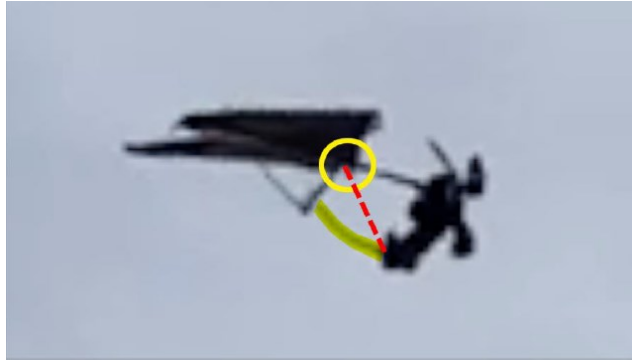
A video of the end of the flex-wing's fall was taken by an eyewitness. The analysis of this video showed that the wing had already ruptured before it hit the ground. The forward tube had detached from the upper beam before the collision with the ground (see **Figure 5**).

*Figure 5: forward tube in green, original position in red, junction with wing circled in yellow
(source: video from eyewitness' telephone)*

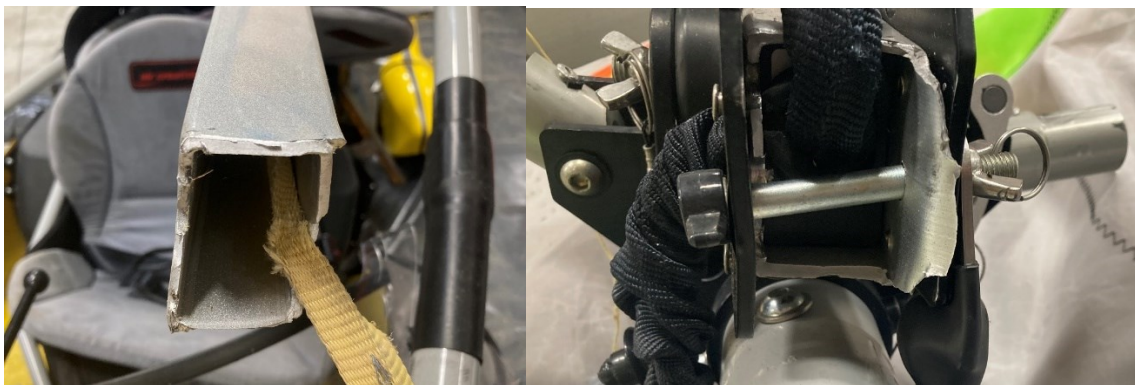
All the damage observed on the wing structure and on the trike was of a sudden nature, the result of overloading. Signs of interaction between the control bar and the forward tube indicated an unusual pitch attitude of the aircraft, consistent with a large pitch movement, characteristic of tumbling (see paragraph 2.7).

*Figure 6: fracture face of upper beam: on LH side, trike side with strap, on RH side, wing side
(source: BEA)*

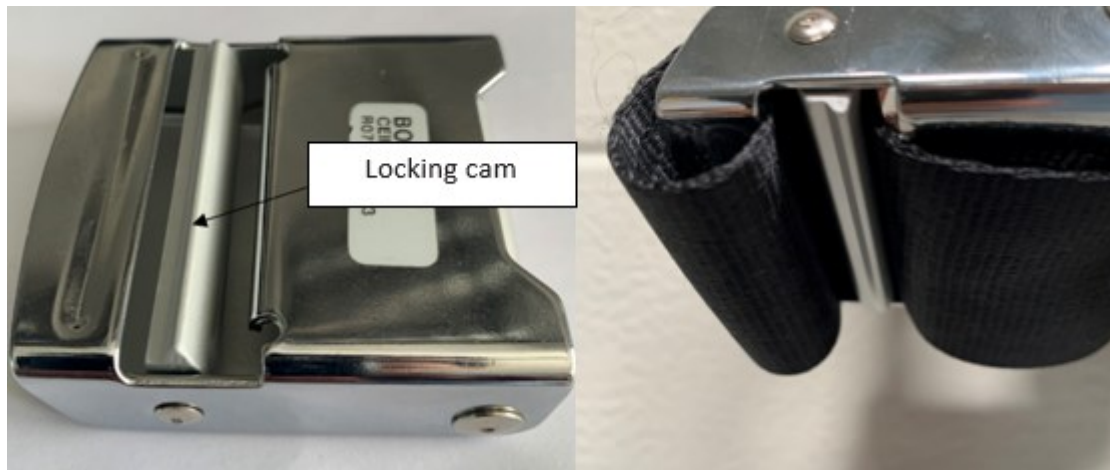
The metal buckle on the passenger's belt was correctly assembled, with the locking cam groove turned towards the "window" through which the strap passed (see **Figure 7**).

Figure 7: female metal buckle on the passenger's lap belt (source: BEA)

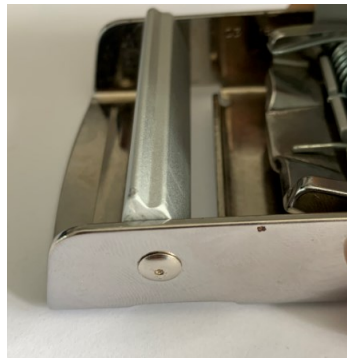
On the other hand, the metal buckle locking cam on the pilot's lap belt was found positioned in the opposite direction. The absence of rub marks on the cam and the absence of deformation suggest that it had been incorrectly assembled.

Figure 8: female metal buckle of pilot's lap belt (source: BEA)

The loosening of the strap in the female buckle may have been aided by incorrect assembly of the locking cam, or by the inverted assembly of the strap around this cam. This loosening may also have been facilitated by not using the shoulder strap. Once loosened to its full length, the strap came out of its metal buckle due to the thinness of its hem.

Anjou Aéro and Air Création have checked the buckle locking cams of the production batches concerned. On the date of publication of this report, no incorrect assembly of the locking cam had been noted. In addition, Air Création has issued two documents relating to safety belts. One is a service bulletin entitled *KAIR 24001 - Safety belts* addressed to customers concerned by the production batches, asking them to inspect the locking cams. The other is a service note explaining the adjustment and use of safety belts, and including a reminder of the importance of using the shoulder belt.

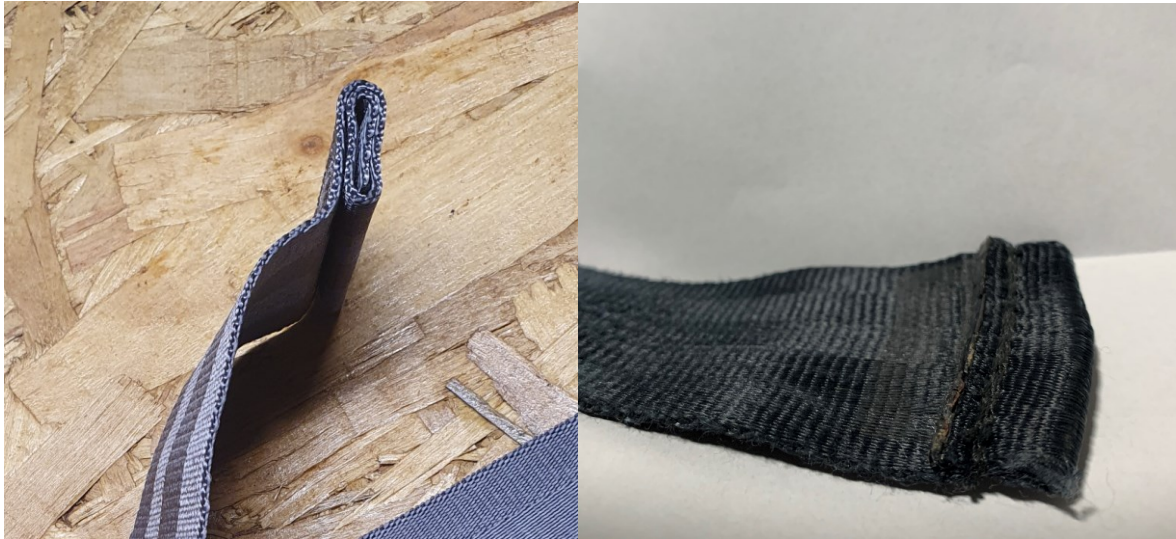
Some differences between these two types of webbing are visible, notably the thickness of the hem (see **Figure 9**).

Figure 9: detail of webbing and hem: on LH side, Anjou Aéro strap, on RH side, strap assembled on Air Création microlight (source: Anjou Aéro/BEA)

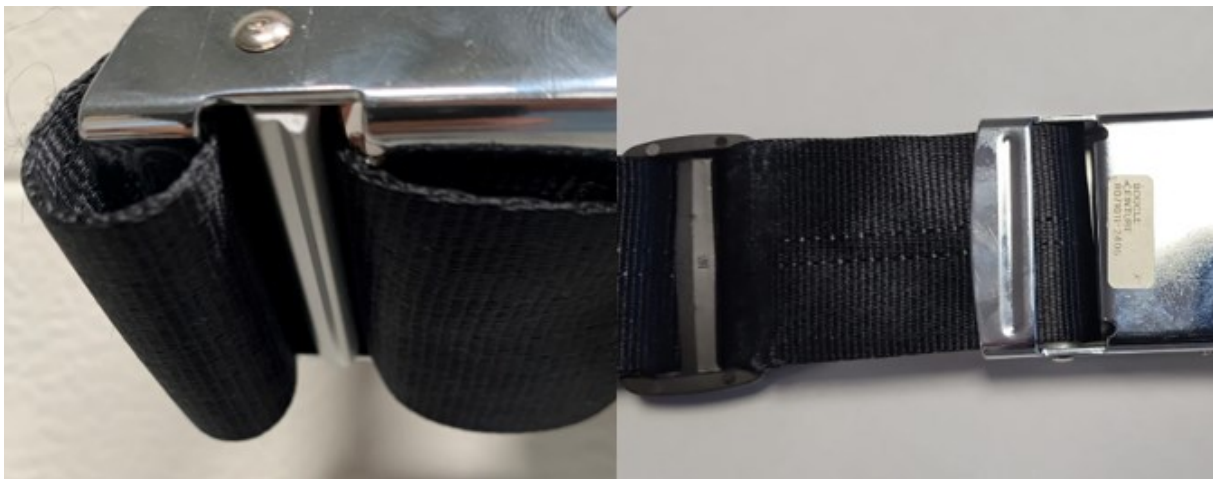
After the accident, Air Création carried out a tensile test on a belt with a strap assembled the wrong way round (see **Figure 10**) on the female side of the buckle. It can be observed that the locking cam turned over, and the strap and buckle separated. A light mark can be seen on the locking cam.

Figure 10: on LH side, correct assembly of strap on metal female buckle, on RH side, reverse assembly (source: BEA/ Air Création)

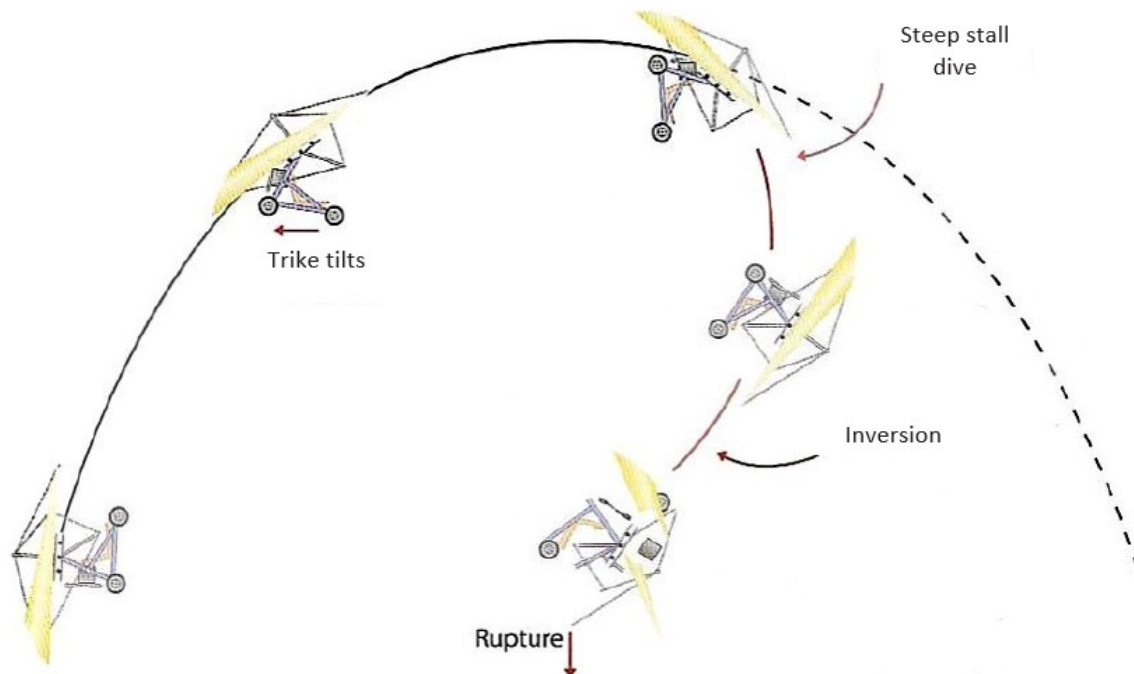
The microlight pilot manual explains that tumbling follows a stall in ascent, with the wing creating a nose-down torque that causes it to rotate, while the trike tilts backwards due to its weight. This is followed by the wing tipping forward and the microlight rolling over onto its back, often leading to a rupture of the wing. An input to recover from a stall that is too rough can contribute to this tipping forward movement.

The most risky situations, to be avoided "absolutely" according to the manual, are stalls at full power, a series of increasingly radical stalls, abrupt power reductions on a steep climb, and stalls obtained by a rapid thrust on the control bar, even with the engine idling. It also recommends that if the pilot enters

Figure 11: representation of the tumbling phenomenon
(source: microlight pilot manual, annotations BEA)

a stall in climb, or as soon as he feels he is in a situation conducive to tumbling, that he hold the control bar firmly so that it does not slip out of his hands. When in an actual tumble, the pilot's only chance of salvation is to deploy his airframe parachute.
