Accident to the Shark
identified **22LE**
on Sunday 23 June 2024
at Saint-Pol-de-Léon

Loss of control during cruise without external visual references, collision with ground, during a revenue flight

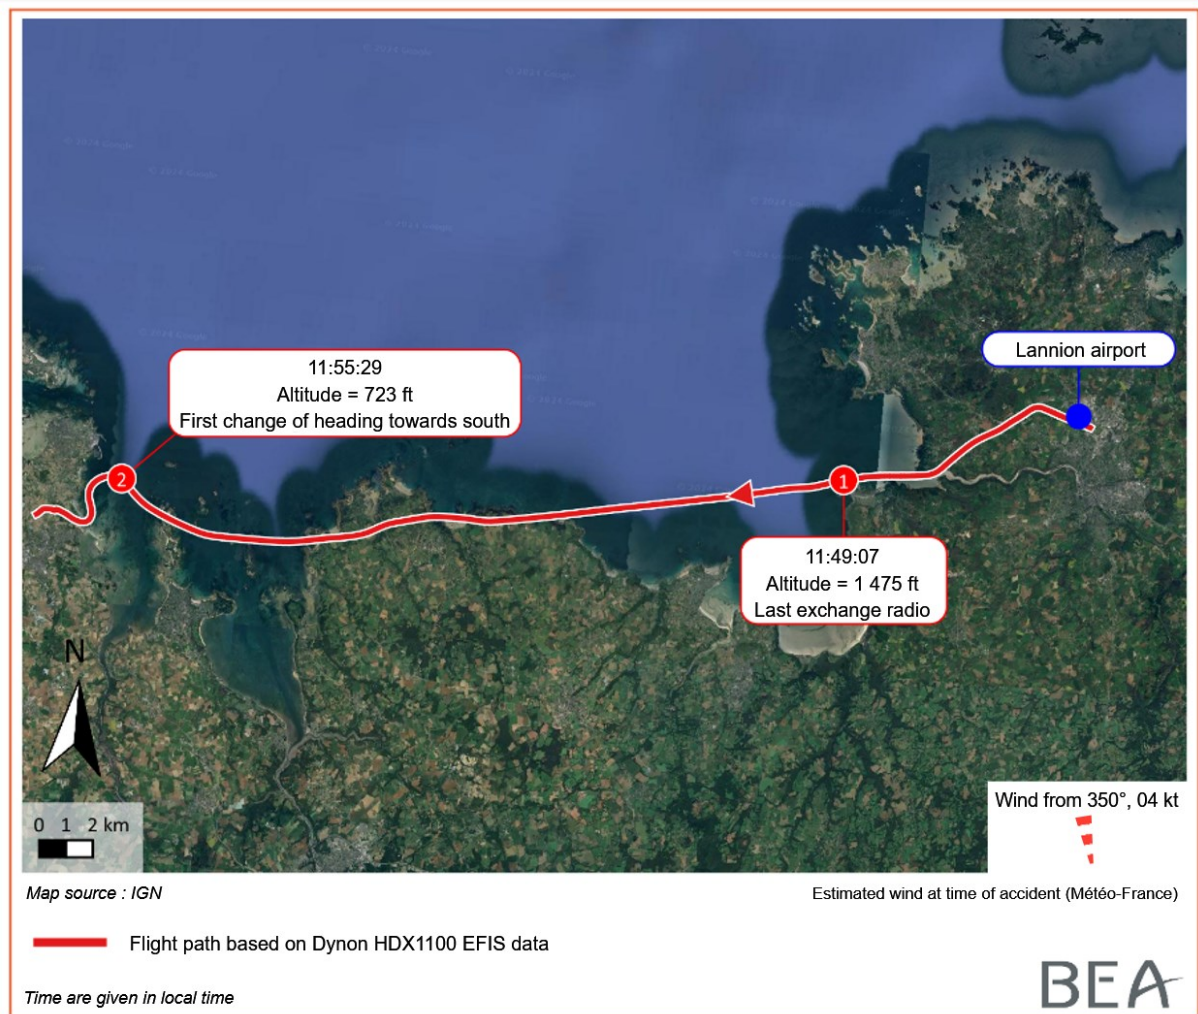
Figure 1: flight path of 22LE

Three minutes later, the pilot left the Lannion A/A frequency and contacted Iroise FIS. The pilot indicated that he was going to fly along the coast towards Ouessant and was going to climb to an altitude of 1,500 ft. He specified that he would not be touching down at Ouessant. The pilot read back the QNH given by the controller and climbed to 1,500 ft. This was the pilot's last radio exchange (see **Figure 1**, point **①**).

After a few minutes, the pilot descended to around 600 ft and from point **②**, carried out two turns with altitude changes one after the other.

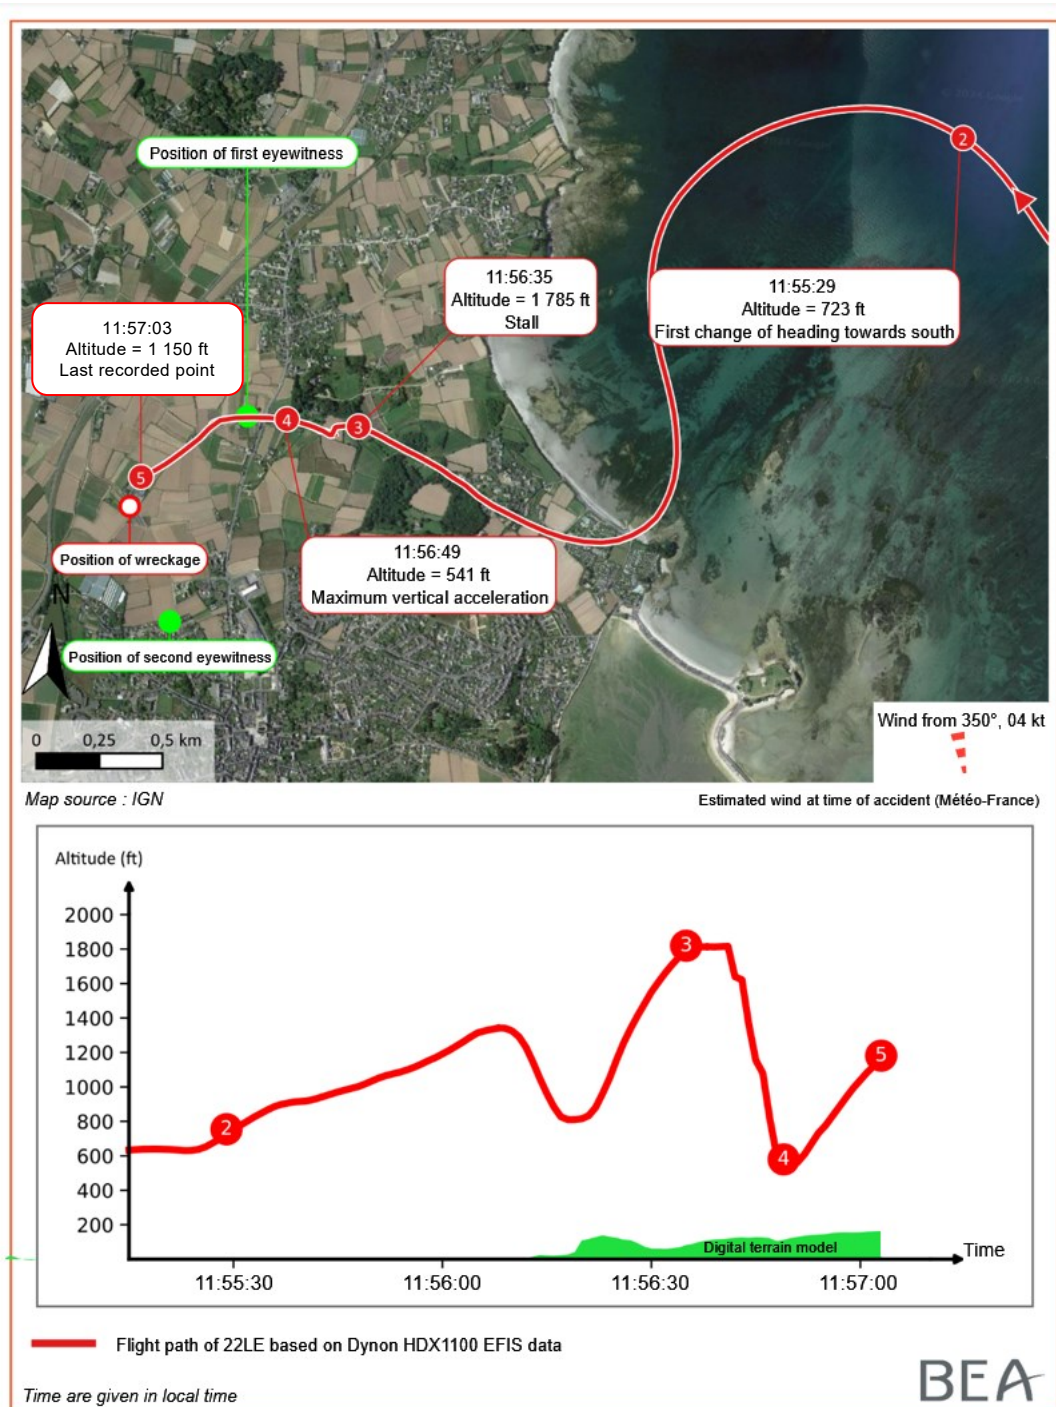
Figure 2: end of flight path of 22LE

On completing these turns, at 800 ft, the microlight quickly climbed and the speed progressively decreased until it reached around 50 km/h at 1,800 ft (see **Figure 2**, point ③). The aural AOA² warning was activated. Substantial variations in load factor were observed, the smallest recorded load factor being 0.2 g. The engine speed and manifold pressure dropped sharply. Witnesses on the ground reported having heard “engine misfires”.

The microlight then descended more than 10,000 ft/min to around 540 ft (point ④). The engine parameters were corrected. The aural *OVER GEES*³ warning was activated, the accelerometer recorded a vertical acceleration of around 8 g when the pilot carried out a pull-out. A first witness saw the microlight pass over him and enter a cloud. At the last recorded point (point ⑤), the microlight was at an altitude of 1,150 ft, in climb to 2,500 ft/min, with a speed of around 68 km/h. A second witness then saw the microlight pitch down towards the ground at a nearly vertical angle and then lost sight of it. The microlight collided with the ground.

In addition, eyewitnesses who were near the accident site reported very low visibility, a very low ceiling and the presence of mist. The first witness (see **Figure 2**) stated that the microlight passed over him flying in a straight line. The microlight was at a height of approximately 420 ft at that moment. The witness explained that the microlight climbed and that he saw it enter the cloud layer immediately afterwards. The microlight initially climbed to a height of approximately 530 ft. Based on this information, it can be concluded that the base of the cloud layer was between 420 ft and 530 ft. Another witness stated that visibility was less than 600 m, as a reference located at that distance from his position was obscured by fog.

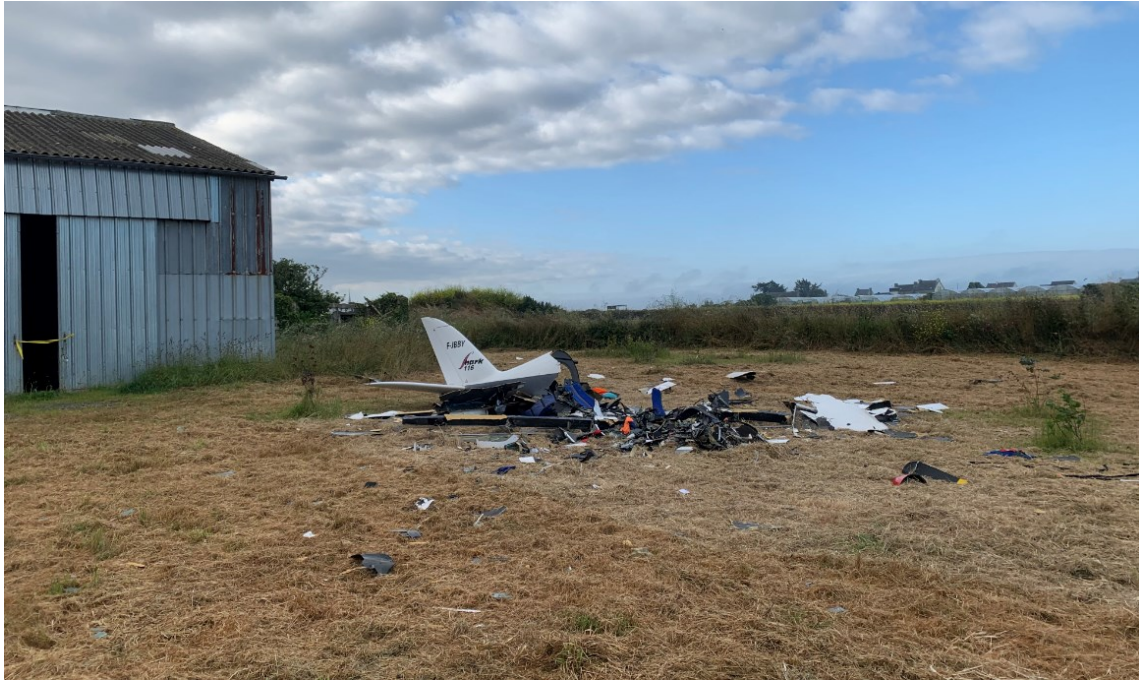
Figure 5: photo of accident site (source: BEA)

The examination of the site and the wreckage found that the microlight had collided with the ground with a very high nose-down pitch attitude (between 45° and 90°) and high speed.

The wreckage was complete and grouped together. The examination of the flight controls was able to determine that these latter were continuous before the collision with the ground. The airframe parachute had not been activated.

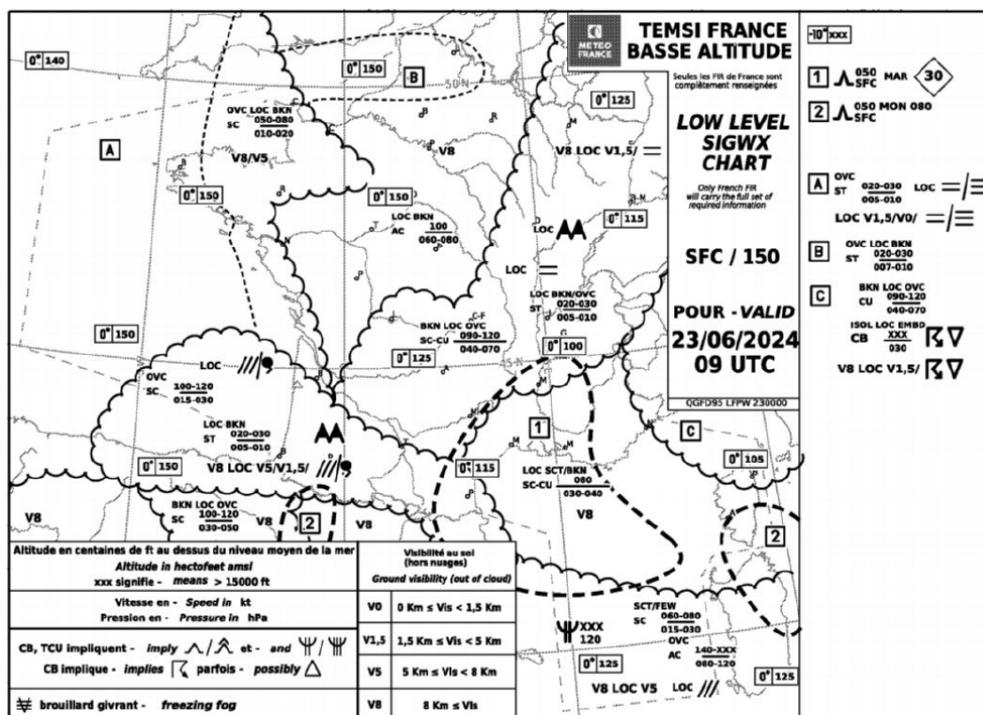
Figure 6: 11:00 SIGWX chart (source: Météo-France)

The 11:00 SIGWX chart indicated for Brittany, low stratocumulus cloud cover between 3,000 and 7,000 ft thick, based between 1,000 and 2,000 ft. The forecast visibility was less than 8 km. Ouessant and Saint-Pol-de-Léon were situated in zone A where it was forecast as being:

- overcast with stratus cloud based between 500 ft and 1,000 ft;
- mist and fog locally;
- reduced visibility, less than 1.5 km.
