Accident to the AS-06
identified **23DI**
on 26 May 2022
at Guéret-Saint-Laurent (Creuse)

Failure of the left wing in flight, collision with the ground

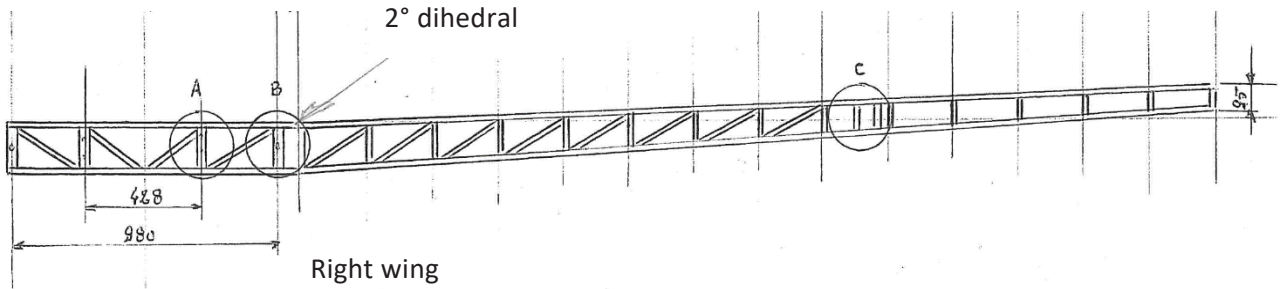
Figure 1: diagram of the right spar viewed from the rear
(Source: microlight's technical file, annotated by the BEA)

The spar of each wing consisted of an assembly made of:

- square steel tubes at the lower and upper surfaces;
- two rectangular tubes and steel angles, connected to the square tubes using the brass soldering technique^{4,5};
- two plywood webs bonded on the front face and rear face.

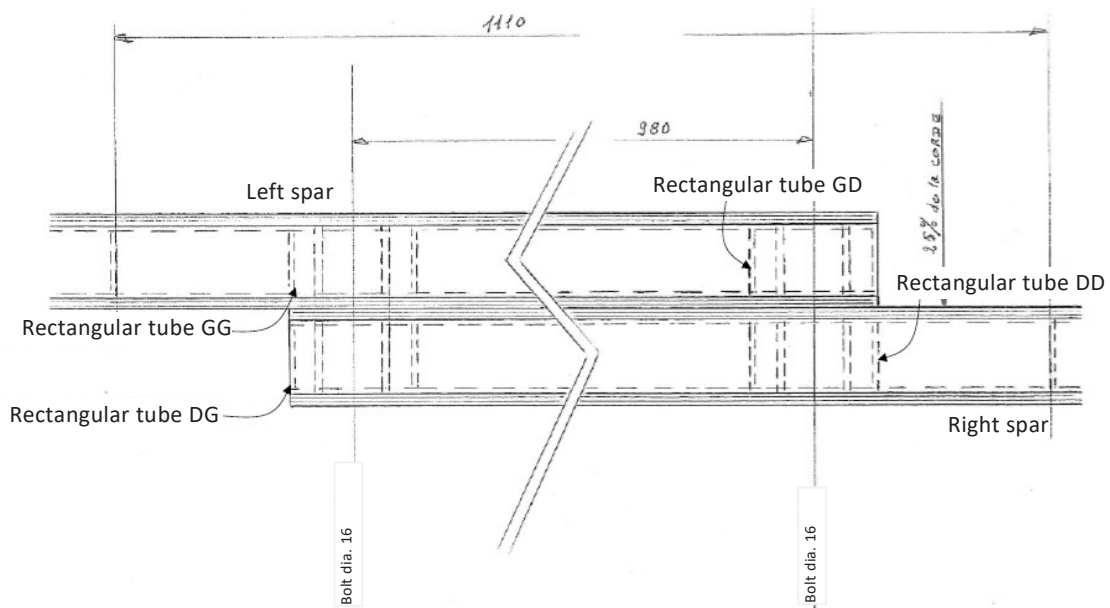
Figure 2: diagram of the assembly of the two spars, viewed from above
(Source: microlight's technical file, annotated by the BEA)

The two rectangular tubes of the left spar were used to connect it to the right spar (and to attach the main landing gear to the two spars) using two screw-and-nut assemblies. In this assembly, the left spar was located in front of the right spar (see **Figure 2**).

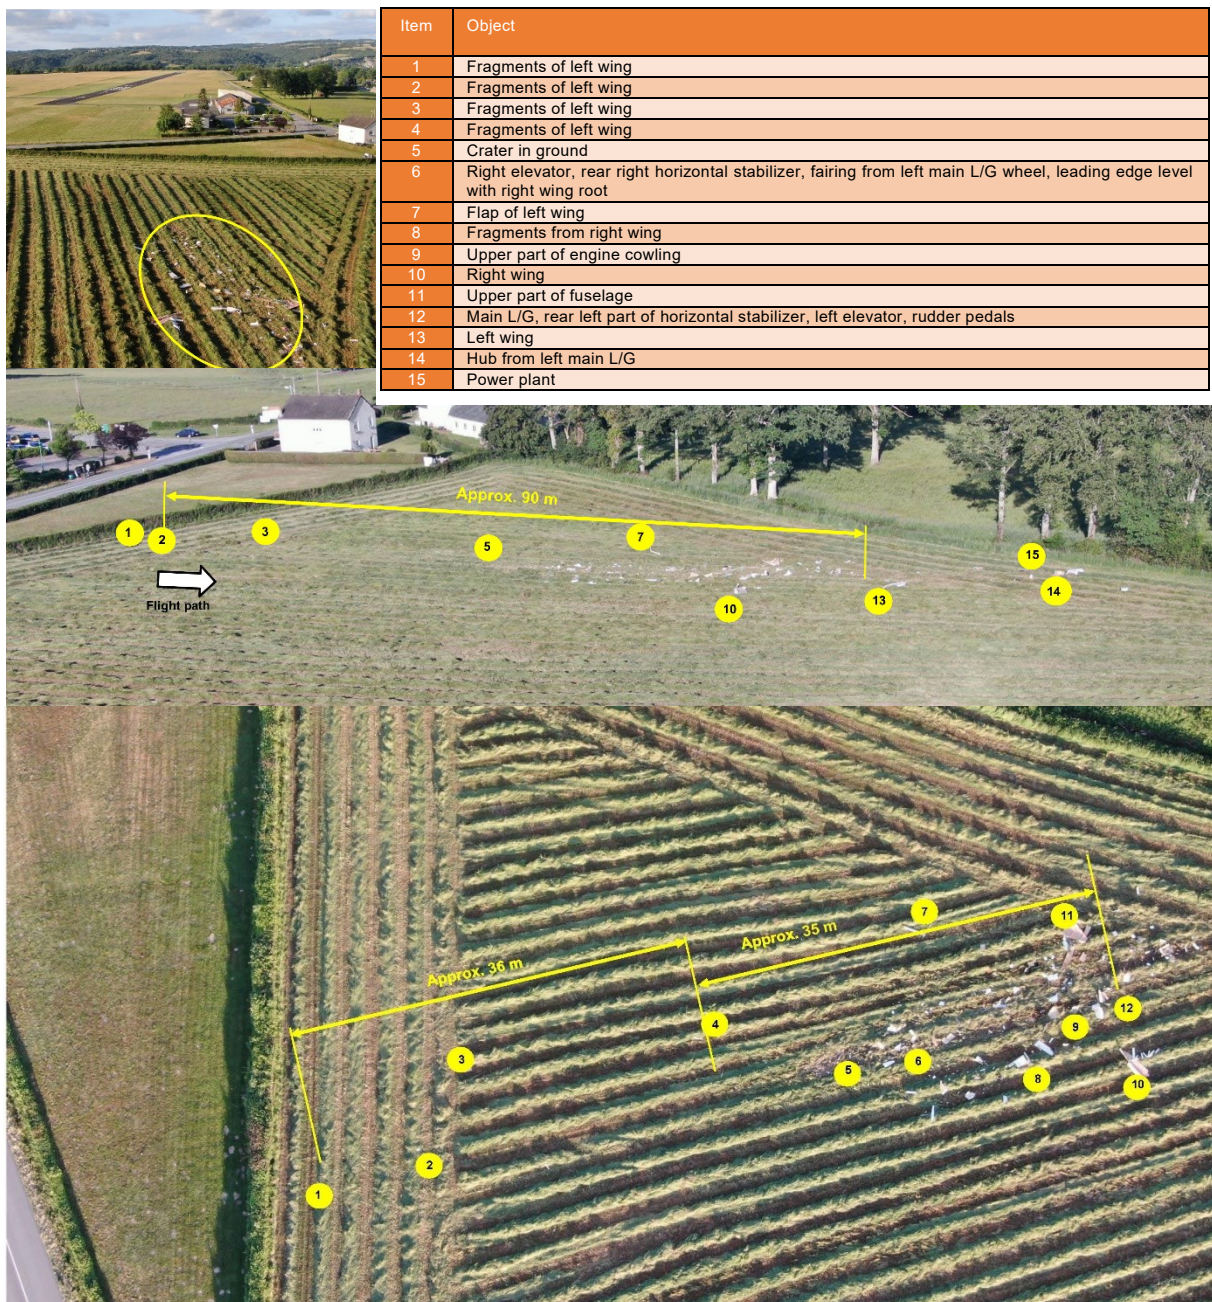
Figure 4: distribution of the microlight debris
(Source: BGTA, annotated by the BEA)

Some small pieces of debris were found in the immediate vicinity of the end of runway 22. They probably came from the left-wing root.

Other debris from the microlight was located about 200 m beyond the end of runway 22, in a field. These pieces of debris were spread over a distance of approximately 100 m, along an approximate 200° heading. The point of collision of the microlight with the ground was located at point 5 (see **Figure 3**).

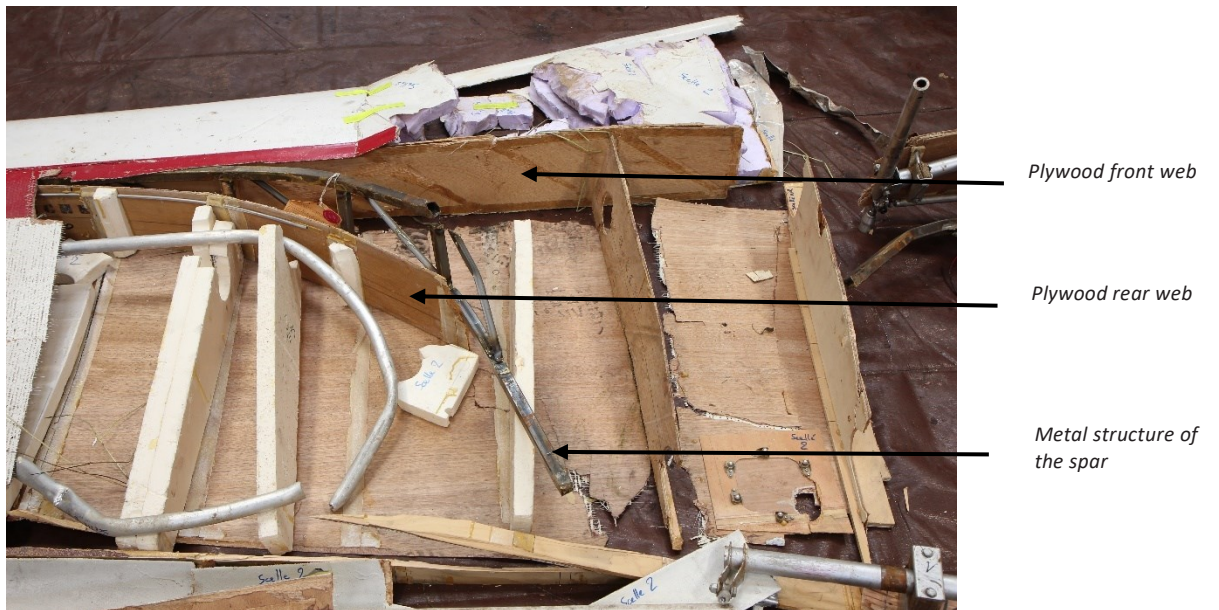
Figure 5: left-wing root

The left wing was partially reconstructed (see **Figure 5**). The metal structure of the spar was ruptured and bent backwards on the root side, which was corroborated by friction marks from the root (associated with black discolouration) on the fuselage. The two plywood webs were no longer glued.

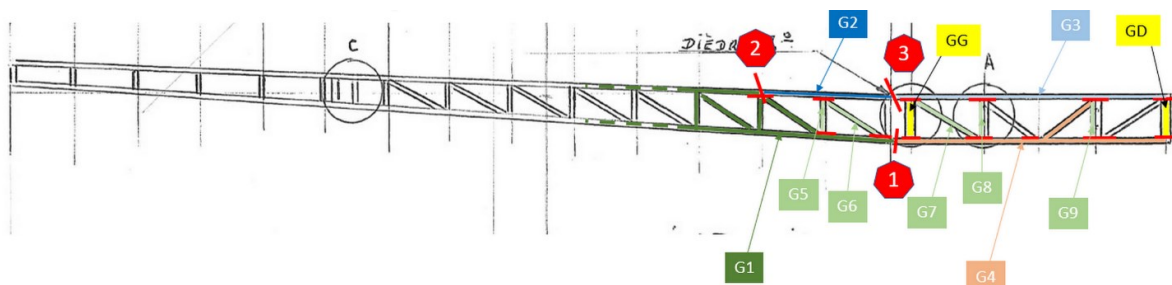
Figure 6: diagram of the left spar viewed from the rear, based on Figure 1.

The left spar was fractured into several pieces (see **Figure 6** and **Figure 7**). Three failures occurred at the square tubes on the lower and upper surfaces (see **Figure 6** and **Figure 7**, points **1**, **2** and **3**). Several other failures occurred at the brazed joints between the angles and the square tubes. Angles marked G5, G6, G7, G8 and G9 were therefore found detached. Two angles were not found.

The two rectangular tubes of the left spar (see **Figure 6** and **Figure 7**, **GG** and **GD**) and the two rectangular tubes of the right spar were all found detached from the spars at their brazed joints, but were still attached to each other and to the main landing gear plates by the crew-and-nut assemblies.

Failure zones are marked in red.

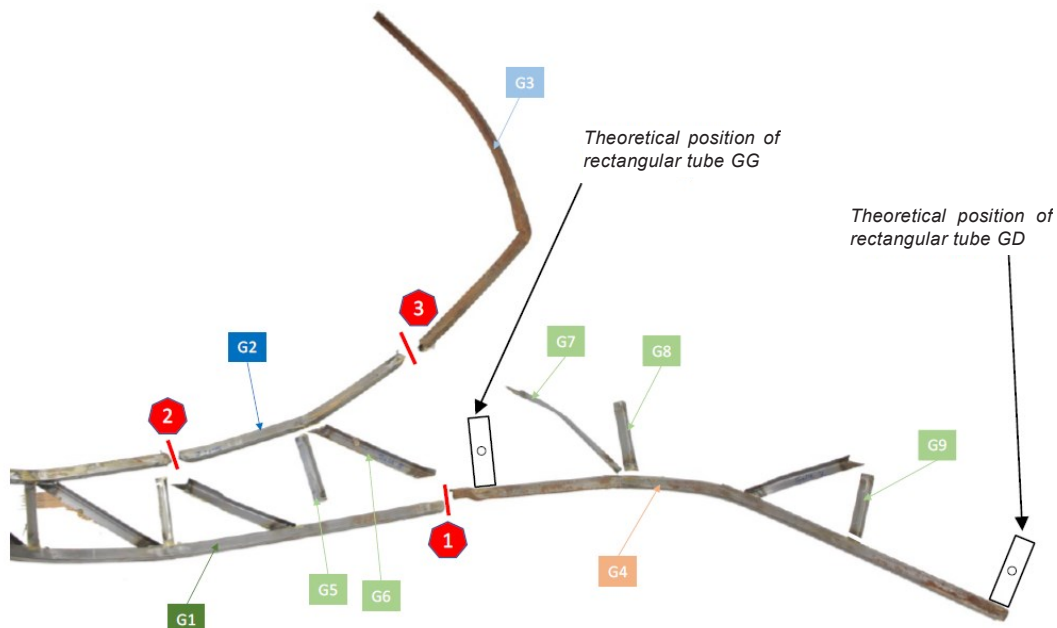
Figure 7: left spar reconstructed at the BEA premises, viewed from the rear

The brazed joints on the left spar showed many defects⁸, such as misalignments between the parts to be soldered, too little or too much filler material, too much brazing clearance, or the presence of blisters.

The brazed connection between square tube G2 and angle G5 (fractured) showed signs of a progressive fatigue cracking (presence of microscopic fatigue striations).

This connection also showed a lack of brazing filler brass. As the tube and angle were detached, it was not possible to determine precisely whether there was also a misalignment or too much brazing clearance between these two parts.

The distortions observed on the spar evidenced a backward and upward movement of the left wing in relation to the fuselage. The spar showed distortions characteristic of a sudden failure under upward bending.

To summarise, one or more brazed joints between the spar components failed under fatigue. The spar could no longer withstand the stresses exerted during the flight and failed suddenly due to overload.

The quality of the brazed joints most probably contributed to the failure of the spar in flight.
