Accident to AIR CREATION - IXESS 13¹
identified **24TS**
on Sunday 20 August 2023
at Brantôme-en-Périgord

Collision with a power line

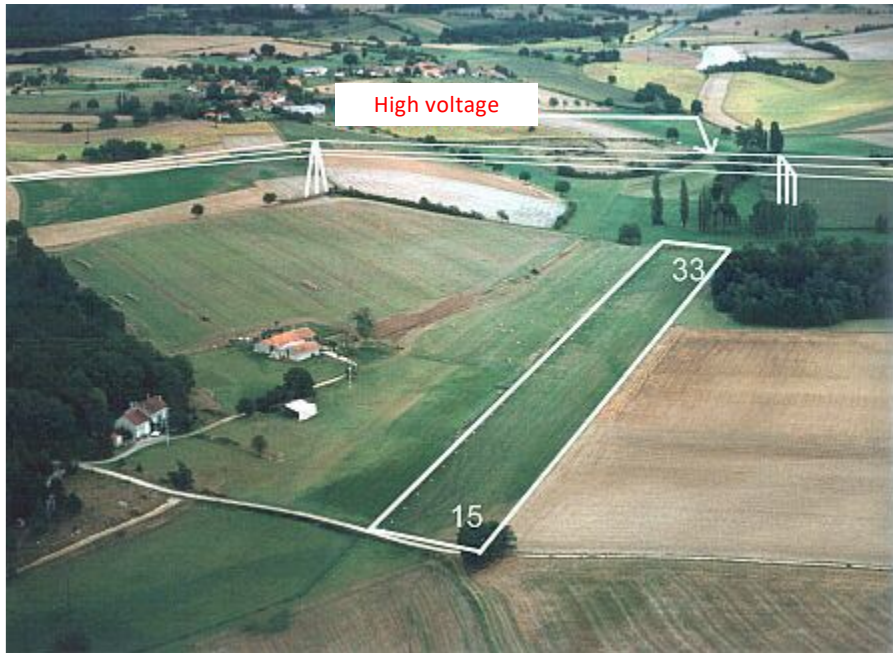
Figure 1: Valeuil microlight strip (source: [BASULM](#)⁴, annotations BEA)

Valeuil microlight strip is oriented on QFU 33°-15°. Measuring 480 m long, it is bordered by a high-voltage power line at a height of around 30 m, situated at around 200 m to the south-east (source: BASULM).

The wreckage was lying between the high voltage line and the group of trees abeam threshold 33. Several strands of the high voltage line had ruptured.
