Accident to the Aéroservices Guépy 582
 identified **25AAG**
 on Tuesday 28 May 2024
 at Thise

Time	Around 16:15 ¹
Operator	Private
Type of flight	Local
Persons on board	Pilot
Consequences and damage	Pilot fatally injured, microlight destroyed

**Reduction in engine power in initial climb, loss of control
 in turn, collision with ground**

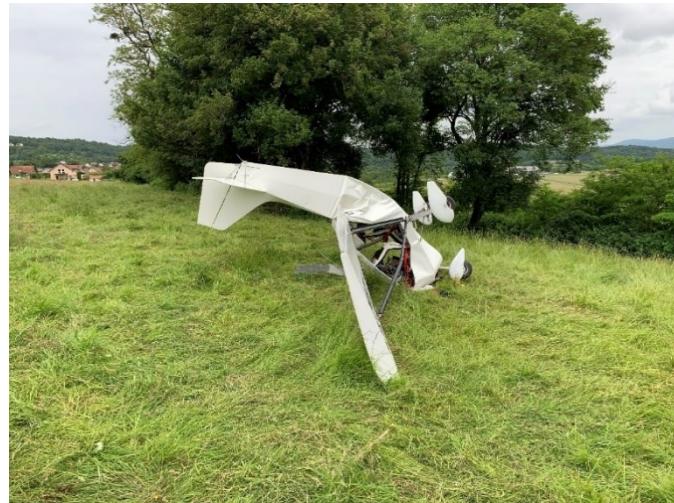
The microlight collided with the ground with a nose-down attitude close to 90°. All of the damage observed was the result of the collision with the ground.

Figure 2: wreckage of 25AAG (source: BEA)

The stick was broken and its deflection could not be checked⁵. The pitch, yaw and roll controls were continuous and the rigging was nominal. The elevator trim control, which is not one of the original microlight controls, was found in a close to neutral position. However, it was inverted with respect to the expected effects on the elevator.

The examinations of the wing structure revealed that the fabric/wood bonding was weak on the lower surface of the two wings without it being possible to determine if these areas could have separated in flight.

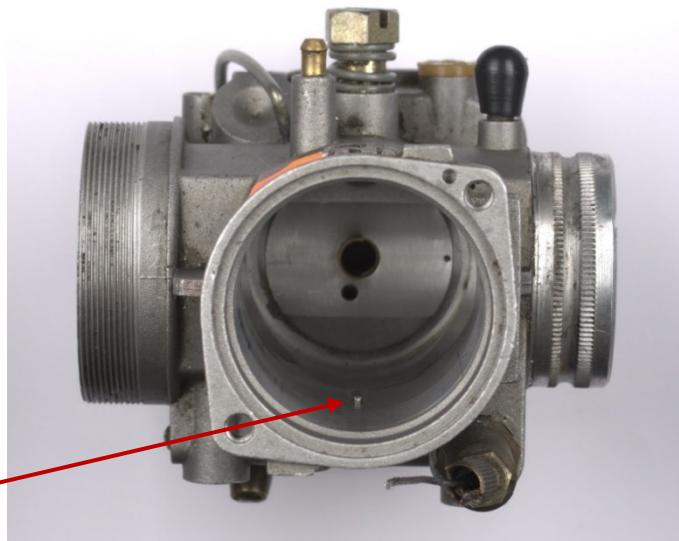
mixture drawn into the cylinder according to the position of the throttle control. On the front carburettor of 25AAG, this throttle slide was blocked in the up position, i.e. in the 'full throttle' position, despite the load of the spring to keep it in the down position when the power was reduced.

Figure 3: front carburettor, viewed from above (source: BEA)

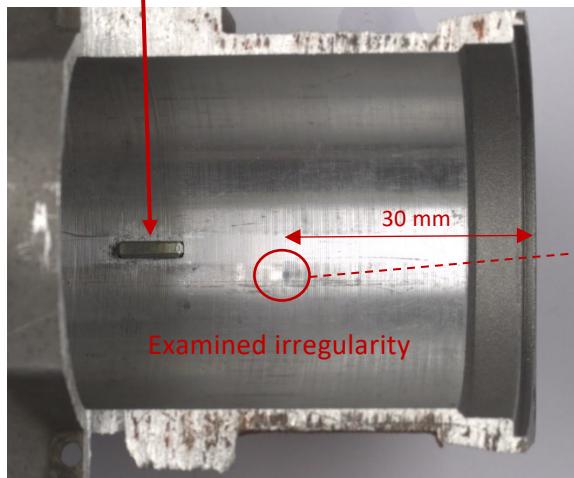
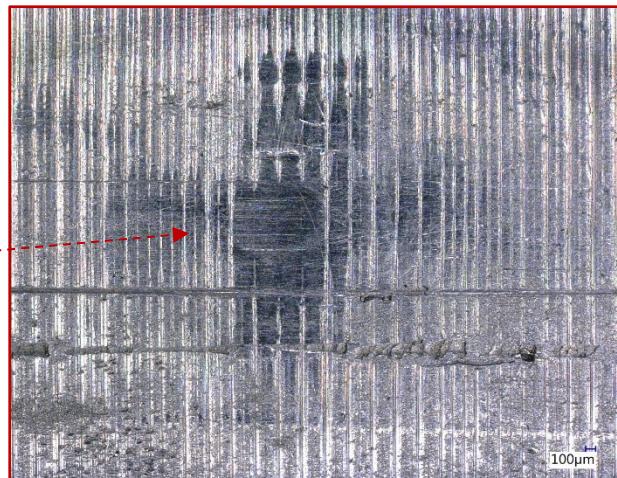
Examinations carried out on the body of the front carburettor revealed an irregularity on its inner surface, approximately 100 microns thick, which may have caused this blockage. Observations made on the surface of this irregularity (scratches, polished appearance, buttering) indicate repeated sliding of the throttle slide in the carburettor body, clearly indicating the presence of the irregularity prior to the accident flight.

It was not possible to formally determine what caused this irregularity. The most likely hypothesis is a localised external impact which occurred during maintenance work, for example. Damage is indeed visible on the corresponding external surface. Tests carried out by the BEA on the second carburettor showed that this hypothesis was quite possible: an external impact caused local deformation on the inner surface. The hypothesis of a local manufacturing irregularity was ruled out due to the drilling process used on this moulded part.

Figure 4: surface irregularity in body of front carburettor, observed after cutting open body on longitudinal axis (source: BEA)

A difference in position between the two throttle slides could cause a desynchronization of the two carburettors. This would result in an imbalance between the thrust developed by each piston, leading at the very least to strong vibrations and variations in speed, and possibly even a reduction in the power delivered by the engine.
