**Accident** to the paramotor  
identified **26AKA**  
on 1 September 2023  
near Ribérac-Tourette aerodrome

## Loss of control in flight, line twisting, collision with ground

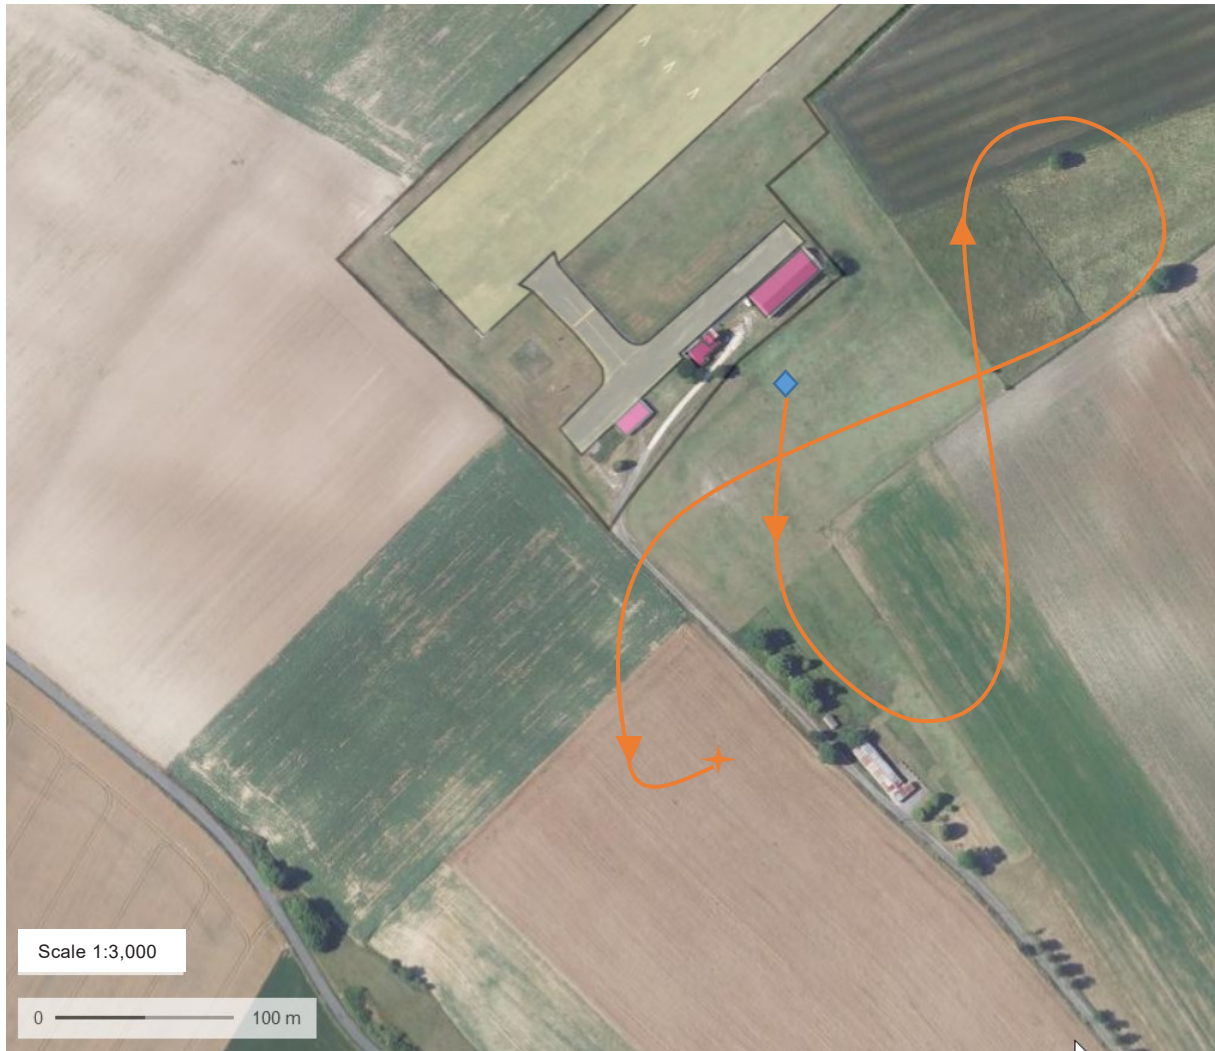
Figure 1: estimated path  
(Map source: IGN)

In preparation for take-off, the wing inflated and deviated to the left<sup>3</sup>. After setting the wing straight, the pilot then ran south-west towards trees located on the edge of the aerodrome. He made a “figure-of-eight” manoeuvre, starting from the left at low height before returning to line up parallel to the runway centreline. He then announced that he was leaving the frequency for a local flight. One of the witnesses on the ground clearly heard an increase in engine speed, but did not notice any significant increase in altitude. When the paramotor was at a height of approximately 40 m, the witnesses saw the wing twist and then fall in rotation towards the ground.

The witness saw the pilot move to the left in relation to the centreline of runway 23 and attempt a manoeuvre to the right, before finally turning left and making a turn-around close to the model aircraft runway. The witness explained that the pilot was probably trying to gain height and avoid the trees located on the south-western edge of the facilities.

The pilot took off and was then carried to the left of the take-off axis. He made a low-height U-turn, probably to avoid obstacles, and returned to the take-off direction, reaching a height of approximately 50 m. The wing's lines then twisted to the left, without the pilot being able to slow the rotation or attempting to use the risers or the right control.
