**Accident** to the KITFOX  
identified **27ADS**  
on 8 March 2022  
at Bernay Saint-Martin

<b>Time</b>	Between 16:00 and 16:30 <sup>1</sup>
<b>Operator</b>	Private
<b>Type of flight</b>	Unknown
<b>Persons on board</b>	Pilot
<b>Consequences and damage</b>	Pilot fatally injured, microlight destroyed

## Loss of control, collision with the ground

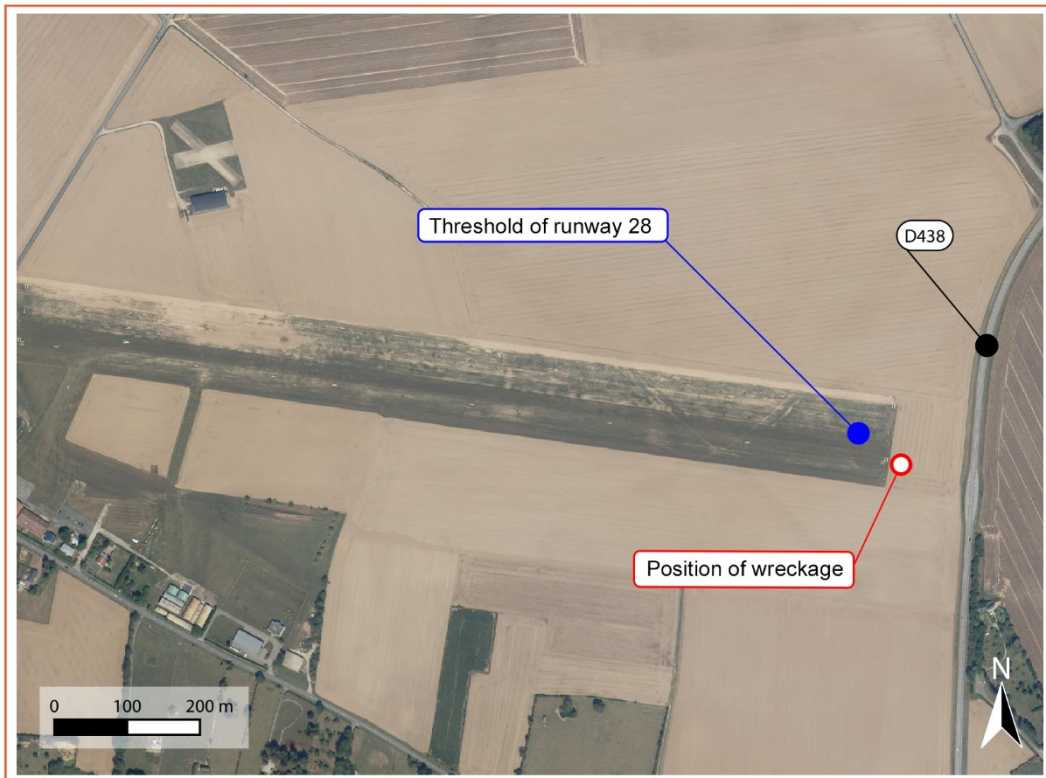
The wreckage was found a few metres past the threshold of runway 28, approximately three metres to the left of the runway 28 centreline. It was oriented on a heading of between 260 and 280°, in the opposite direction to the direction of take-off.

**Figure 1: position of the wreckage (source: BEA)**

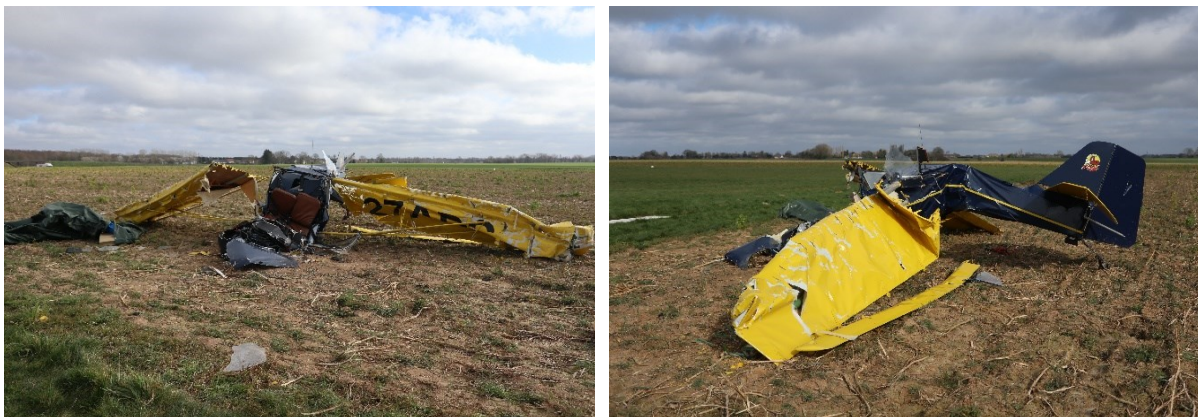
The wreckage was complete, the cabin was totally destroyed and the engine was embedded in the ground. Both wings were damaged, partly separated from the airframe, and their leading edges showed marks of contact with the ground. The ruptures observed on the flight controls (rudder, elevator and flaperons) showed that they had violently broken under the impact with the ground. The damage to the wings made it impossible to determine the position of the flaperons at the time of the impact with the ground. These observations showed that the microlight struck the ground with energy and a significant nose-down angle. The examinations carried out did not reveal any element that could have contributed to the accident.

The examination of the engine also did not reveal any element contributing to the accident.

**Figures 2 and 3: photos of the wreckage (source: BEA)**
