Accident to the MAGNI M16
identified **29SR**
on Monday 2 October 2023
on Morlaix - Ploujean aerodrome

Gyroplane upset during landing run

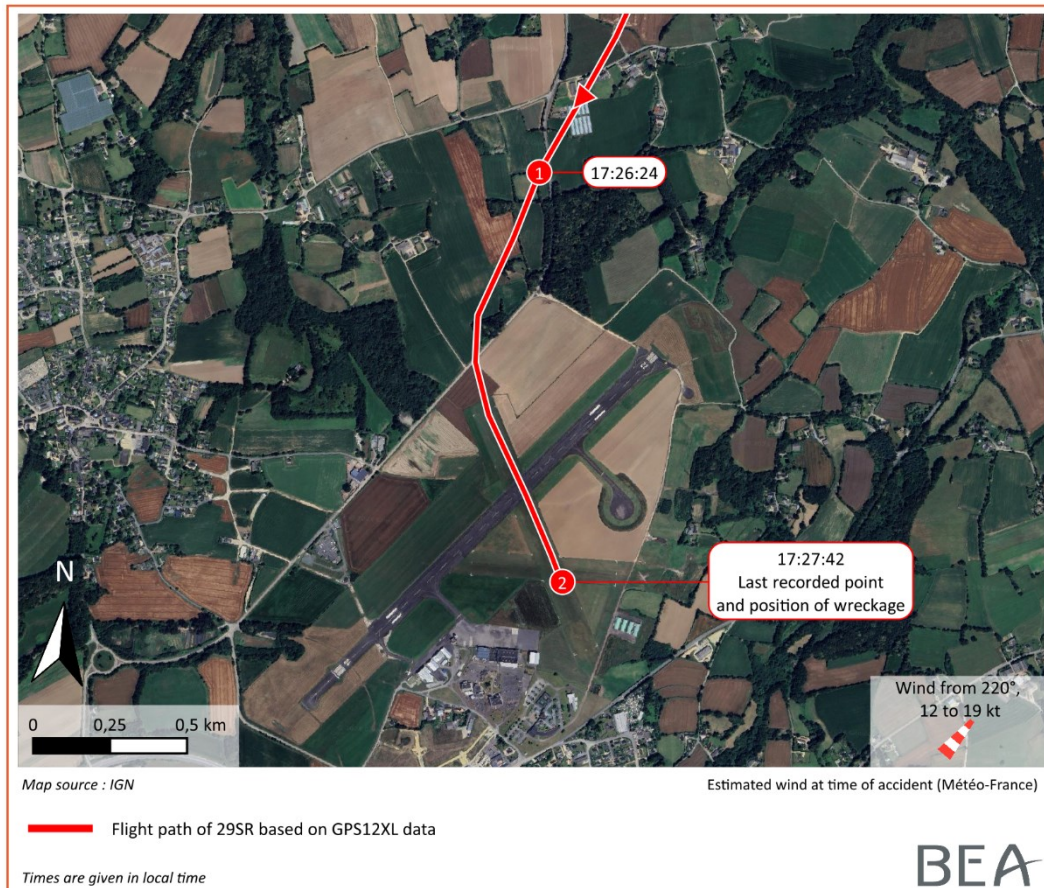
Figure 1: inbound flight path of gyroplane
