Accident to the DTA Magic
identified **30SR**
on 28 May 2021
at Vairé microlight strip

This is a courtesy translation by the BEA of the Final Report on the Safety Investigation. As accurate as the translation may be, the original text in French is the work of reference.

Collision with vegetation during approach

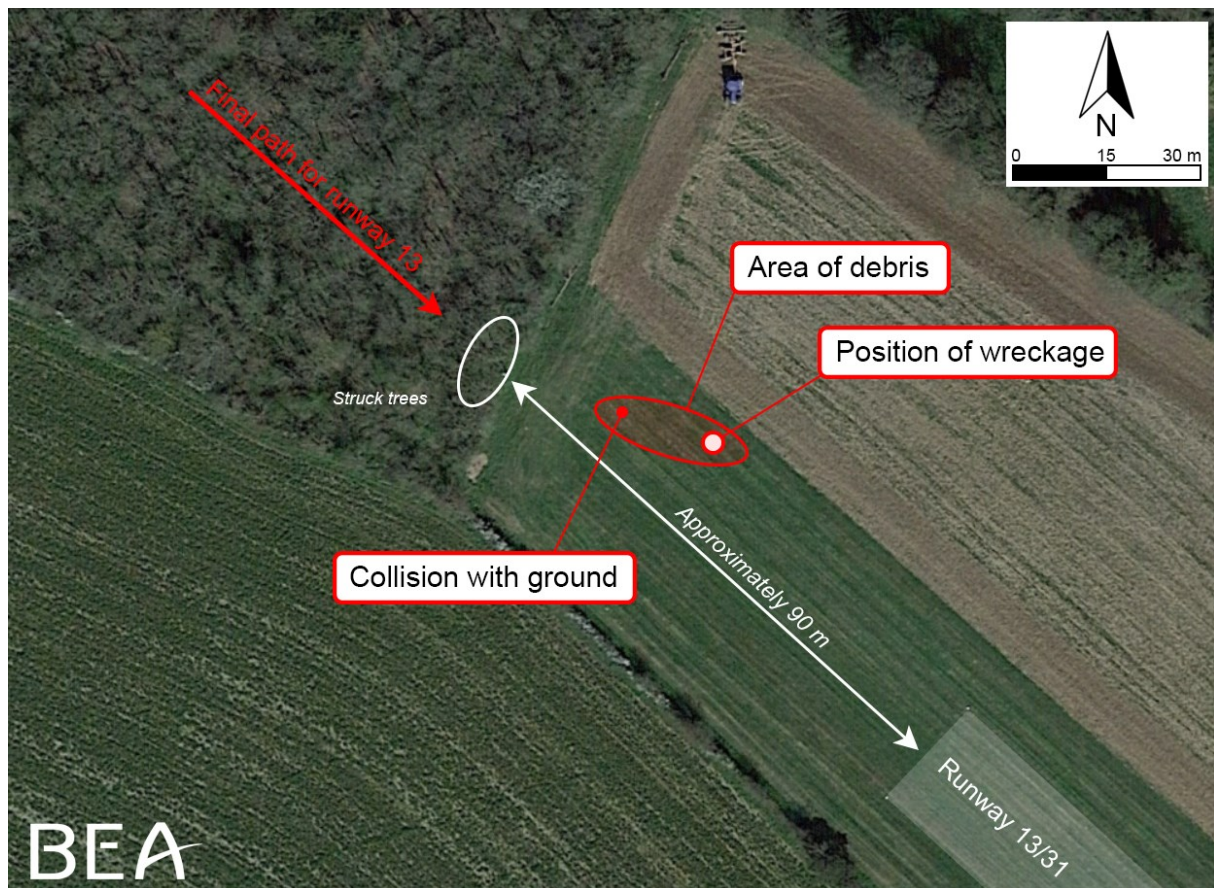
Figure 1: accident site (Source: BEA)

The marks in the vegetation indicated that the microlight struck the tops of trees about 10 m high, at the edge of the wood (see Figure 1). A branch split lengthwise was found about five metres from the tree that was struck.

The microlight collided with the ground about 15 m from the trees it struck, then it came to a stop about 30 m from the edge of the wood.

Most of the debris from the microlight as well as branches were spread between the point of impact and the main wreckage.

The wing was complete and had several rub marks from the trees. It was properly connected to the trike and all pins were in place. Branches were found in the LH strut and at the front of the trike. All of the distortion and failures observed on the trike and the control bar resulted from the collision with the ground.

The presence of trees before runway 13 requires a specific and precise final approach when the runway threshold is used as the aiming point. In this context, the safety margins are extremely reduced, or even non-existent, even though the approach is carried out with the engine at reduced speed and with a steep slope. The FFPLUM plans to contact the strip owner to suggest that a displaced threshold be defined to provide more reasonable safety margins.
