Accident to the Ozone Freeride 17
identified **36UU**
on 25 June 2022
at Savines-le-Lac (Hautes-Alpes)

Wing collapse in flight, loss of control and collision with the surface of a lake

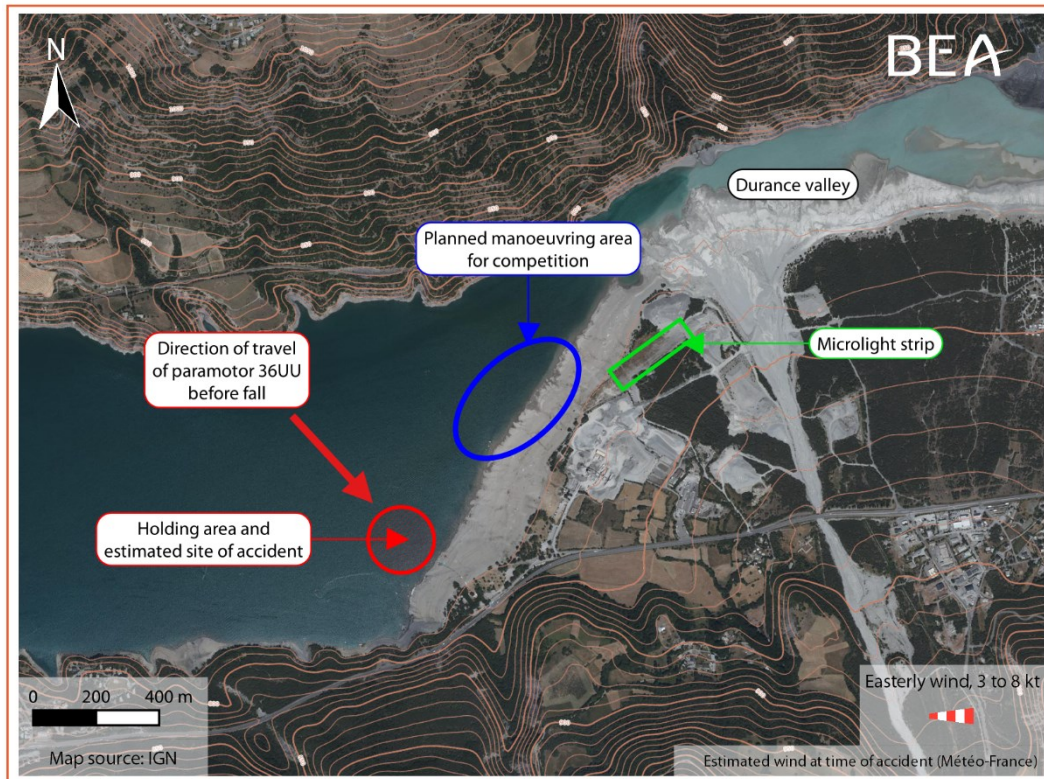
Figure 1: accident site

On the day of the accident, the pilot was preparing for his first slalom of the day. He was the ninth participant in the competition's running order. He was in the holding area, at an estimated height of between 100 and 150 m. While in straight flight, his wing suddenly collapsed. The paramotor fell and collided with the surface of the lake less than five seconds after the wing collapsed.
