**Accident** to the SUPERGUÉPARD 912 UL  
identified **43YH**  
on 3 September 2022  
at Noron l'Abbaye (Calvados)

<b>Time</b>	Around 07:20 <sup>1</sup>
<b>Operator</b>	Private
<b>Type of flight</b>	Cross-country
<b>Persons on board</b>	Pilot and passenger
<b>Consequences and damage</b>	Persons on board fatally injured, microlight destroyed

**Flight in weather conditions incompatible with flight under VFR rules, collision with the ground**

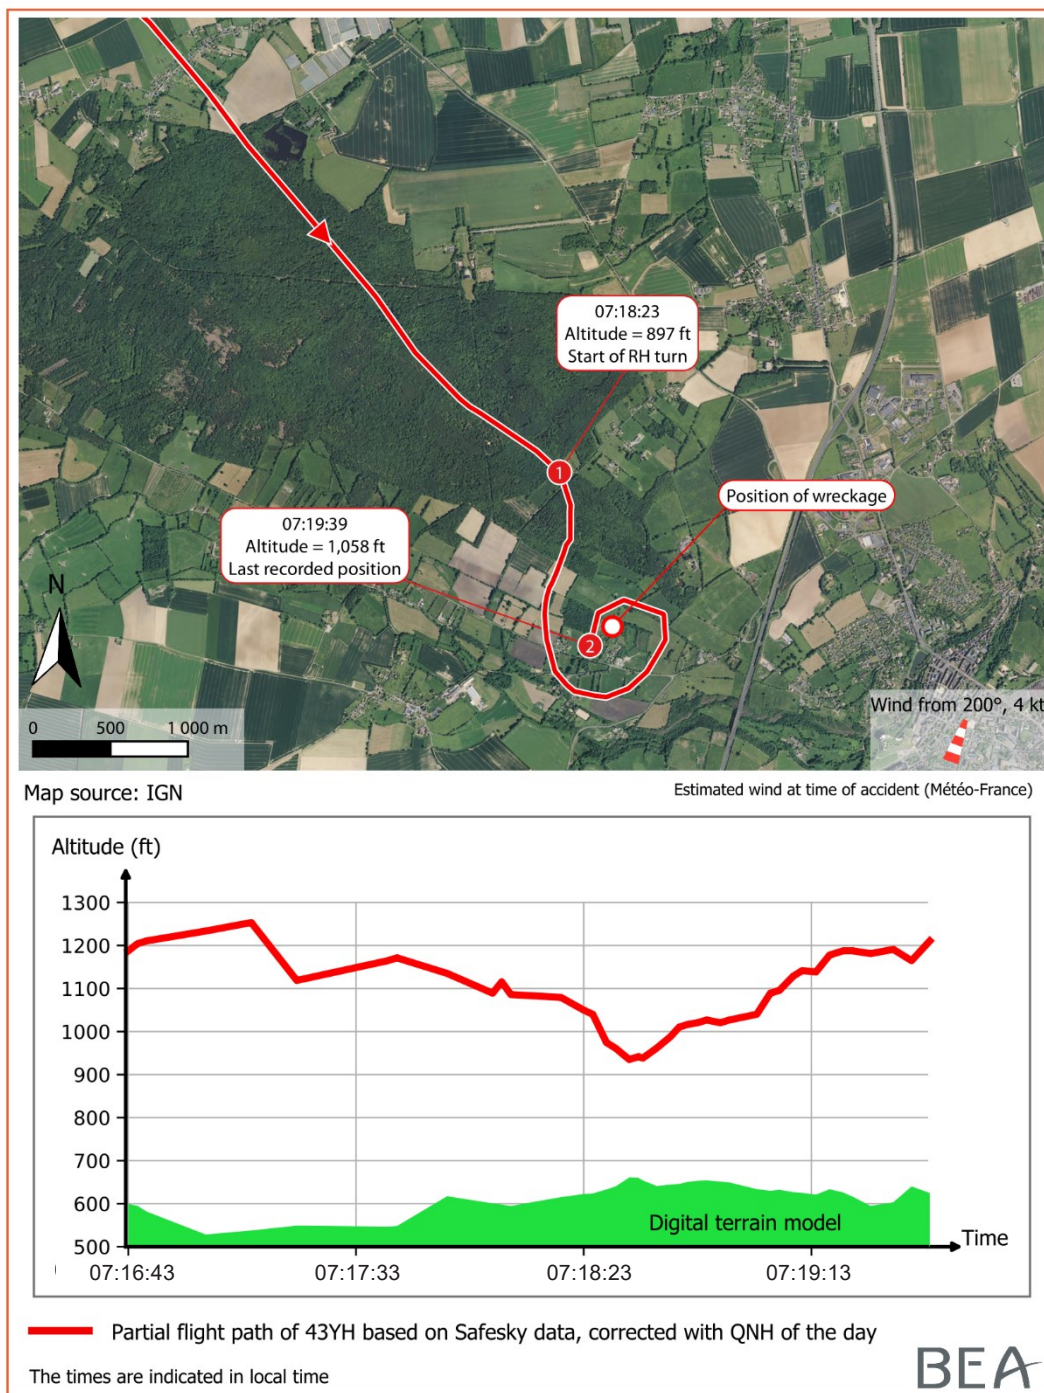
The pilot, accompanied by a passenger who was also a pilot, took off at around 07:05 from Caen-Carpiquet airport (Calvados) bound for Blois-Le Breuil aerodrome (Loir-et-Cher) where the World Microlight Exhibition was taking place. He climbed towards an altitude of 1,500 ft and initially took a south-east route, then a south-south-west route. The microlight's altitude first decreased to approximately 1,100 ft at 07:18. The pilot turned to the right at around 07:18:20 and then initiated a U-turn to the left with a turning radius of between approximately 350 and 400 m, less than 3 km west of the town of Falaise<sup>2</sup> (Calvados). During this U-turn, the altitude decreased to approximately 950 ft before increasing to approximately 1,200 ft. At approximately 07:19, the left turn continued with a smaller turning radius of between approximately 200 and 250 m. The last recorded position (radar and SafeSky application) of the microlight was at an altitude of 1,200 ft and less than 200 m from the accident site. The microlight then made contact with trees in a wood at a steep angle and with a southerly heading.

Figure 1: partial flight path of the microlight

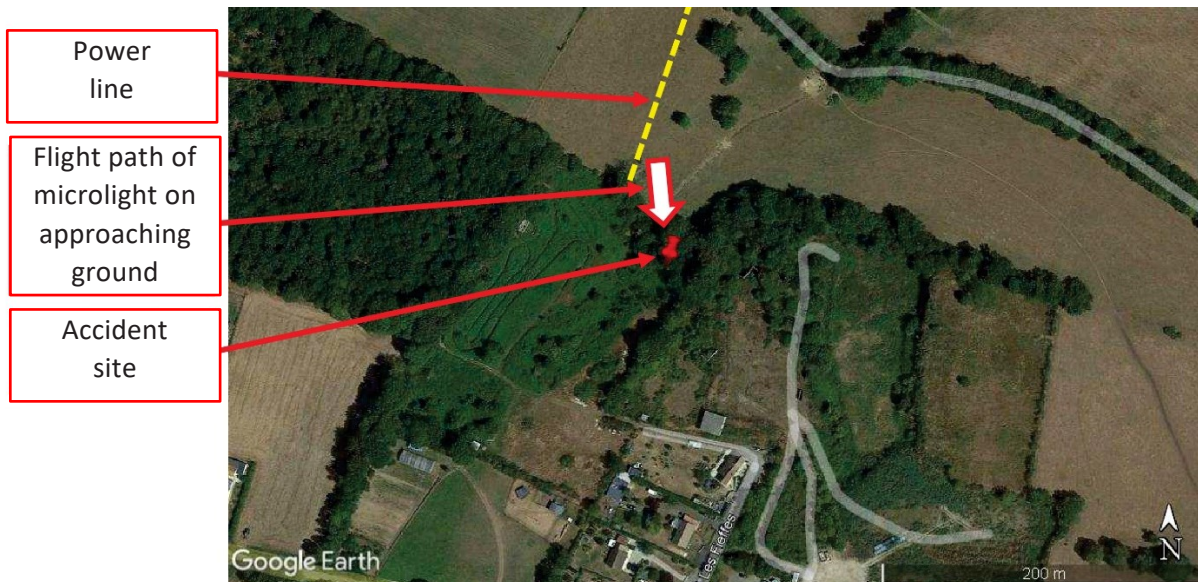
The accident site was located at an altitude of approximately 190 m, around 35 km south of Caen-Carpiquet airport and less than 3 km from the town of Falaise. The wreckage was found in a wooded area surrounded by several fields clear of vegetation. A low-voltage power line located before the accident site (in relation to the aeroplane's final path) crossed one of the fields. It was not damaged by the microlight. The marks in the vegetation indicated a final path of the microlight oriented south before collision with the ground at a steep angle (see *Figure 2*).

*Figure 2: accident site*

The microlight's structure was destroyed, with the fuselage being strongly compressed in its centreline and the wing being torn off. Damage observed on the wing resulted from the accident. This damage and the marks in the vegetation indicated that the microlight generated a substantial amount of kinetic energy before it collided with the ground.

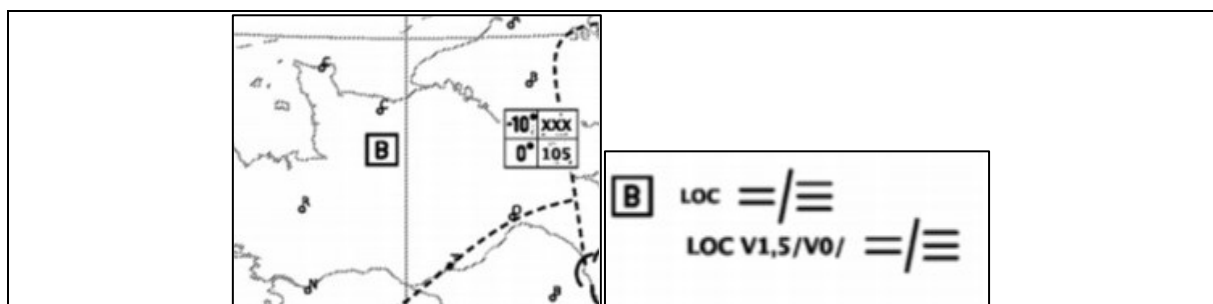
The (low altitude) SIGWX chart France issued on 3 September at 06:00, which was available before the flight, specifically forecast visibilities locally lower than 5 km and 1.5 km as well as mist and fog for 08:00 (see *Figure 3*).

Figure 3: excerpt from the SIGWX chart France with the weather forecast for 3 September 2022 at 08:00

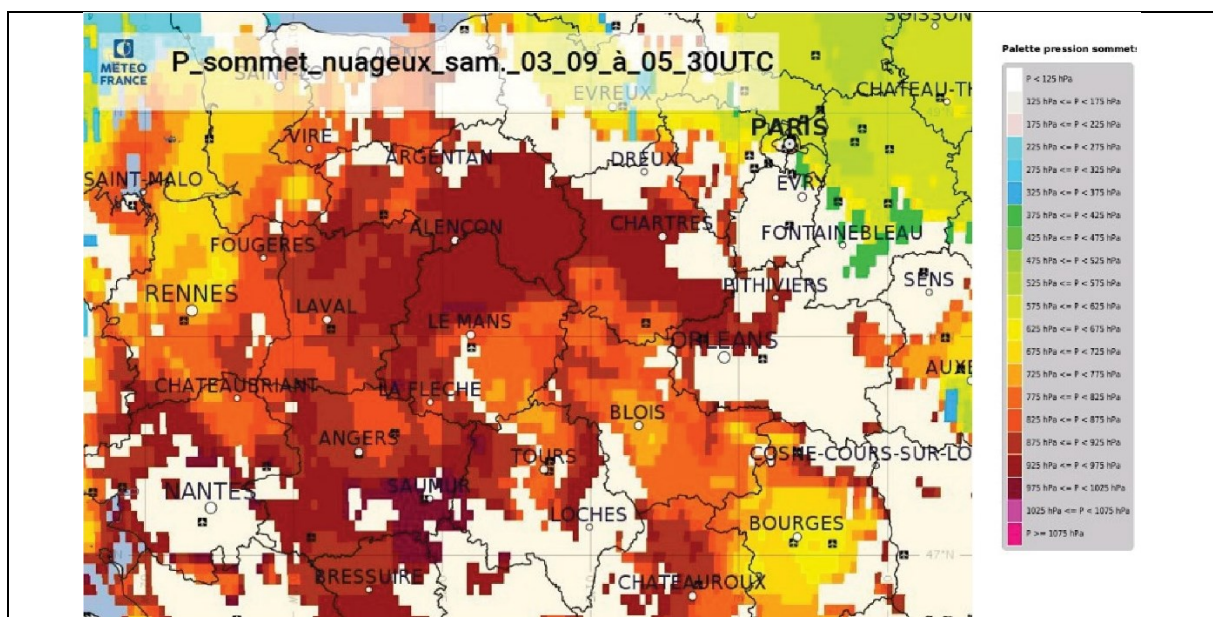
The satellite image (see *Figure 4*) showed low-level clouds, also confirmed by the METAR reports available. The brown colour indicated stratus clouds with a top at approximately 500 m. The orange colour indicated stratocumulus clouds with a top at approximately 2,000 m.

Figure 4: satellite image at 07:30

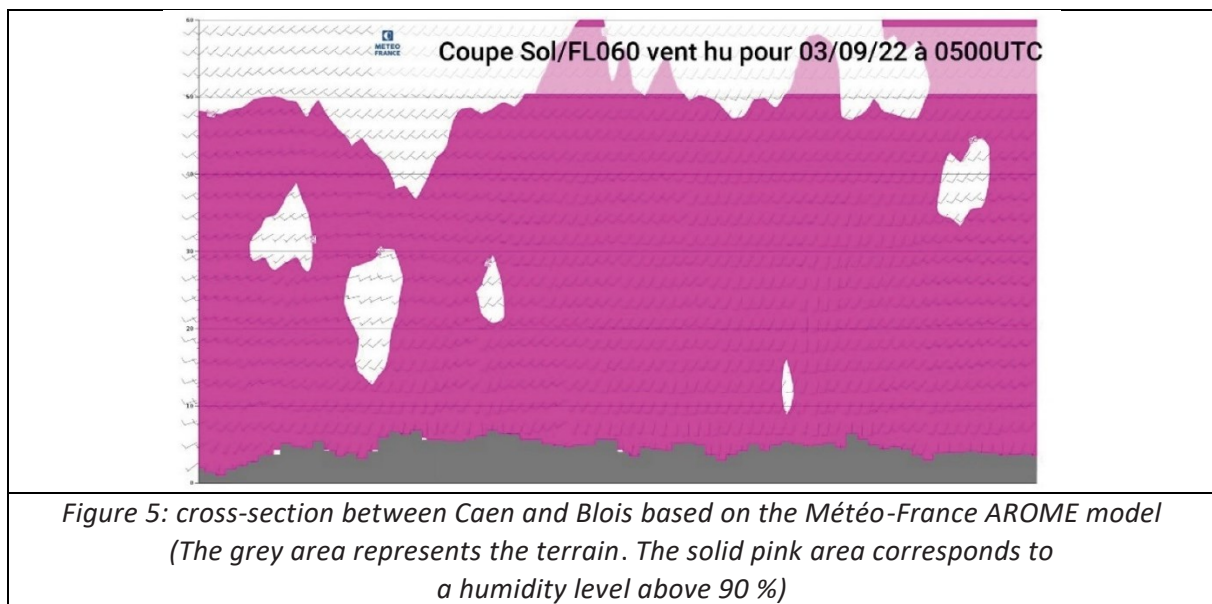
A cross-section, based on the Météo-France AROME model, extending from the ground to flight level 60 (FL060) between Caen and Blois at 07:00 on 3 September, showed stratiform clouds touching the terrain (see *Figure 5*).
