Accident to the TL-3000 Sirius
identified **44AWF**
on Thursday 18 November 2021
close to Meaux - Esbly aerodrome

Time	Around 16:00 ¹
Operator	Private
Type of flight	Local
Persons on board	Pilot
Consequences and damage	Pilot fatally injured, microlight destroyed
This is a courtesy translation by the BEA of the Final Report on the Safety Investigation. As accurate as the translation may be, the original text in French is the work of reference.

Attempted turn-around to departure aerodrome at low height, collision with an antenna in adverse meteorological conditions for flight under VFR

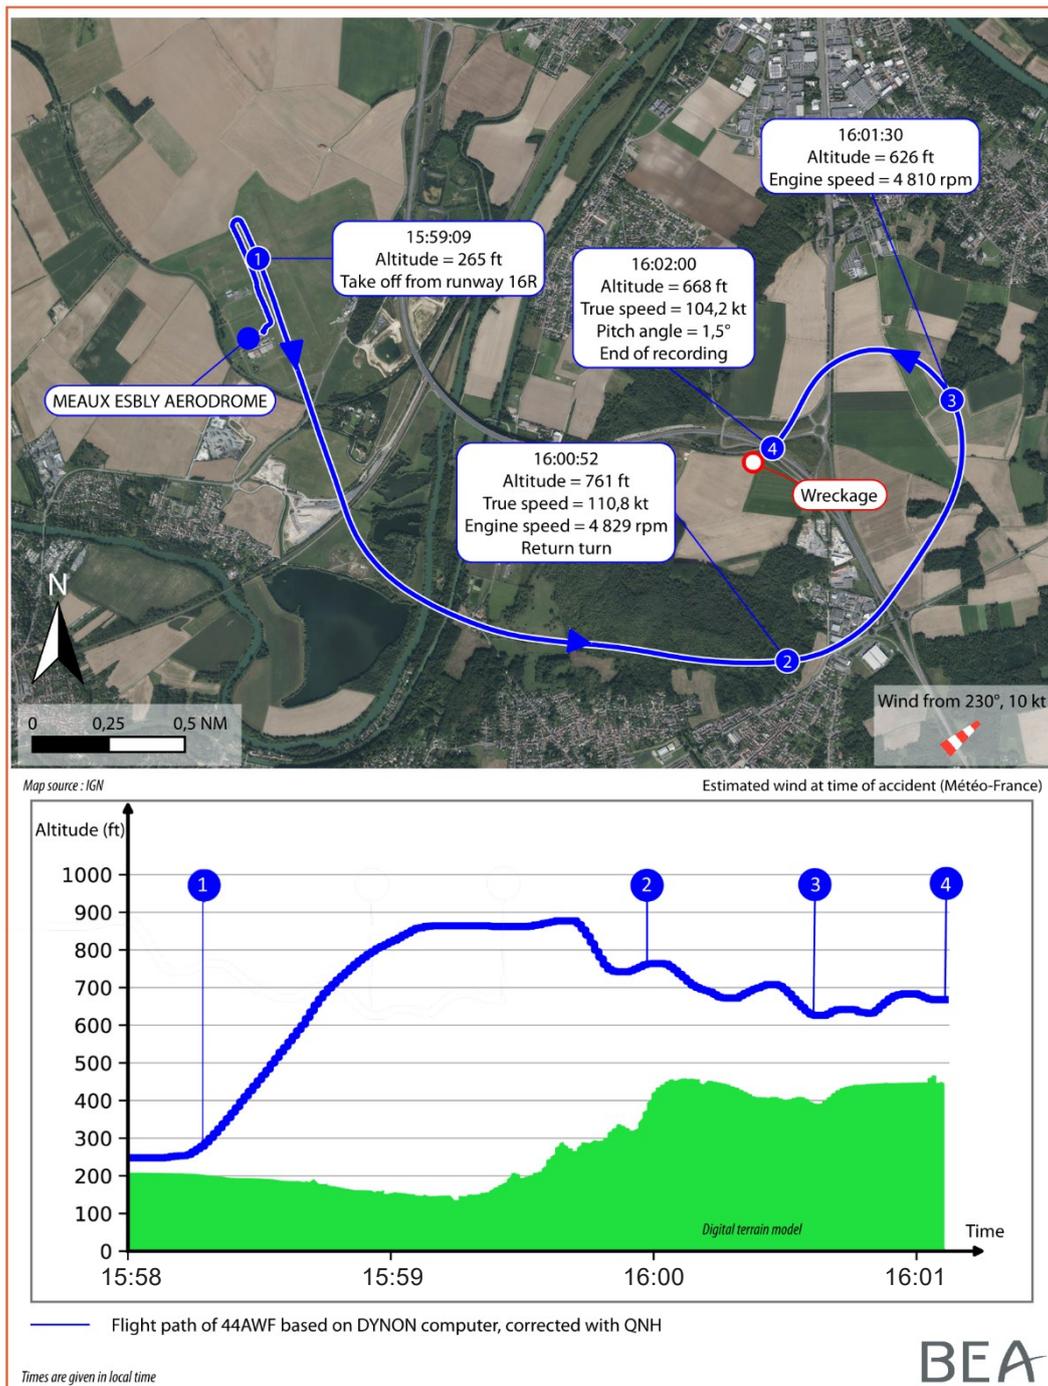
The pilot took off at 15:59 (see **Figure 1**, point ①), climbed on the runway axis to an altitude of 890 ft² (this would be the highest point of the flight), and then began a first LH turn.

At 16:00:28, he informed the controller that there was no ceiling, and that he was only going to fly around Meaux. The controller asked him to keep monitoring the frequency. The pilot then turned left towards the aerodrome (point ②); at this point he was at an altitude of 760 ft (a height of about 360 ft), and a speed of roughly 110 kt.

At 16 h 01 min 33 (point ③), the pilot was at an altitude of 630 ft (i.e. a height of about 230 ft), he indicated to the controller that visibility was very low.

At around 16:02, the microlight's last position was recorded (point ④), its altitude was 668 ft. A short time later, the microlight collided with a relay antenna, the top of which rises to an altitude of 653 ft³.

Figure 1: flight path of 44AWF taken from Dynon D-1000 computer

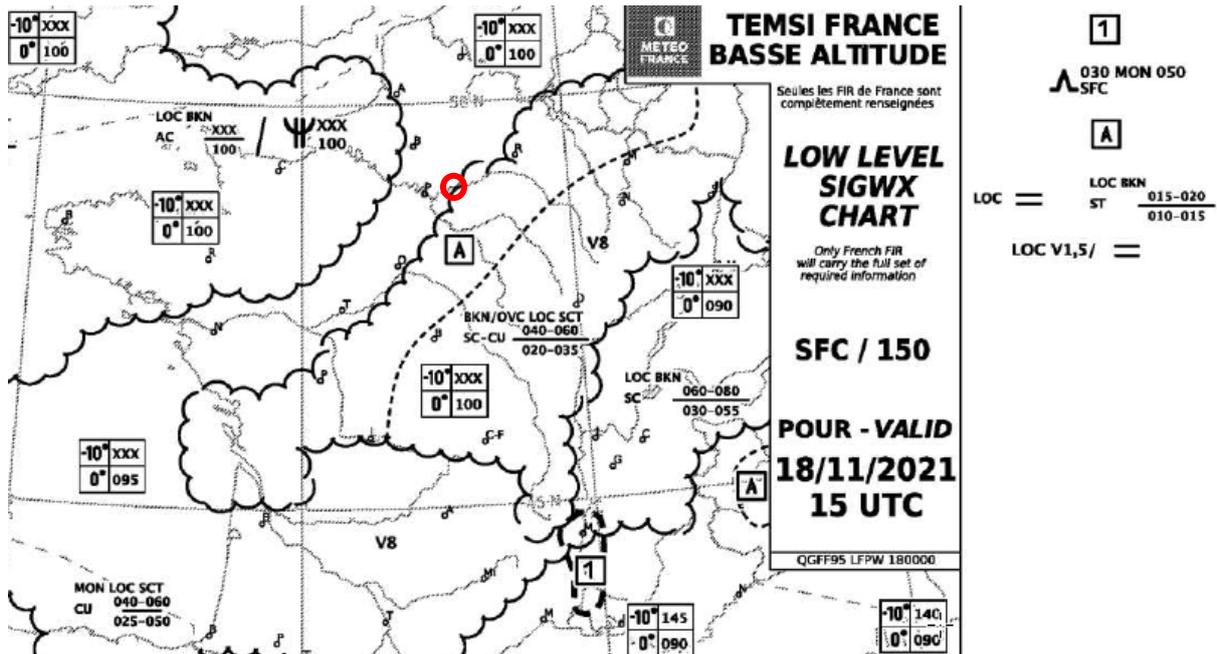
The 16:00 SIGWX chart showed that Meaux was at the limit between:

- an area of stratus clouds based between 1,000 and 1,500 ft, and localized fog with visibility between 1,500 and 5,000 m;
- an area of clear sky or few clouds.

Figure 2: 16:00 SIGWX chart (source: Météo-France)
