Accident to the BILLY XS
identified **44AXU**
on Saturday 23 September 2023
at Blain

Collision with a power line

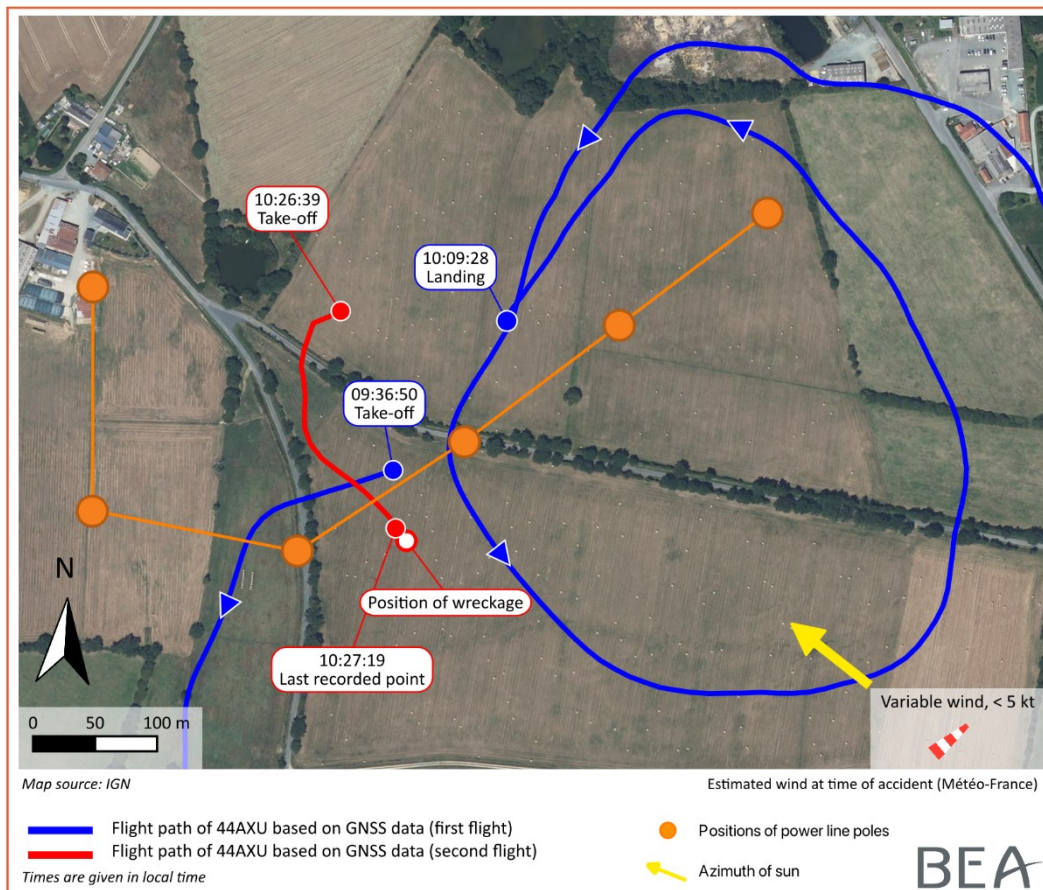
Fifteen minutes later, at 10:26, the pilot took off facing south from the field in which he had landed. He turned left shortly afterwards to follow a south-easterly route and came into contact with, at a height of eight metres and less than a minute after taking off, the cables of a 20,000 V medium voltage (MV) power line.

Figure 1: flight paths followed and positions of power lines and the sun

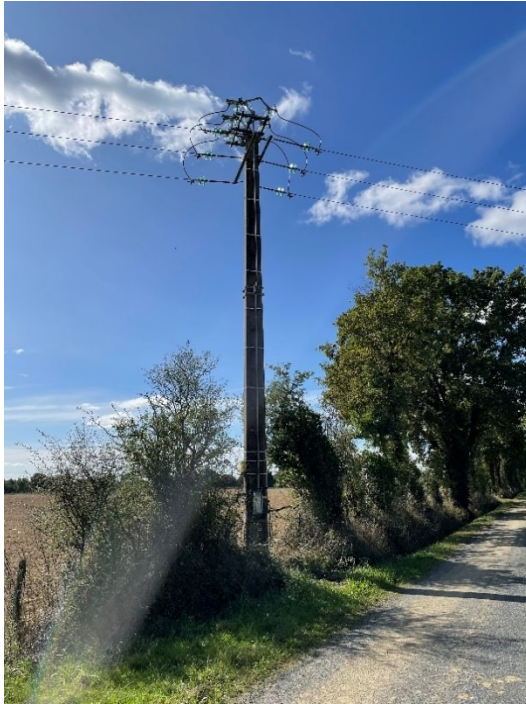
The wreckage was located in a field with no visible crop. A main road separated the field from which the pilot had just taken off and the field where he struck the MV power line. The road was lined with trees; the height of some of these trees was close to that of the poles. The power line was on a north-east/south-west axis, perpendicular to the flight path followed by the pilot. It was composed of 13-m high concrete poles and three cables. The two poles either side of the accident site were located in a row of trees (see **Figure 2**) at a distance of 150 m from each other. The damage to the three power line cables was characteristic of contact with an object at a height of around eight metres.

Figure 2: one of the two poles either side of the accident site (source: BEA)

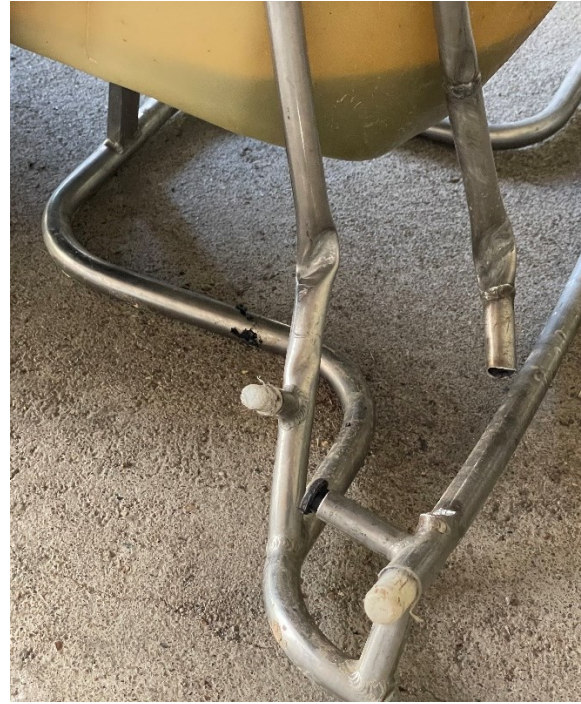
Figure 3: marks on paramotor chassis from contact with one of the power line cables (source: BEA)

Except for the marks caused by the paramotor chassis coming into contact with one of the power line cables (see **Figure 3**), the damage observed on the paramotor was the result of the collision with the ground.
