Accident to the class 6 DYNALI H3 Sport
identified **45ARJ**
on Wednesday 20 September 2023
at Bazoches-les-Gallerandes

Collision with the ground during low-height flight

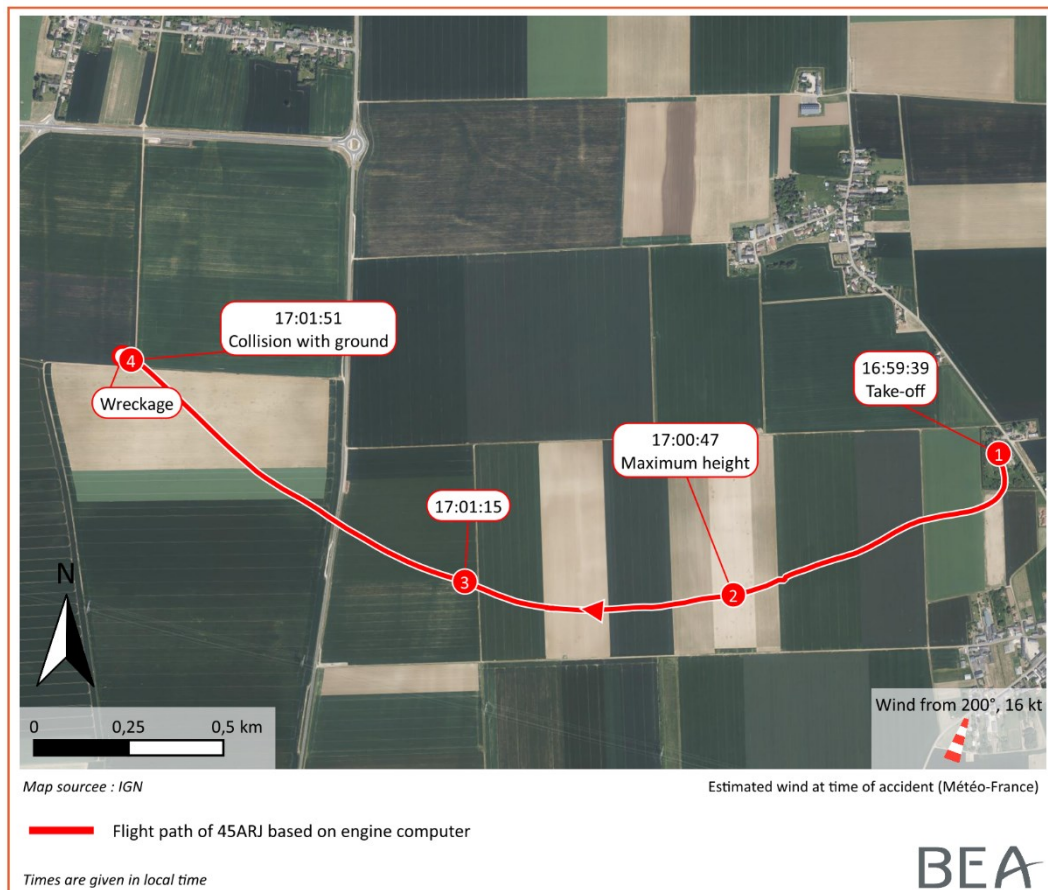
The pilot, accompanied by a passenger, took off from the private Helicopter Landing Site (HLS) at his home at around 17:00 and headed south-west (see **Figure 1**, point **①**). Around one minute later, the microlight reached a height of no more than 300 ft³ (point **②**) and then flew for around thirty seconds westwards. It then descended to a height of no more than 150 ft (point **③**) in a north-westerly direction with a ground speed of around 100 km/h. The microlight collided with the ground around forty seconds later (point **④**).

Figure 1: flight path of 45ARJ
