**Accident** to the JMB Aircraft VL3E  
identified **49ADC**  
on Sunday 30 July 2023  
close to Cholet-Le Pontreau aerodrome

**Pilot incapacitation on final, go-around, loss of control,  
collision with ground**

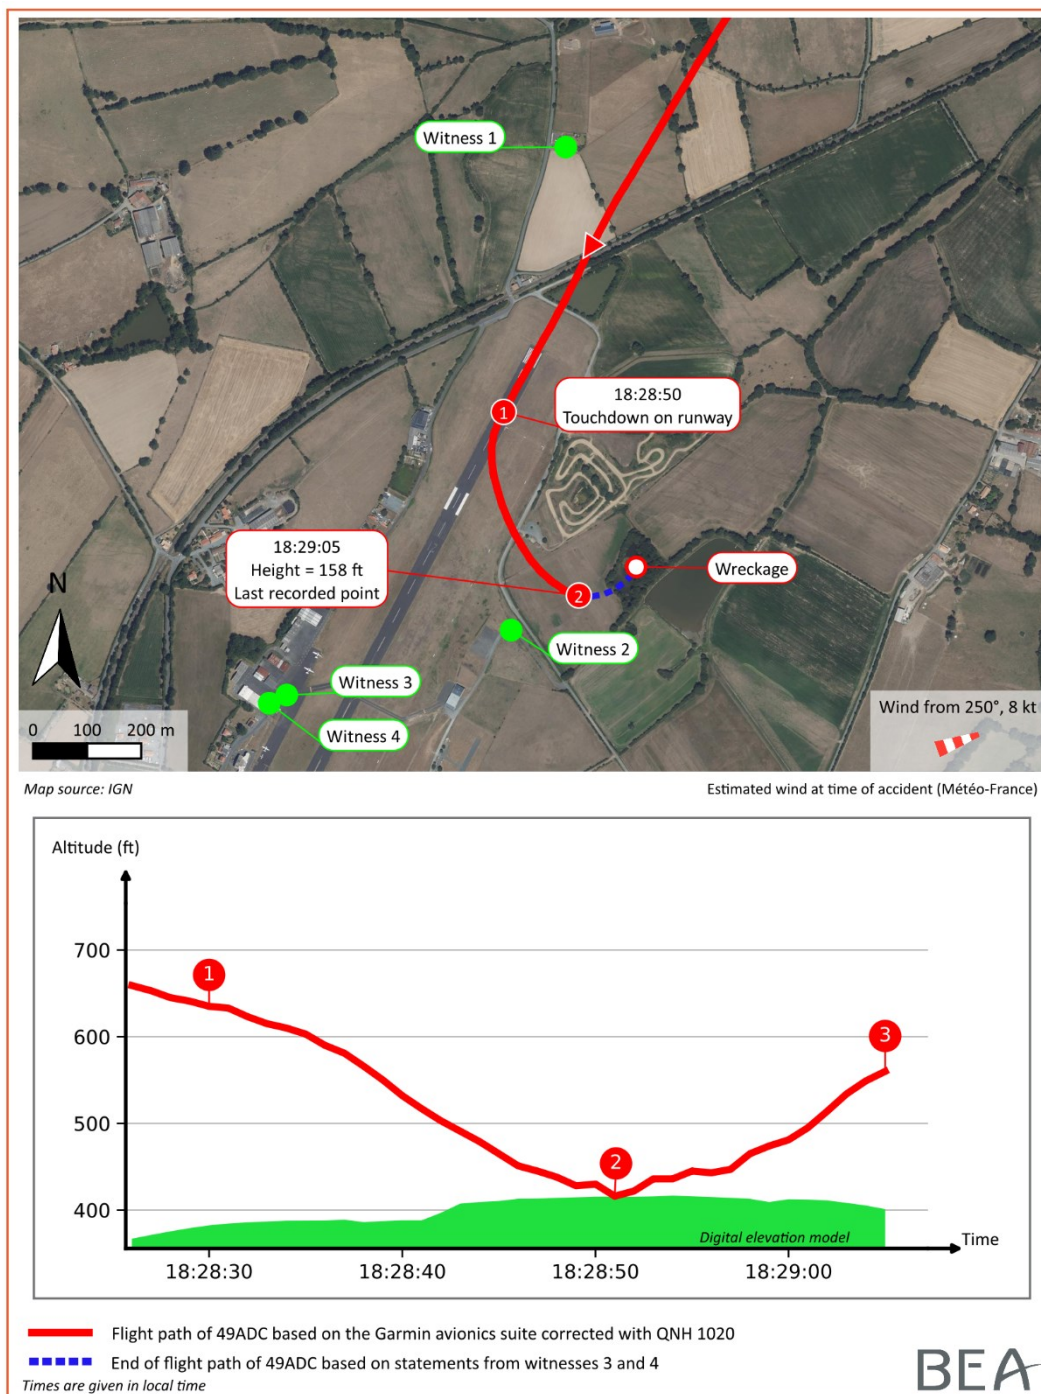
Witnesses 3 and 4 indicated that they then saw the microlight take a steep LH bank and pitch down towards the ground. The wreckage was found in a stretch of water at around 400 m to the LH side of the threshold of runway 21.

Figure 1: microlight's path at end of flight

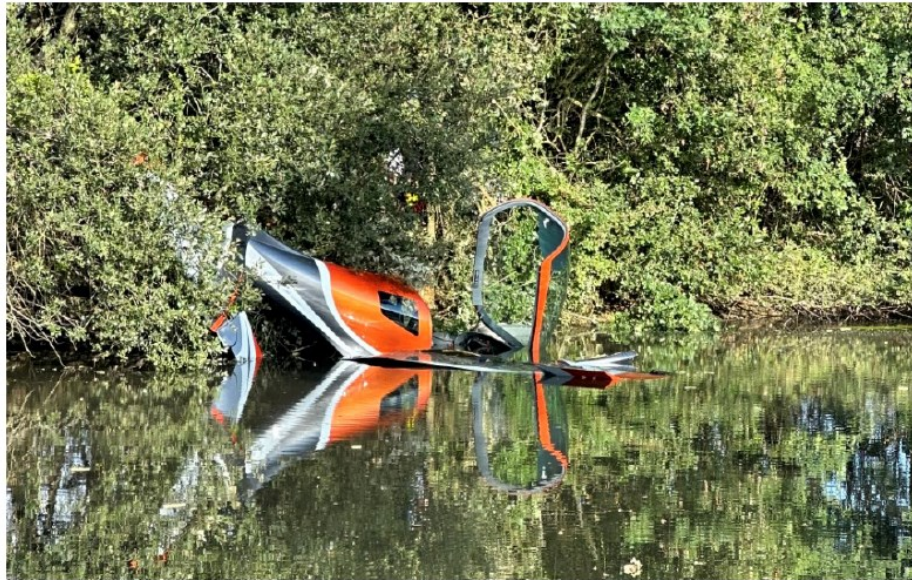
The stretch of water in which the wreckage was found submerged was surrounded by vegetation. Marks in the vegetation south of the wreckage indicated that the final flight path of the microlight was on a northerly heading. The microlight then made a U-turn around its yaw axis given its final position oriented south.

*Figure 2: photo of wreckage from west bank  
(Source: Brigade de Police Aéronautique de Rennes)*

The wreckage was complete except for a propeller blade which was not found.

The examination of the wreckage did not reveal any anomaly which could explain the accident.
