**Accident** to the RANS S12  
identified **55JU**  
on Sunday 16 April 2023  
at Billy-sous-Mangiennes

This is a courtesy translation by the BEA of the Final Report on the Safety Investigation. As accurate as the translation may be, the original text in French is the work of reference.

## Loss of control on short final, collision with ground

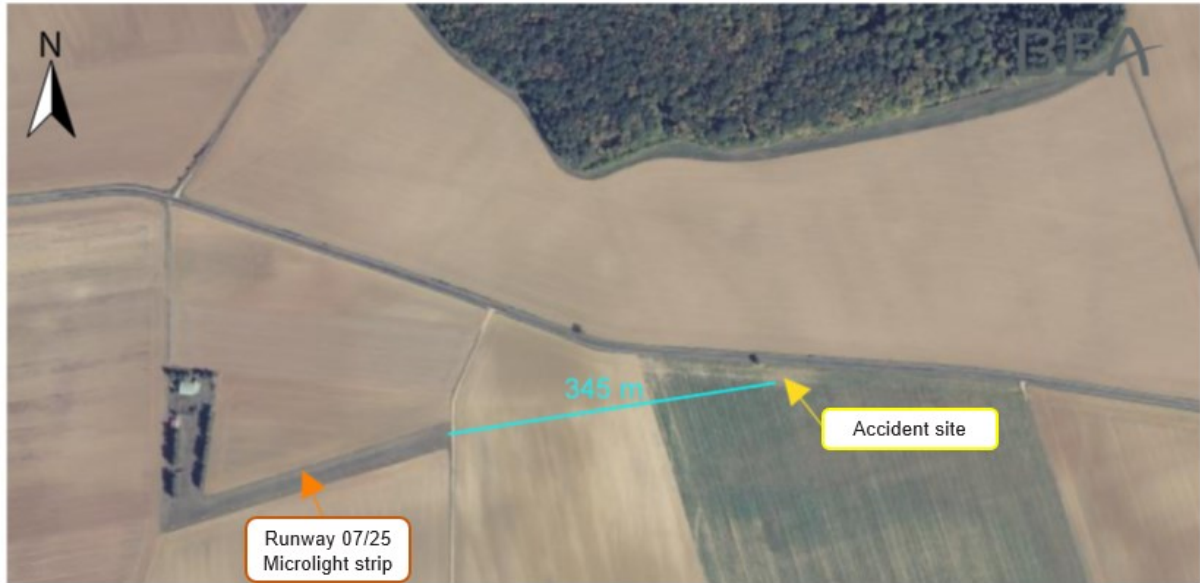
The wreckage was located in a field, close to Billy-sous-Mangiennes microlight strip, at 345 m from the threshold of runway 25 (see Figure 2).

Figure 2: overall view of accident site (source: Géoportail)

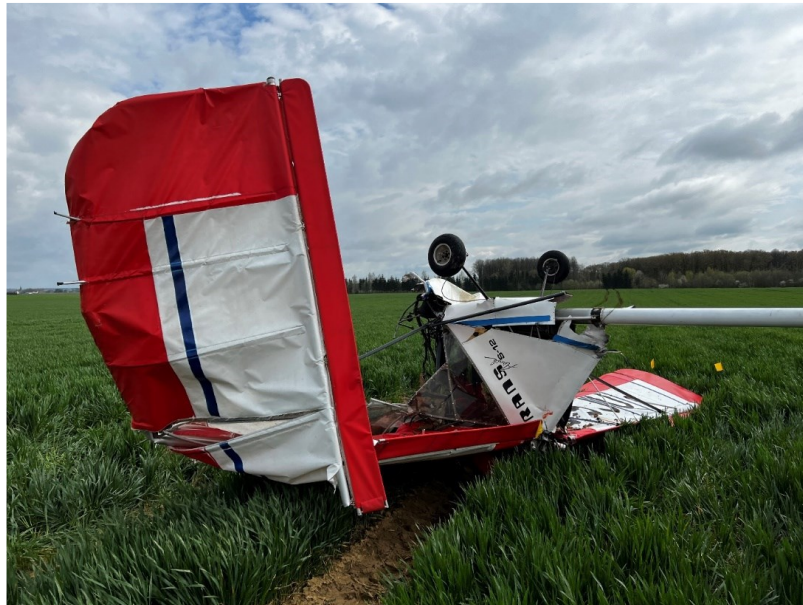
Figure 3: wreckage of 55JU (source: BEA)

The aircraft was found inverted, the nose was destroyed, the RH wing was bent by almost 90° and the top of the vertical stabilizer was lying on the ground (see Figure 3).

The damage observed was consistent with a high nose-down attitude at the time of the collision with the ground. It is probable that the RH wing contacted the ground before the LH wing. The ruptures to the structure and the flight controls show the characteristics of a sudden failure consistent with the collision with the ground.
