Accident to the Ikarus C42B
identified **57BPJ**
on 22 September 2022
near Dieuze-Guéblange aerodrome (Moselle)

Time	Around 09:40 ¹
Operator	Association ULM des PIAFS du Saulnois
Type of flight	Local
Persons on board	Pilot and passenger
Consequences and damage	Pilot and passenger fatally injured, microlight destroyed

Collision with vegetation then with the ground, post-impact fire

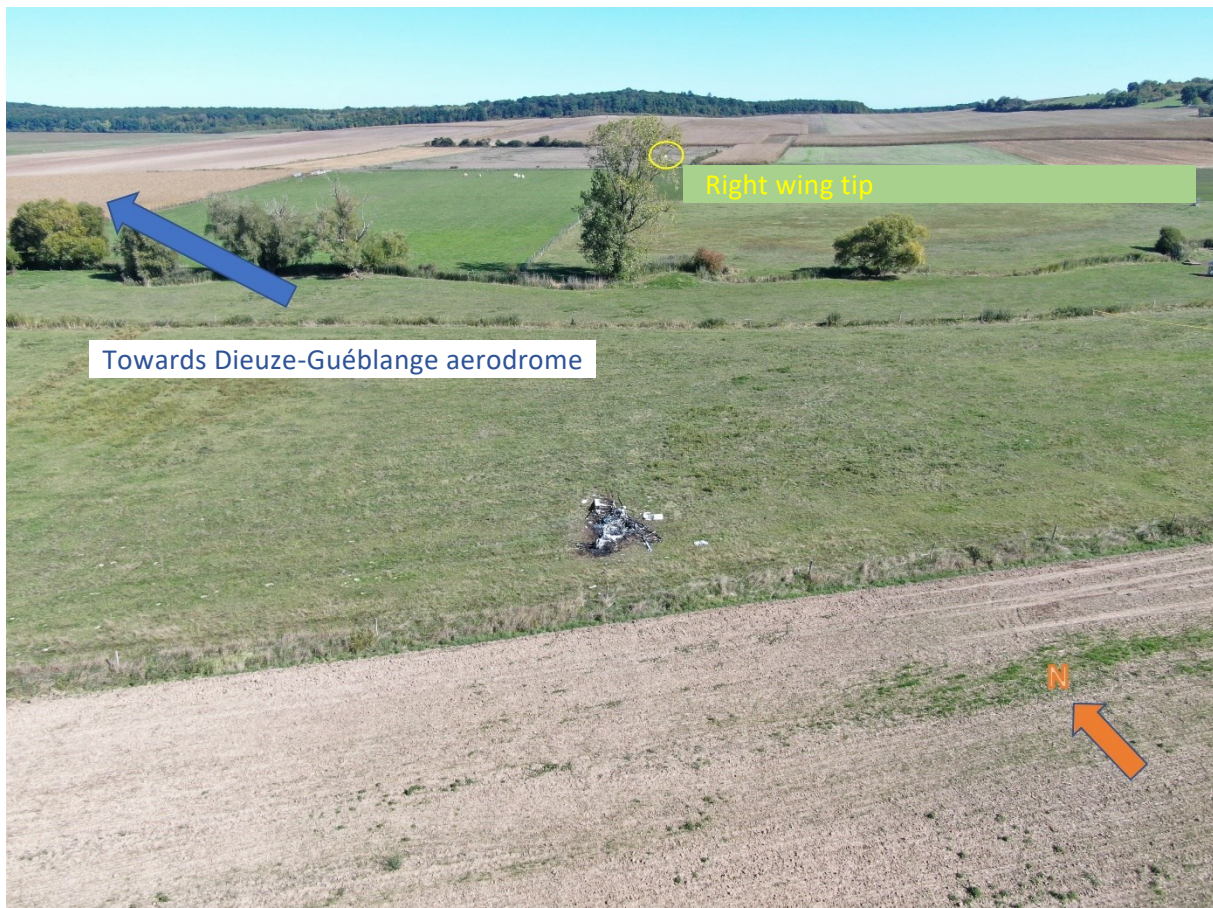
Figure 2: general view of the site and wreckage (Source: BGTA Metz, BEA annotations)

The wreckage was located in a field approximately 1,200 m south of the start of runway 05. The microlight was completely burned. The tip of the right wing was torn off when it made contact with a tree, before the aircraft hit the ground. This element was found at the top of a poplar of 15 to 20 m in height, located around 100 m north of the main wreckage. This tree, the largest in the area, was rather isolated.

With the exception of the line of trees containing the poplar, the environment was suitable for a forced landing.

The extent of the damage caused by the fire limited the scope for examination. As regards the flight controls, only the yaw and elevator trim controls could be studied. They were probably operational at the time of the collision with the vegetation.

All of the damage observed on the fuselage, wings, tail units and landing gears was the result of the collision with the vegetation and the ground and of the fire which ensued.

The absence of damage to two of the propeller's three blades, the characteristics of the damage to the third blade as well as the damage to the propeller spinner were consistent with the propeller not rotating or rotating at very low speed at the time of the collision with the ground. The engine was substantially damaged by the fire. This engine was not equipped with a torque limiter.
