Accident to the class 3 JMB AIRCRAFT VL-3-A
identified **59DUJ**
on 19 June 2020
at Mortemer

SAFETY INVESTIGATIONS

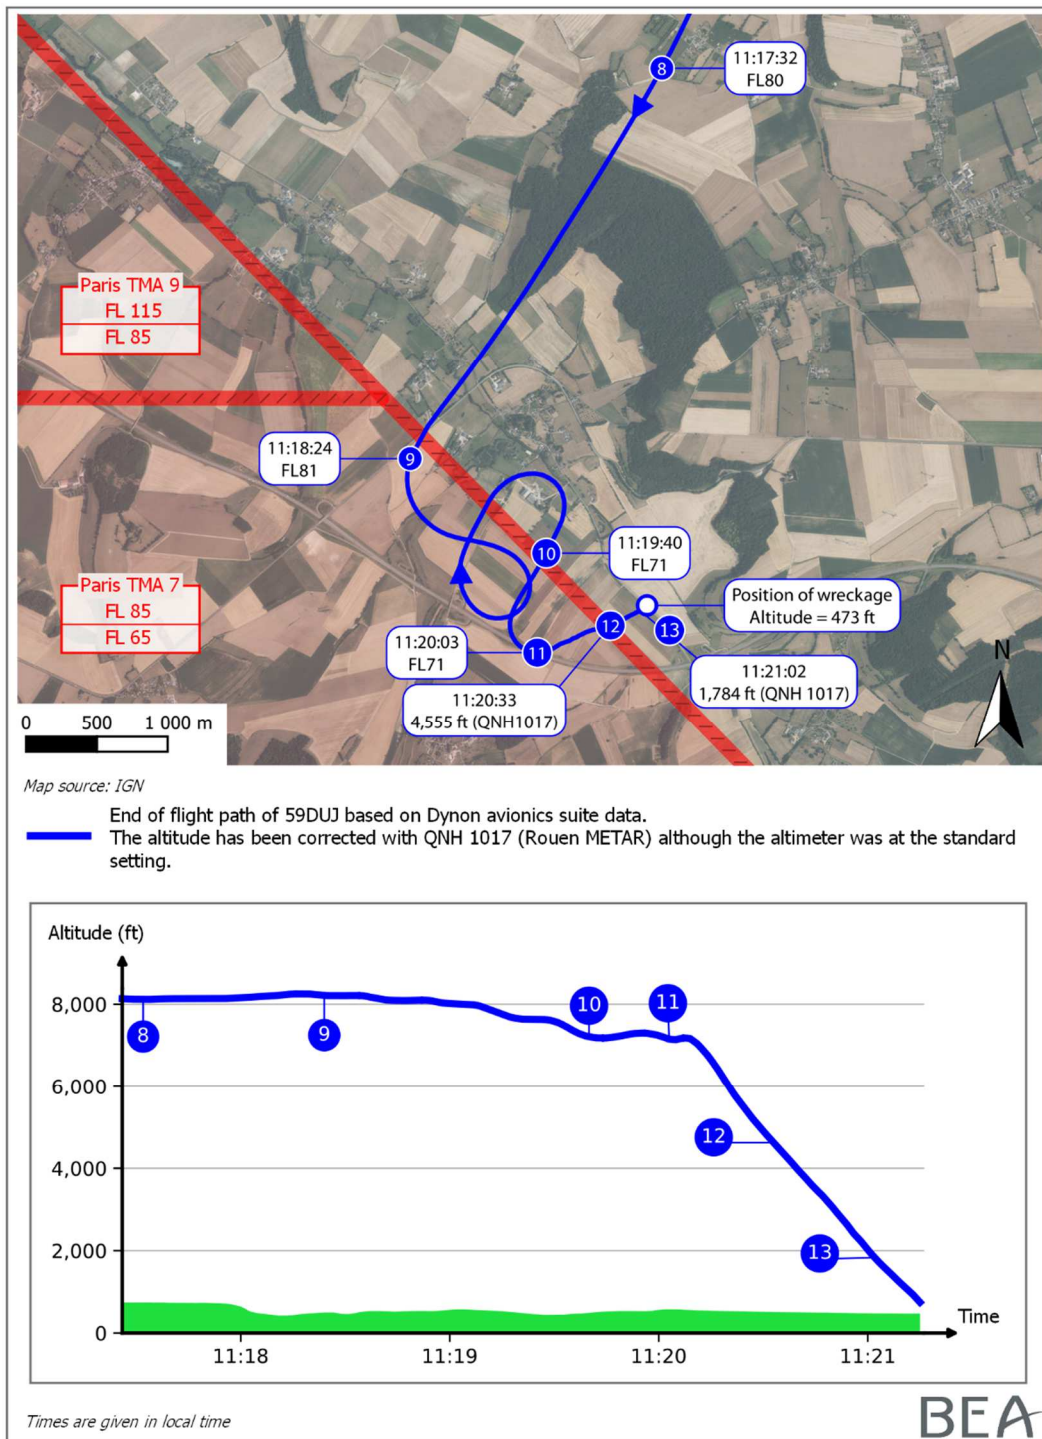
Figure 2: zoom on flight path with vertical profile for end of flight

At 11:18:19, when 59DUJ was at an altitude of around 8,200 ft, the pilot started to descend and turned left. The indicated airspeed which had decreased was 103 kt.

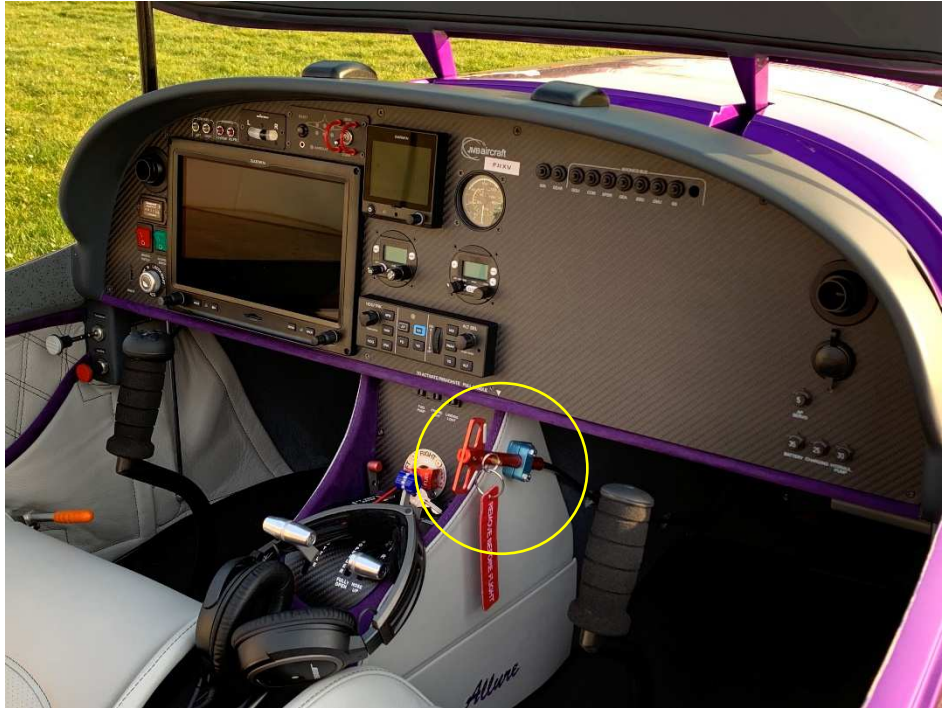
Figure 3: VL-3 cockpit with airframe parachute activation handle (source: BEA)

A safety pin located on the side of the handle protects the system from any untimely firing. This pin must be removed before any flight.

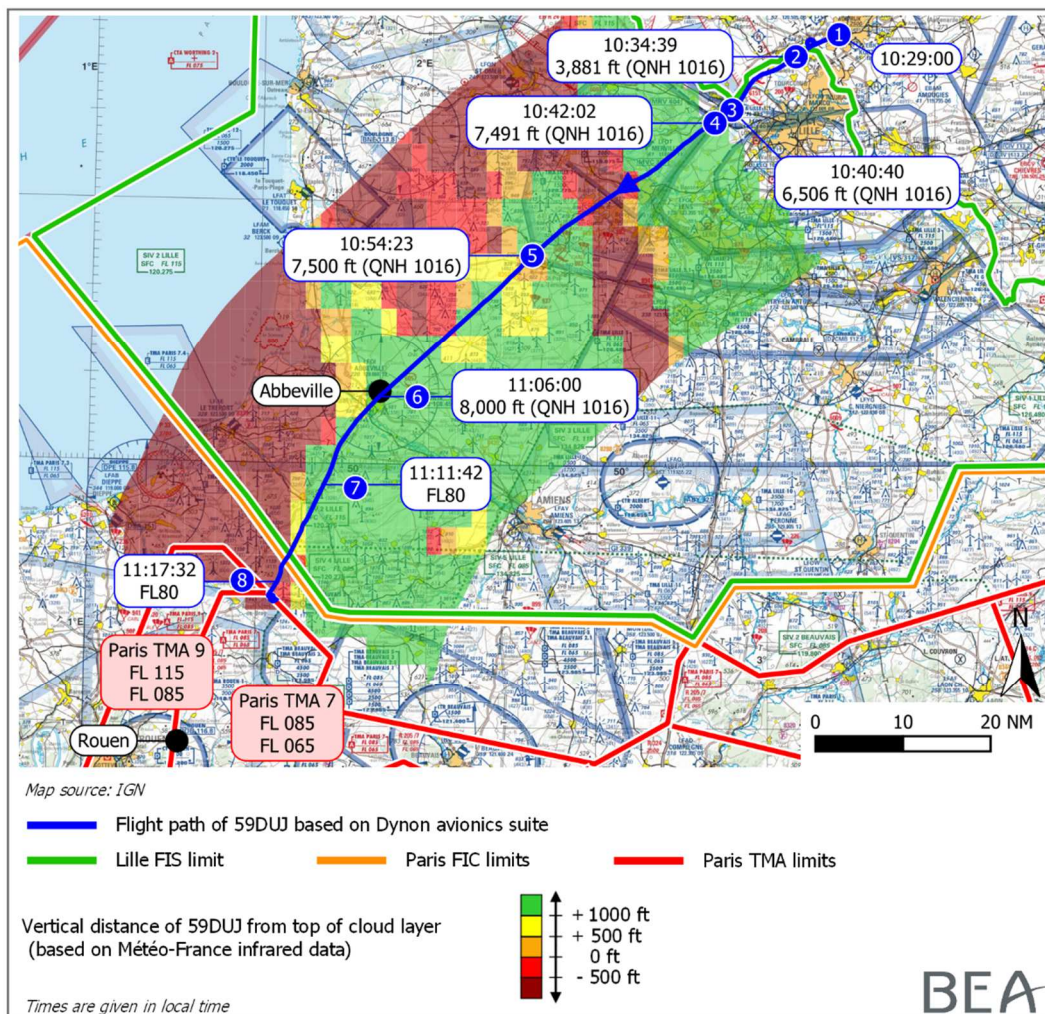
Figure 10: height of top of cloud layer with respect to 59DUJ during its on-top flight

In **Figure 10**, based on Météo-France's infra-red satellite images spaced 15 minutes apart for all of the flight of 59DUJ, the BEA shows the altitude of the top of the cloud layer abeam the flight path and relative to the altitude of 59DUJ during its on-top cross-country flight. The movement of the front was interpolated as 59DUJ advanced in increments of about one minute of flight, using successive infra-red images.

In **Figure 10**, each square or quadrant measures 3.2 by 5.8 km and its colour is determined by the altitude of the highest cloud in the quadrant, even if it is only an intermittent cloud top. Consequently, the fact that the flight path of 59DUJ passes through a "red" square does not necessarily mean that the microlight passed through clouds. It could simply have been flying close to the tops of cumulus clouds while avoiding them, as can be seen in the photos of

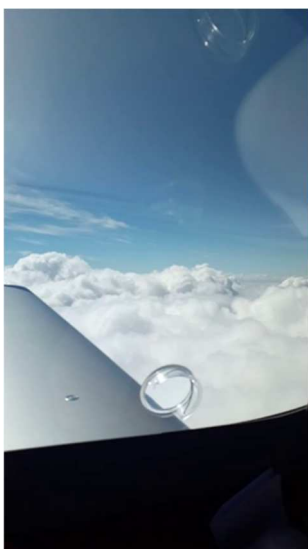
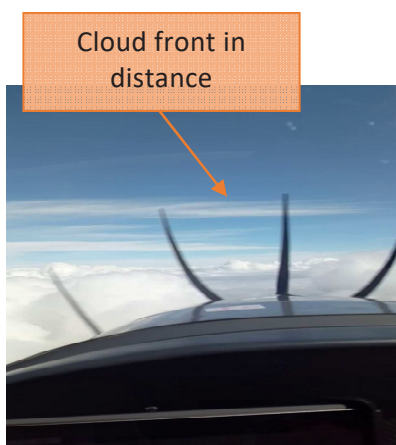
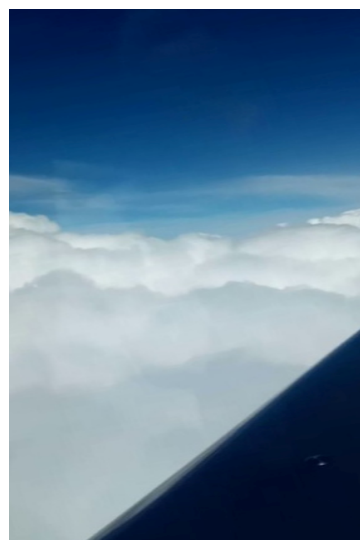
Figure 11: photos from a video taken by the passenger at 10:57 at 7,800 ft

Figure 11 shows the occluded front, which contained clouds higher than the flight altitude of 59DUJ and appeared to the pilot as a “wall” of cloud to the right of his flight path (as seen in the distance in the photo of what was ahead of the aircraft).

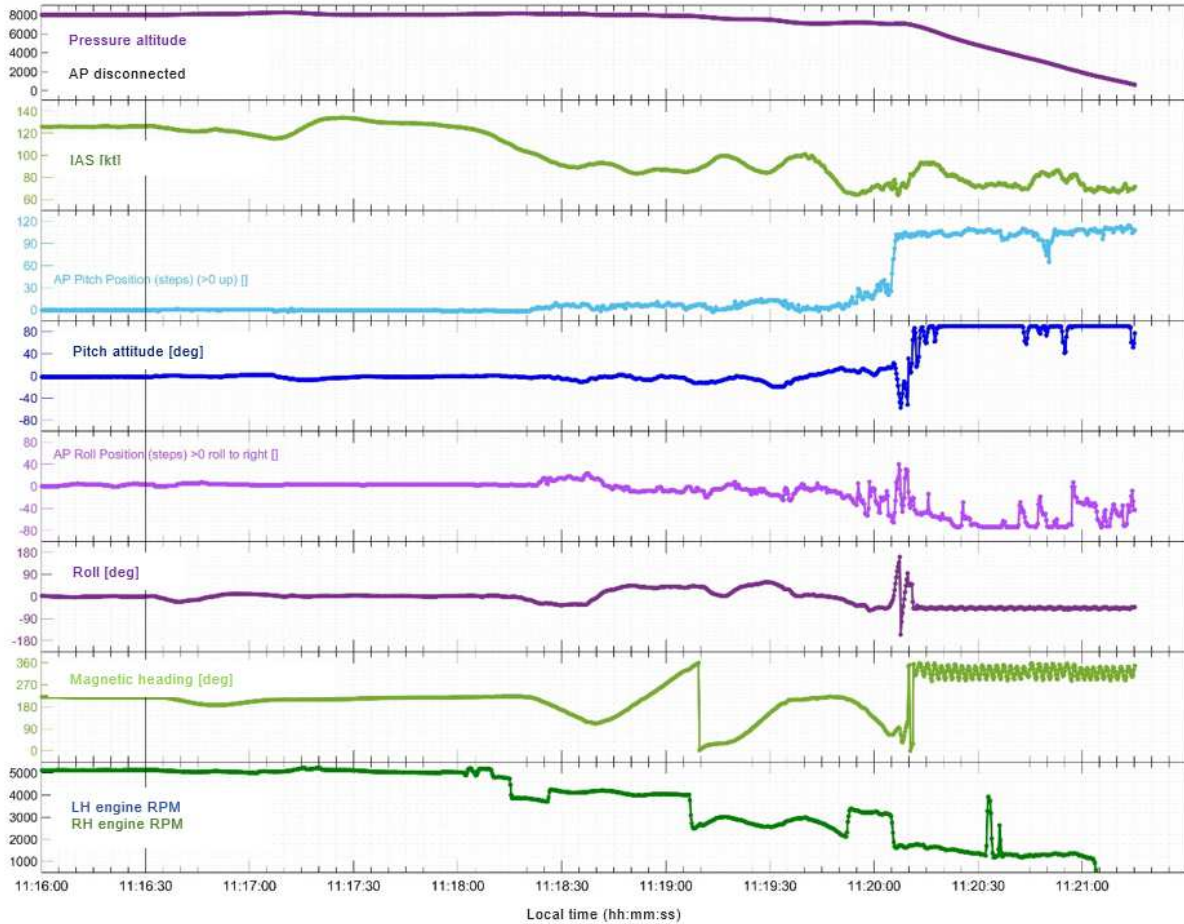
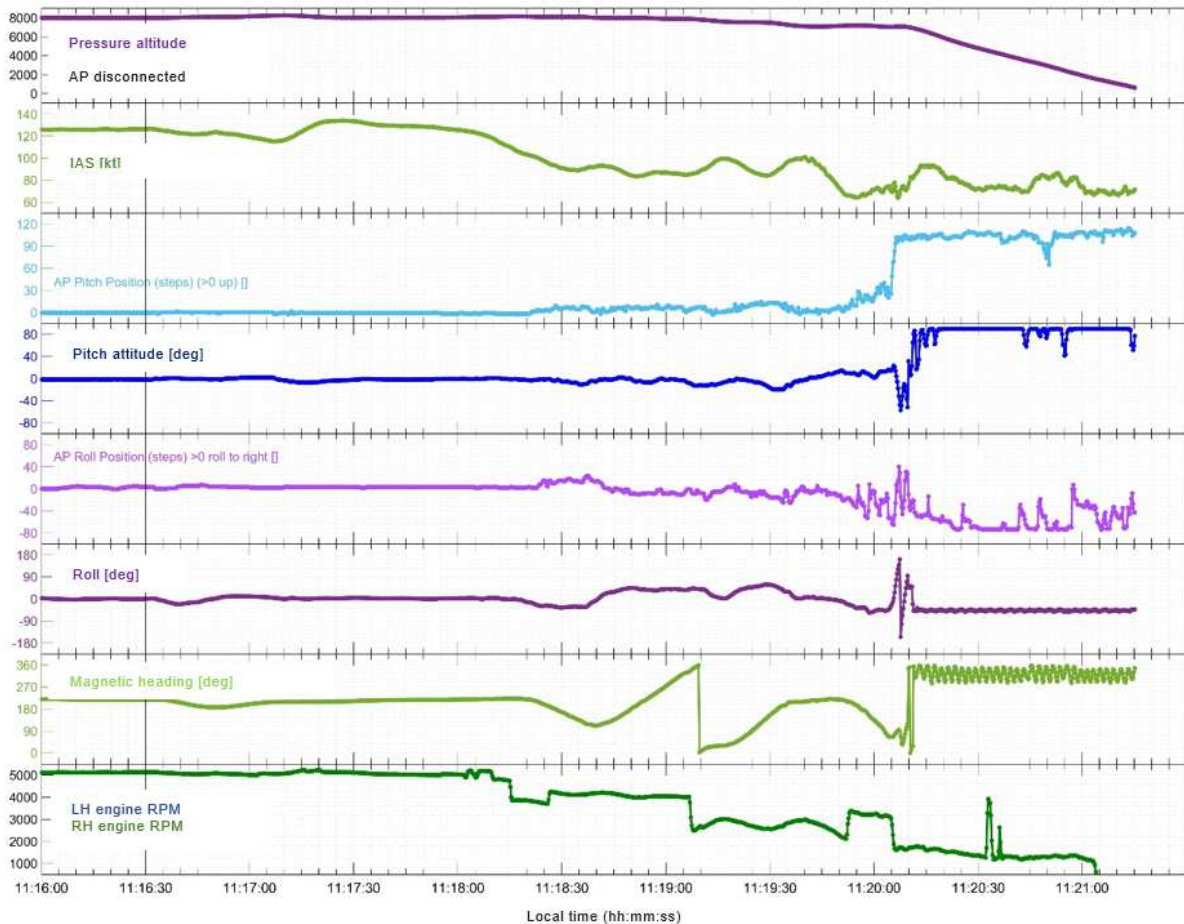
Figure 13: main flight parameters extracted from the EFIS, covering the last few minutes of the flight

The main flight parameters extracted from the EFIS are shown below in

Figure 13 for the last five minutes of flight. The yaw flight control position was not recorded.

Note: Dynon, the manufacturer of the EFIS indicated that the AP Pitch Position and AP Roll Position parameters corresponded to an image of the pitch and roll controls when the autopilot is disengaged.

If we consider that all the parameters recorded are valid, the possible inconsistencies between the pitch and roll control positions (AP Pitch Position and AP Roll Position parameters), the aircraft's attitudes, the altitude and the indicated airspeed could be explained by particular aerological phenomena having been encountered when the aircraft was close to the highly convective cloud layer (see paragraph 1.7.1): turbulence, updrafts or downdrafts, etc. These inconsistencies could also come from the recording of the parameters themselves, given that the conditions for recording the parameters as well as the conditions for installing the systems on microlights are not the subject of a documented certification process.

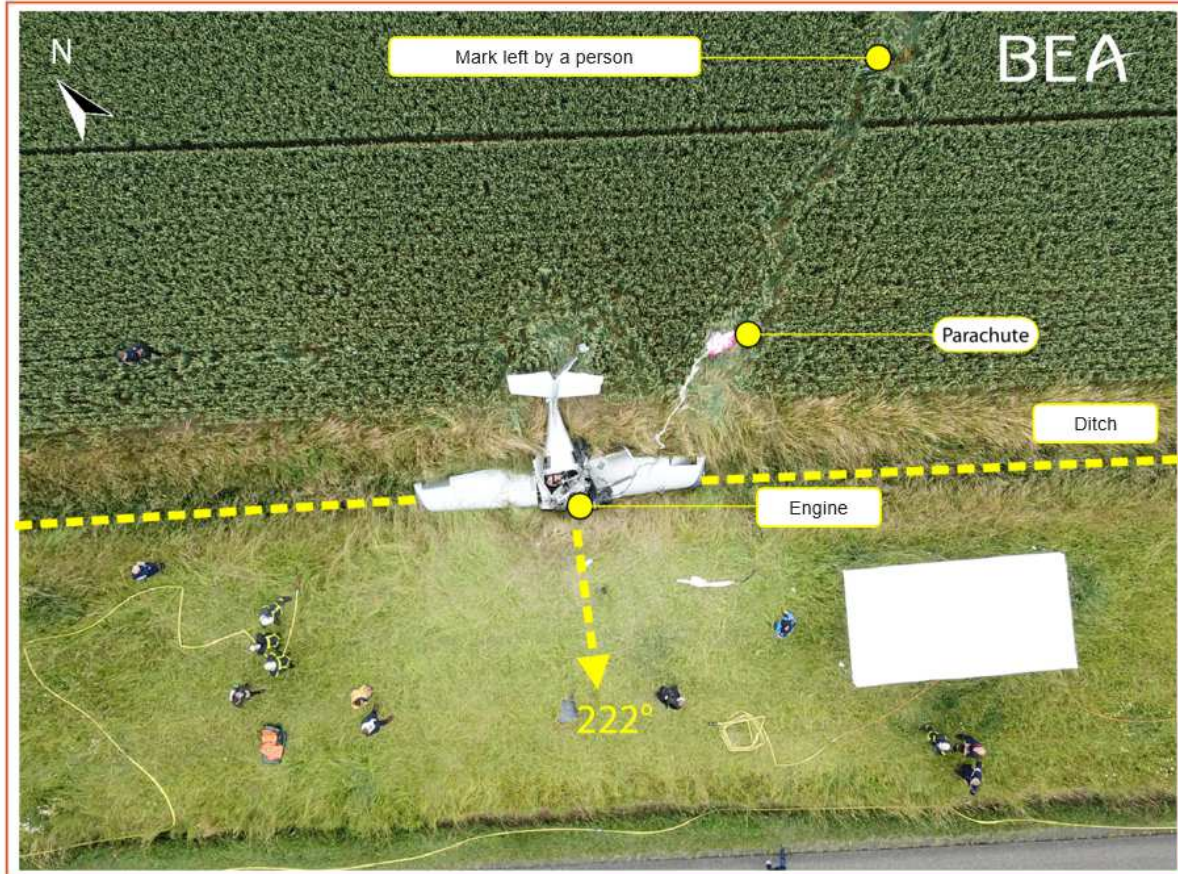
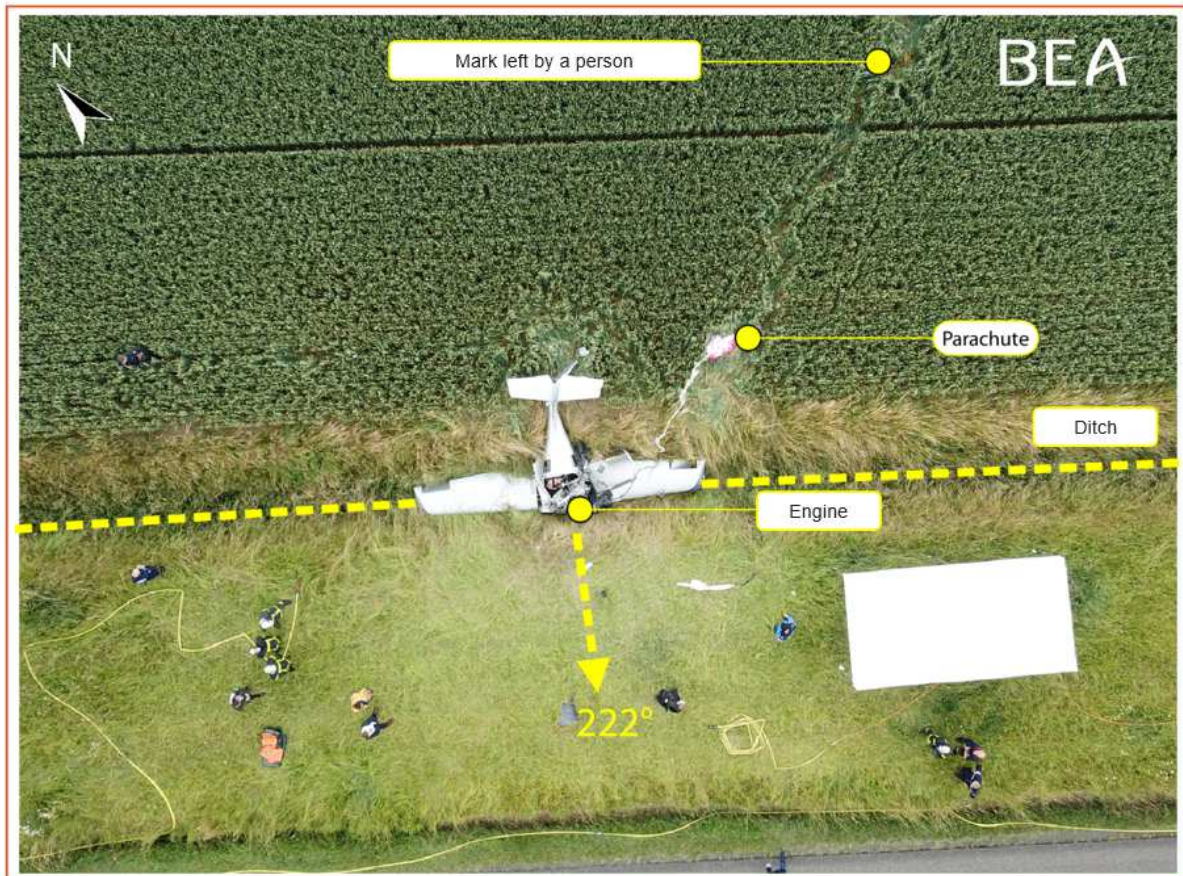
Figure 14: aerial view of wreckage taken by drone (source: GTA, annotations BEA)

The wreckage was lying on its belly in a ditch, the wings aligned with the ditch (see

Observations of the site and wreckage showed that the aircraft collided with the ground with its wings level and a very low horizontal speed.

The examination of the wreckage found that the airframe parachute had been activated following the collision with the ground. The system had not been activated in flight. The safety pin of the activation system had been removed in accordance with the recommendations of the flight manual.

All the deformations and ruptures observed on the wreckage were the consequences of the aircraft's collision with the ground.
