Accident to the Sauper Aviation J300 Joker
identified **63ACL**
on 31 December 2022
at Volvic (Puy-de-Dôme)

Time	Around 15:05 ¹
Operator	Private
Type of flight	Local
Persons on board	Pilot and passenger
Consequences and damage	Pilot severely injured, passenger fatally injured, microlight destroyed

Turbulence, loss of control, collision with ground

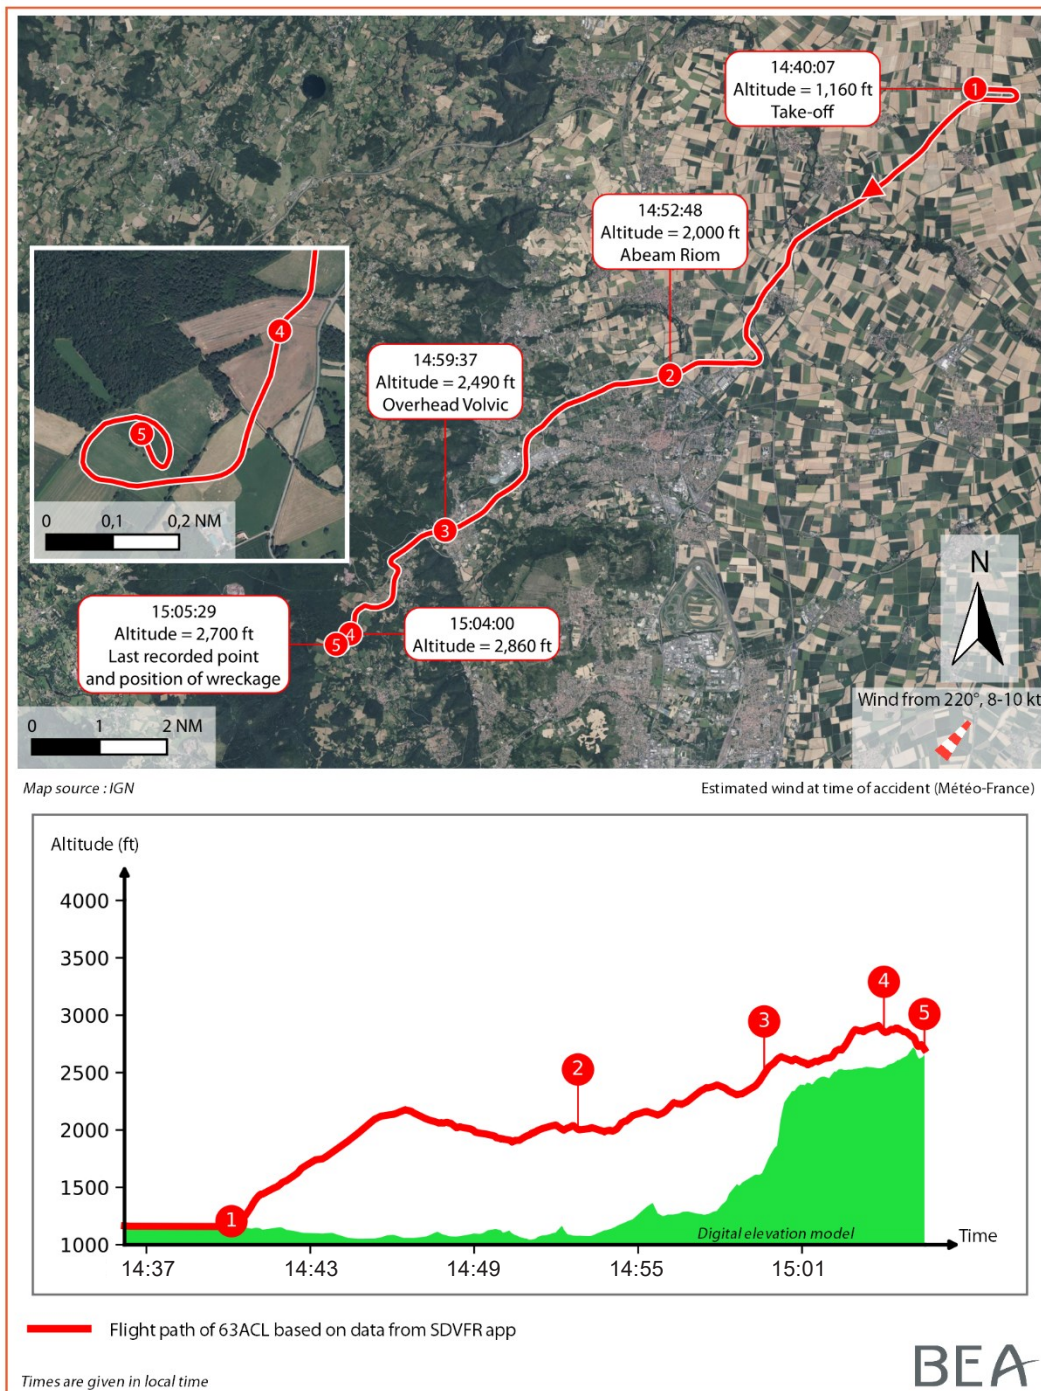
Figure 1: flight path and vertical profile

The pilot, accompanied by a passenger, took off from runway 09 of Sardon private microlight strip (Puy-de-Dôme) (see **Figure 1**, point **1**) at 14:40 for a local flight lasting approximately one hour. The pilot contacted the Clermont-Ferrand airport controller to say that he was heading towards the Chaîne des Puys volcano range. He headed south-west towards the town of Riom (point **2**) at an altitude of approximately 2,000 ft. He started the climb, still heading in a south-westerly direction, and flew over the town of Volvic (point **3**) at 2,500 ft. As he continued to climb towards 2,850 ft and approached the foothills of the Chaîne des Puys volcano range at a height of around 500 ft, the microlight entered an area of strong turbulence (point **4**). The pilot decided to descend, but a gust of wind destabilised the microlight, which entered into a sharp right turn. The pilot did not manage to regain control of the microlight, which collided with the ground in a field (point **5**).
