**Accident** to the Skyranger 95B  
identified **63ASS**  
on 19 June 2022  
at Égletons (Corrèze)

<b>Time</b>	Around 15:00 <sup>1</sup>
<b>Operator</b>	Private
<b>Type of flight</b>	Cross-country
<b>Persons on board</b>	Pilot
<b>Consequences and damage</b>	Pilot fatally injured, microlight destroyed

## Loss of control during initial climb, collision with ground

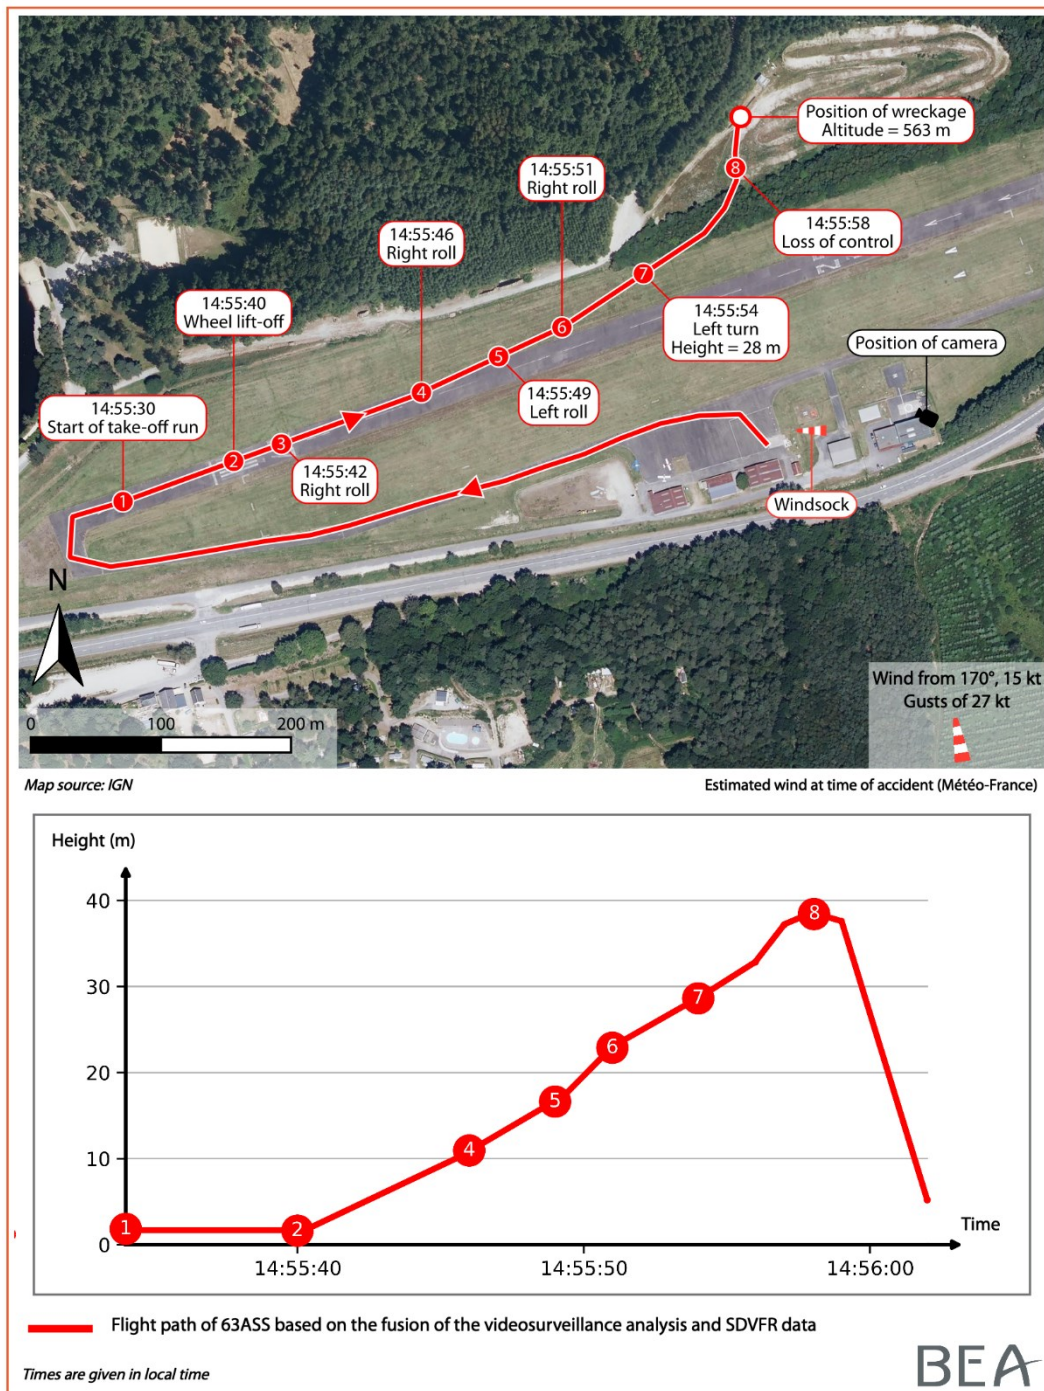
Figure 1: flight path of the microlight

The pilot took off from paved runway 07 at Égletons aerodrome. During the initial climb, the microlight oscillated in roll. As its attitude increased, the microlight turned left and stalled. It made a full spin and collided with the ground behind a line of trees bordering the aerodrome with a steep nose-down attitude.

Between points 2 and 3, just after wheel lift-off, the average ground speed was around 70 km/h<sup>4</sup>. The windsock indicated no wind.

Between points 3 and 4, during the acceleration phase, the average ground speed increased to around 105 km/h. The windsock began to inflate with a right-hand tailwind relative to the microlight's path.

Between points 4 and 5, at the start of the climb, the average ground speed decreased towards 90 km/h, and the windsock indicated a right-hand tailwind of around 5 kt relative to the microlight's path.

Between points 5 and 6, the average ground speed was estimated to be around 100 km/h. The windsock indicated the same wind as previously.

Between points 6 and 7, the average ground speed remained around 100 km/h. The windsock indicated the same wind as previously.
