**Accident** to the LAMBERT - MISSION M106-MK1-TD  
registered **63ASZ**  
on 22 August 2020  
at Ceysnat (Puy de Dôme)

<b>Time</b>	Around 17:45 <sup>1</sup>
<b>Operator</b>	Private
<b>Type of flight</b>	Cross-country
<b>Persons on board</b>	Pilot and one passenger
<b>Consequences and damage</b>	Passenger seriously injured, microlight destroyed

**Hard landing in field, go-around, loss of control,  
collision with trees**

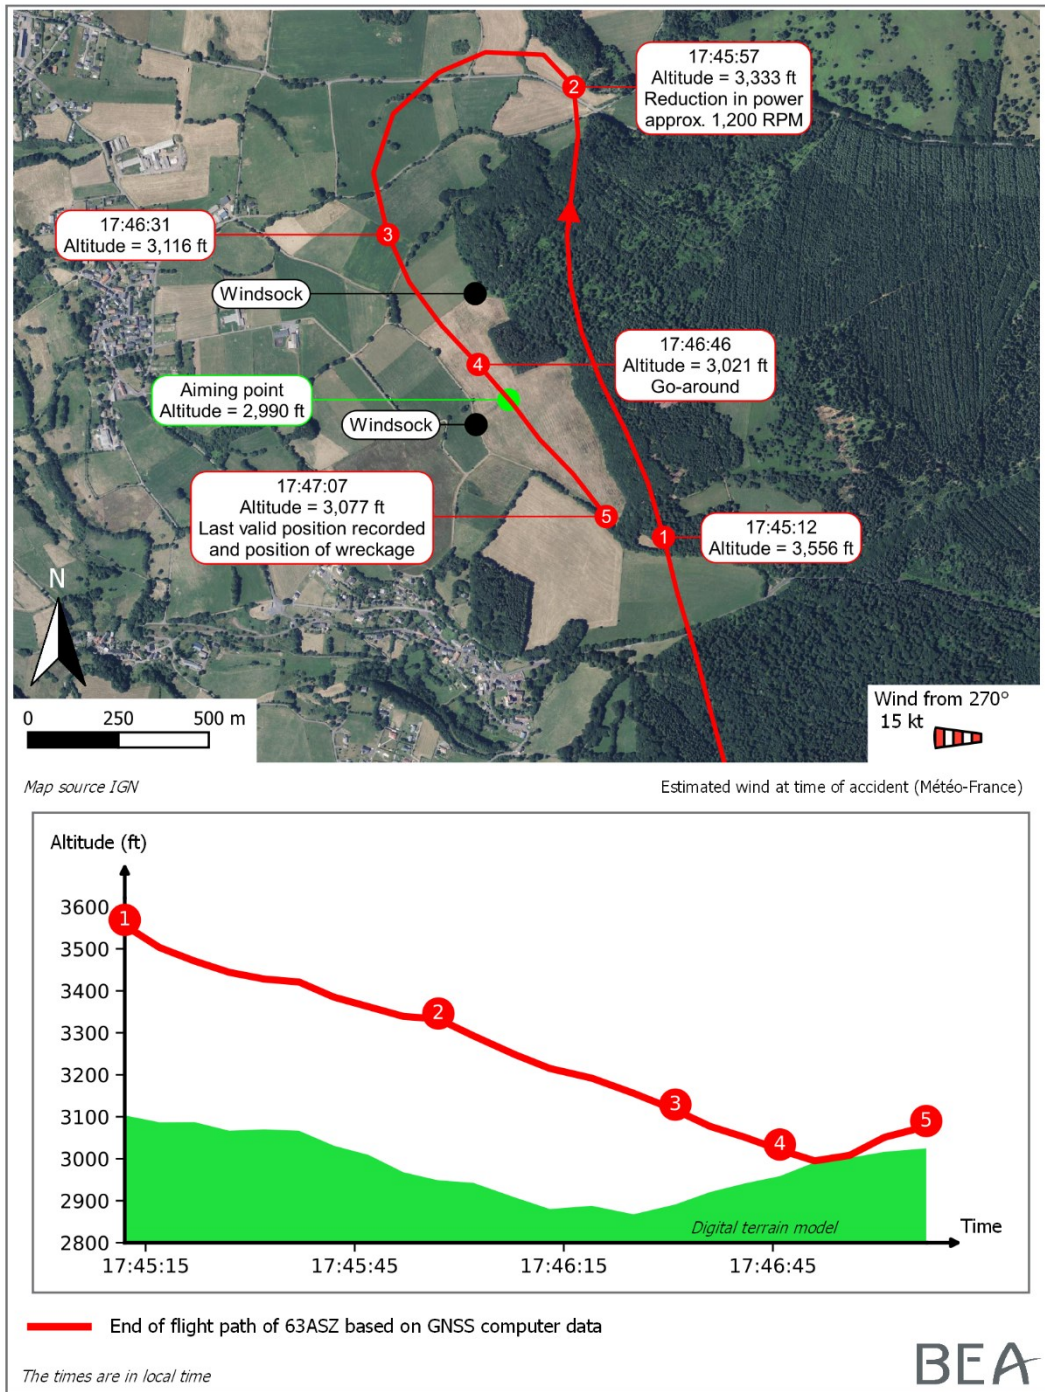
The pilot, accompanied by a passenger, took off from Issoire-Le Broc aerodrome bound for a field located in the commune of Ceysnat that he had previously spotted during a walk. After about 25 minutes of flight, he joined a close downwind leg at a height of approximately 600 ft to observe the two windsocks he had made from a metal tube and warning tape. He then performed a left-hand descending U-turn with reduced engine power to line up on final. He completed his turn on the axis of the field, approximately 650 m from the intended touchdown point and at a height of approximately 125 ft above the field<sup>2</sup>. The pilot explained that a few metres above the field, shortly before the intended aiming point, the speed decreased from 80 to 50 km/h and the microlight sank. The microlight hit the ground hard and bounced. The pilot then applied full power and took a nose up attitude while keeping the flaps in the landing configuration. The microlight did not gain height or speed. The left wing lifted, the microlight veered to the right and collided with trees.

Figure 1: flight path of the microlight (based on the GNSS data)

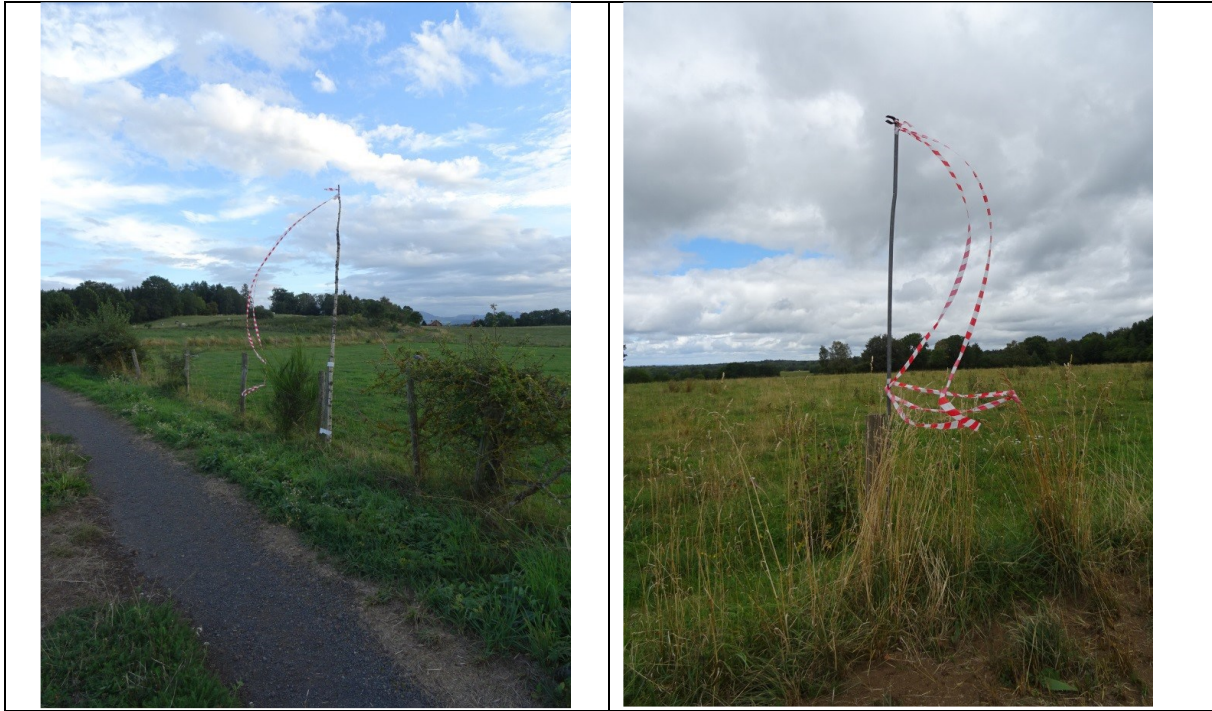
The day before the accident, he drove to the spot to check out the area. He walked around the field to observe the condition of the surface and set up two windsocks, each consisting of a 2.5 m metal bar and a 2 to 3 m-long warning tape.

Figure 2: windsocks installed by the pilot (source GTA)

During the accident flight, the pilot indicated that he observed both windsocks and noted that there was very little wind. He stated that the windsock at the "break" in the field indicated a crosswind from the left, while the windsock in the bottom part of the field indicated the opposite direction. He added that he did not increase his speed and that he fully extended the flaps. He explained that he did not intend to land but only to make a first approach.

The pilot undertook a flight to a field which he had previously spotted on foot and at the edge of which he had installed two windsocks which he had made. The field was on a slope in a hilly environment and was bordered by trees. The warning tape used for the windsocks probably became entangled in the vegetation and fence, causing the pilot to have an erroneous perception of the direction and strength of the wind. The pilot thus undertook a landing with a significant tailwind component without being aware of it. In addition, with a downwind leg close to the field, after the U-turn, the microlight was on the axis of the field at a low height. The pilot then had very little time, about fifteen seconds, to stabilise the final. In this context he was unable to keep control of the microlight which hit the ground hard and bounced, probably due to an aerological phenomenon.

The threat posed by the apparent ease of access to such sites can be mitigated by an in-flight reconnaissance of the site as well as by flying a sufficiently long final leg to give the pilot time to stabilize his path and thus limit the probability of having to reject the approach or the landing.
