Accident to the Aerospool WT9 Dynamic Club microlight identified **67BVN** on Friday 12 April 2024 at Peynier

Loss of control during a stall exercise, activation of the airframe parachute, in instruction

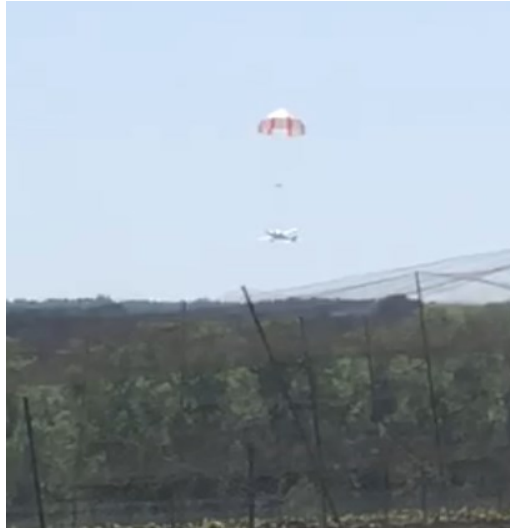
Figure 2: excerpt of a video of the descent under the parachute taken by a witness on the ground

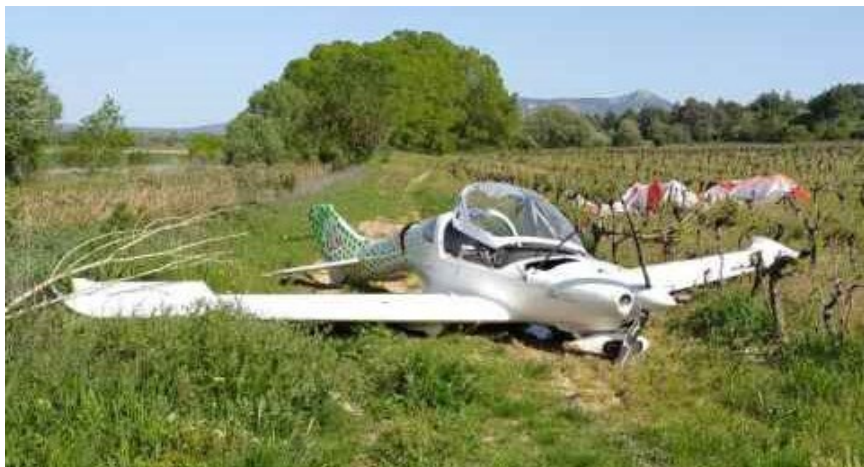
Figure 3: wreckage of 67BVN at the accident site (Source: BGTA)

The wreckage was disassembled and stored in a hangar where it was examined by the BEA. The damage observed on the microlight resulted from the contact with the ground under the parachute. The flight controls were in place and the continuity of the flight control linkages was confirmed. The airframe parachute deployed correctly and was effective all the way to the ground.

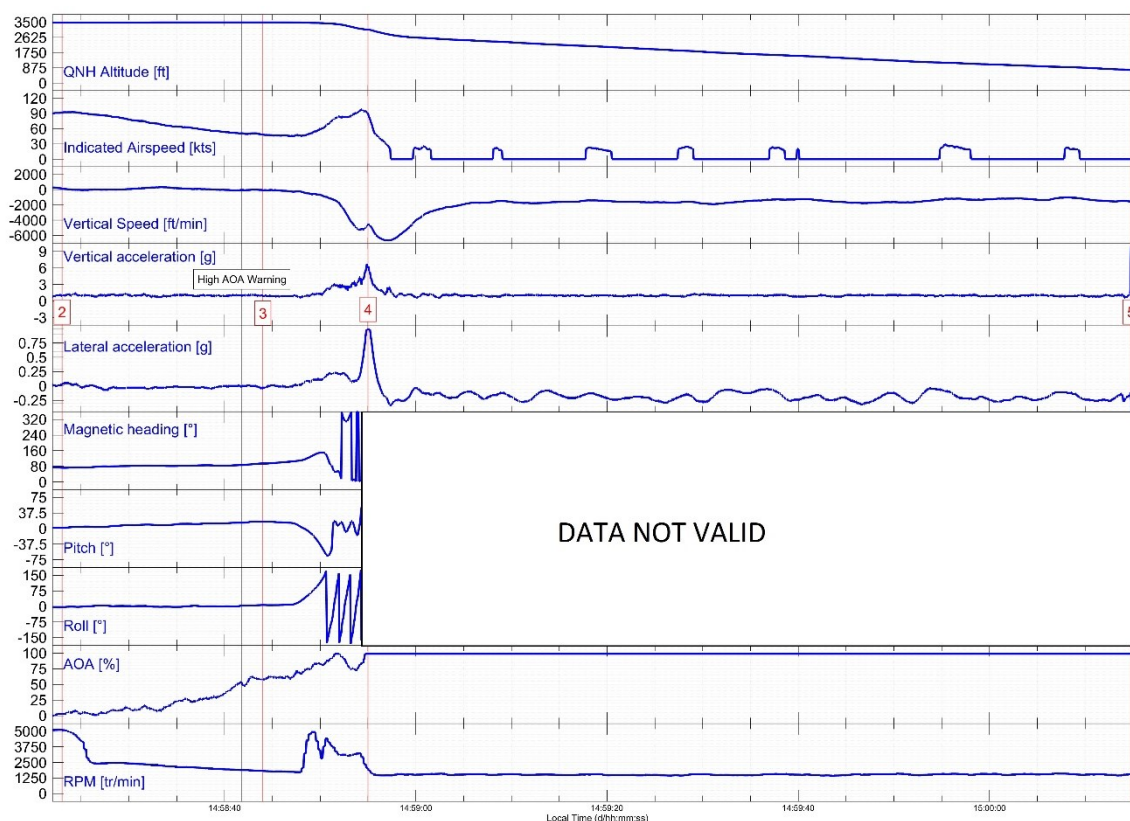
Figure 4: recorded parameters (Source: BEA)

- At 14:58:42, the angle of attack reached 53%, and the “High AOA” alert (see paragraph 2.6) appeared, indicating a high angle of attack close to that of stall.
- At 14:58:47, the microlight started to roll to the right. The angle of attack was 61% then.
- At 14:58:49, the angle of attack reached 76%, the bank angle was 68°, and the power temporarily increased.
- At 14:58:54, a peak load factor of 6.7 g was recorded, corresponding to the partial deployment of the parachute. The altitude was 3,073 ft.
- At 14:58:57, the rate of sink decreased. The parachute was fully deployed.
- At 15:00:15, the microlight collided with the ground, i.e. approximately 1 min and 30 s after the loss of control and 1 min and 18 s after the parachute deployed.

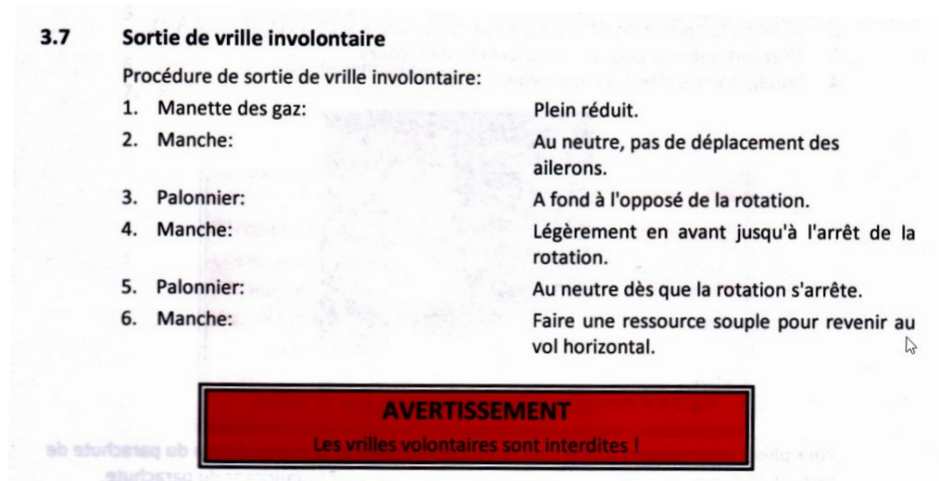
Figure 5: spin recovery procedure in the flight manual for the WT9 microlight
(Source: Finesse Max)

This procedure did not recommend the use of the airframe parachute in the event that the recovery procedure failed. It has since been revised to include the use of the airframe parachute (see paragraph 2.10).

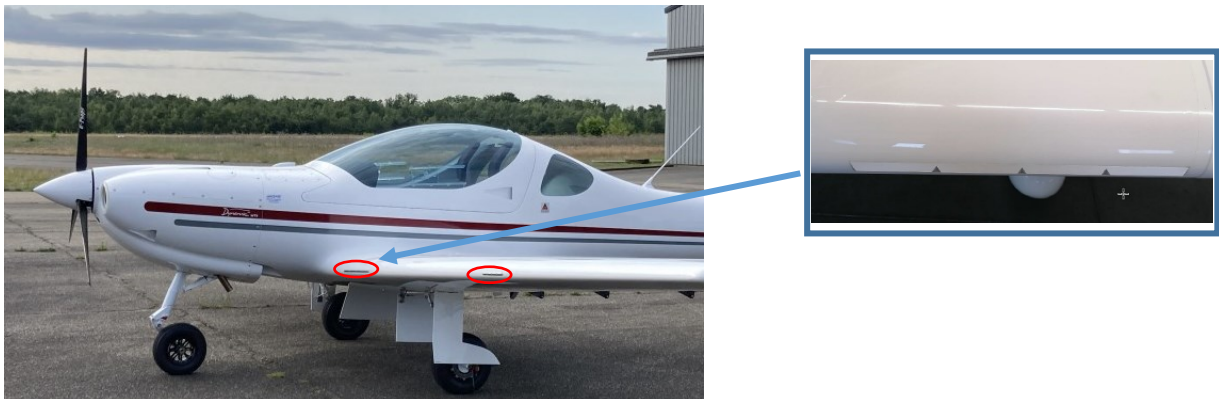
The manufacturer indicated that the stall strips reduced the risk of asymmetric stall and therefore entry into an unintentional spin or spiral.

*Figure 6: stall strips (circled in red) on another WT9 microlight.
(Source: Finesse Max, BEA annotation)*

These stall strips are installed as standard on all new WT9s under CS-LSA certification, and since 2018 as standard on all newly produced WT9 microlights. A retrofit kit also exists for installing stall strips on WT9s which are not so equipped. The microlight 67BVN was not equipped with stall strips.

Following exchanges between the BEA, Aerospool and Finesse Max after the accidents to 67BVN and 04FO, Aerospool published [a Service Bulletin \(ZBWT9 31A / 2024\)](#) that strongly recommended the installation of stall strips on WT9s which were not so equipped. In particular, a full kit is available for sale, so that owners can install them.

the DSAC make the implementation of Service Bulletin ZBWT9 31A / 2024 (Installation of safety equipment – stall strips) mandatory for all Dynamic WT9 microlights which are not so equipped. [FRAN-2025-007]
