Accident to the Allegro SW 912
identified **67ZL**
on 30 January 2022
at Sedan-Douzy (Ardennes)

Time	Around 17:15 ¹
Operator	Private
Type of flight	Local
Persons on board	Pilot
Consequences and damage	Pilot fatally injured, fixed-wing microlight destroyed

Loss of control on base leg, collision with ground, fire

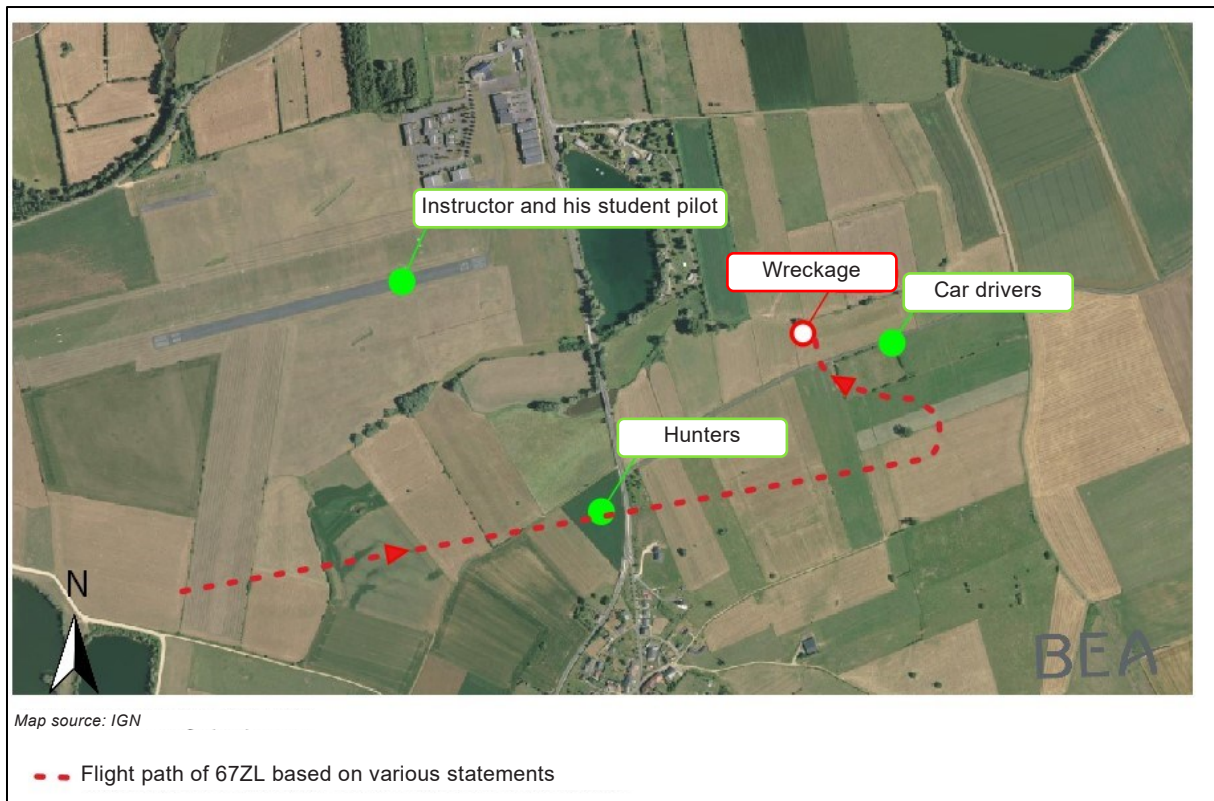
Figure 1: estimated flight path of 67ZL

The instructor indicated to him not to land as he was backtracking up the runway and returning to the hangar. A short time later, the instructor and his student pilot observed 67ZL on the base leg, at low speed and low height, with a high left bank. The instructor stated that the pilot seemed to be carrying out manoeuvres to the right and then to the left. At an estimated height of 100 m, the left wing of the microlight stalled and the microlight pitched down towards the ground.

It collided with the ground around 800 m before the threshold of runway 26 and then caught fire.
