**Accident** to the paramotor  
identified **68AKY**  
on 18 June 2022  
at Saint Rémy (Deux-Sèvres)

## Collision with ground

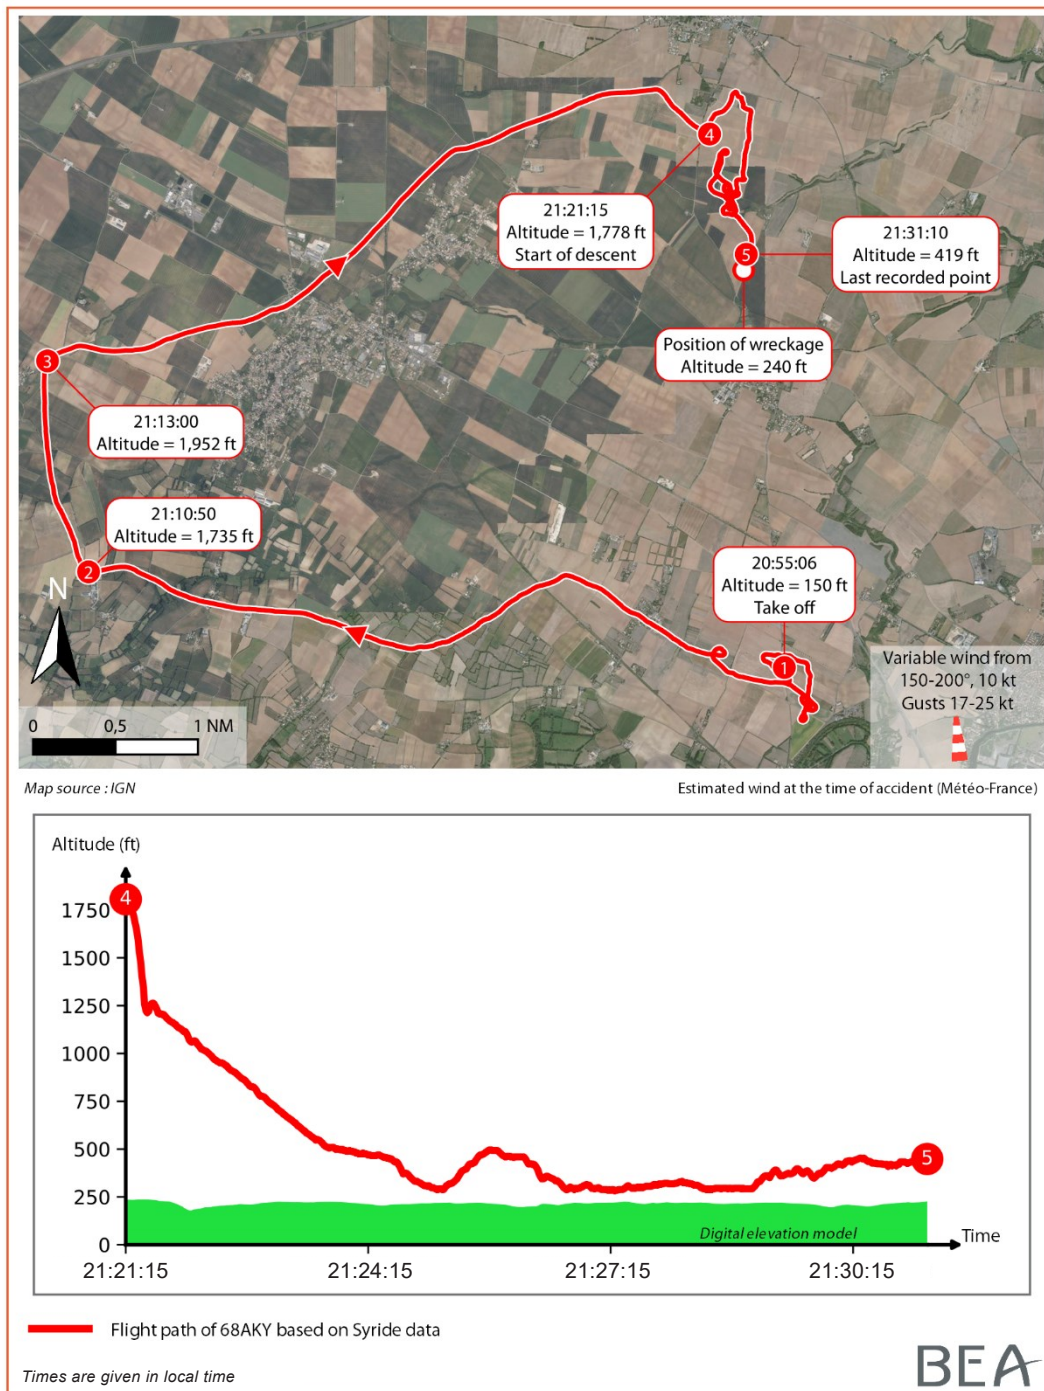
After take-off, the pilot performed manoeuvres at an altitude not exceeding 300 ft, which corresponds to a maximum height of around 200 ft, for approximately three minutes. He then climbed towards 1,800 ft and continued flying for 22 minutes. He then descended and continued his manoeuvres for 10 minutes at an altitude of between 300 and 450 ft (height of between 100 and 250 ft).

At around 21:55, a jogger running near a field of sunflowers heard the sound of an engine and discovered the paramotor wreckage. The engine was still running. The last point recorded by the Syride computer at 21:31 located the paramotor at an altitude of 419 ft. The wreckage was close to the last recorded position.

Figure 1: flight path of 68AKY (Source: BEA)

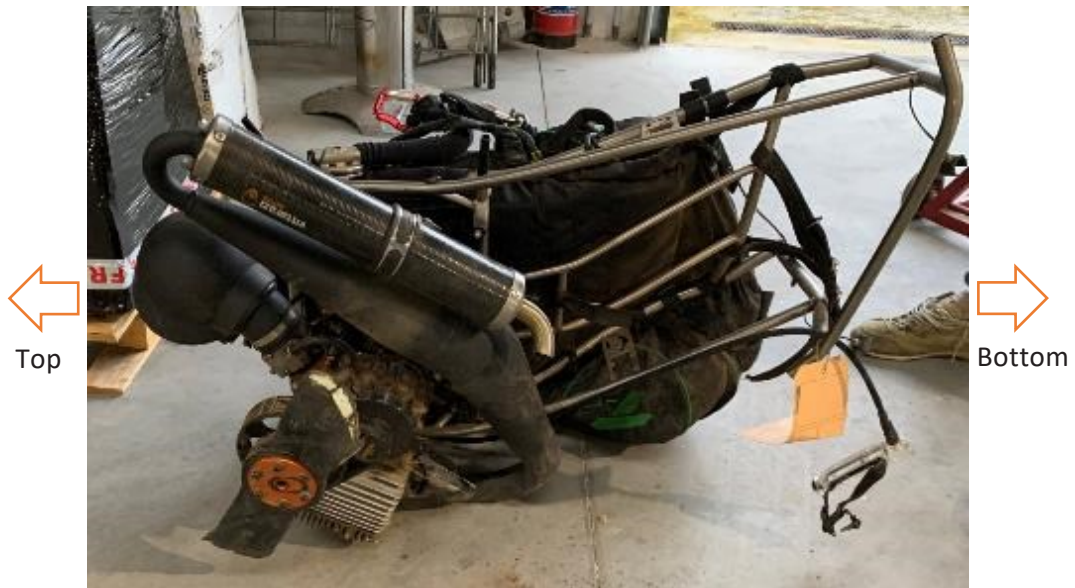
The damage observed on the harness-and-engine assembly was the result of the collision with the ground. This showed that the left and upper left sections of the harness hit the ground, with an unknown wing position. The position of the harness on impact with the ground is shown in *Figure 5*.

*Figure 2: illustration of the position of the harness on impact with the ground, viewed from the rear (Source: BEA)*

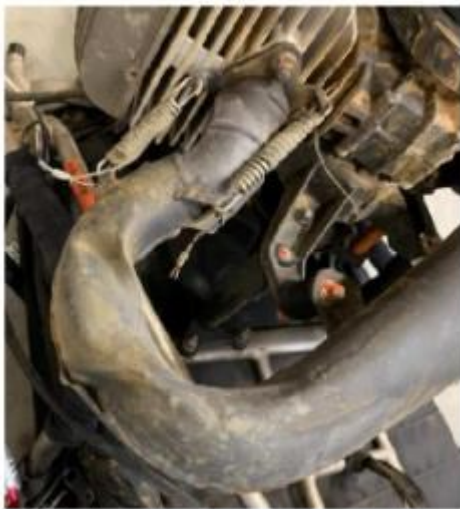
*Figure 3: exhaust system distortion (Source: BEA)*

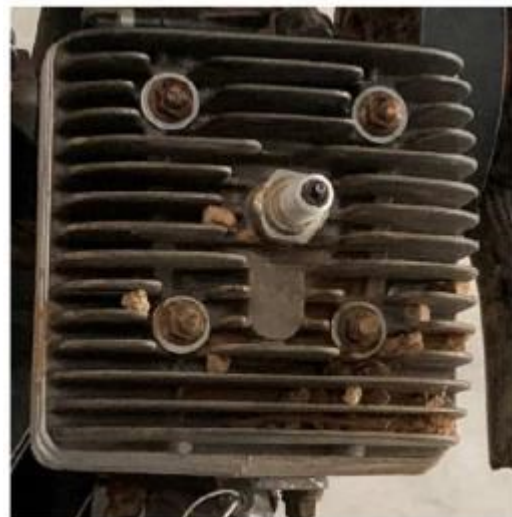
*Figure 4: stones caught between the fins of the engine cylinder head (Source: BEA)*

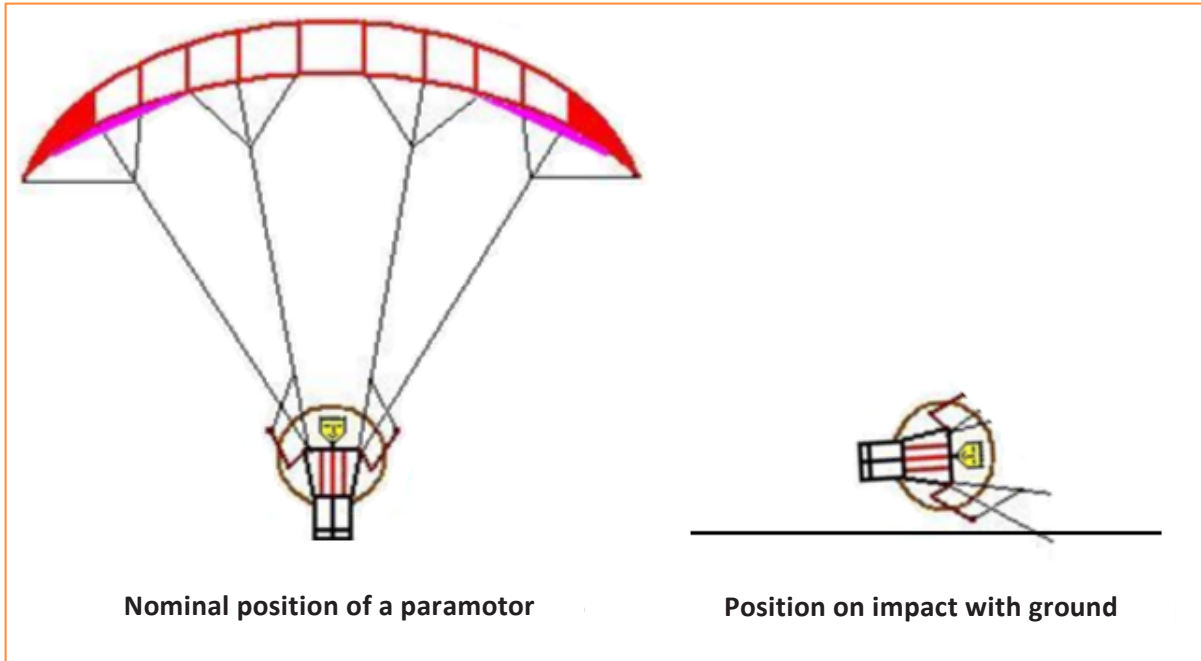
*Figure 5: illustration of the position of the harness at the time of collision with the ground  
(Source: BEA)*

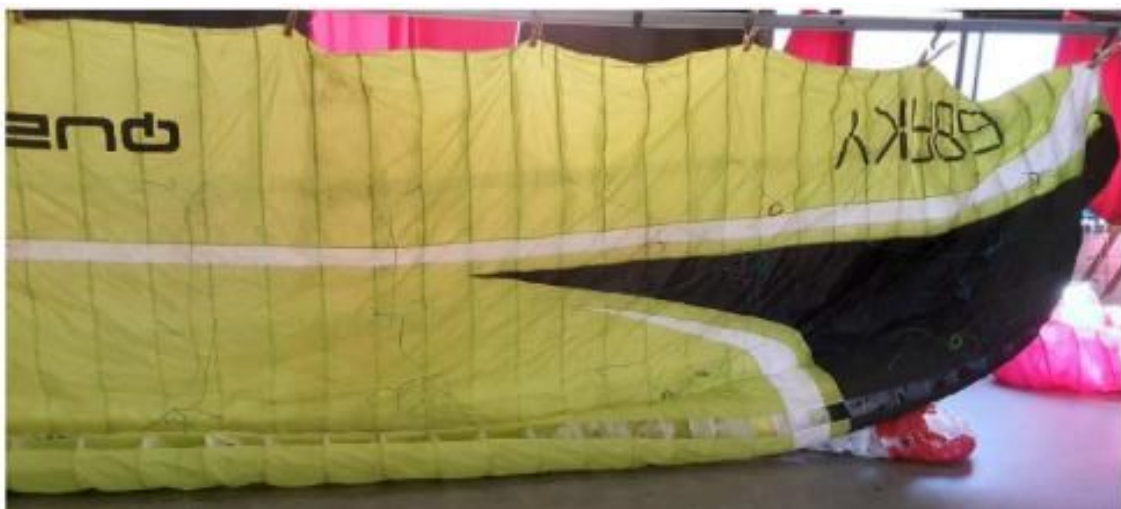
No major fault was found on the wing. A few snags were noted when the wing was inspected, but they did not contribute to the accident.

There was nothing unusual about the risers, and the wing was symmetrically set (100 % untrimmed). In this configuration, the pilot was flying in a “maximum speed” configuration, with a wing that was more responsive to the pilot’s inputs.

The setting of the wing could not be determined due to the rigging lines having been cut by the emergency services.

*Figure 6: wing examination (Source: BEA)*
