Accident to the Tomark SRO Viper SD4
identified **69AHM**
on Thursday 8 June 2023
at Pouilloux

Time	Around 16:50 ¹
Operator	AQUILAIR Aircraft
Type of flight	Cross country
Persons on board	Pilot and one passenger
Consequences and damage	Pilot and passenger fatally injured, microlight destroyed
This is a courtesy translation by the BEA of the Final Report on the Safety Investigation. As accurate as the translation may be, the original text in French is the work of reference.

**Engine shutdown in initial climb, loss of control in turn,
collision with ground, fire**

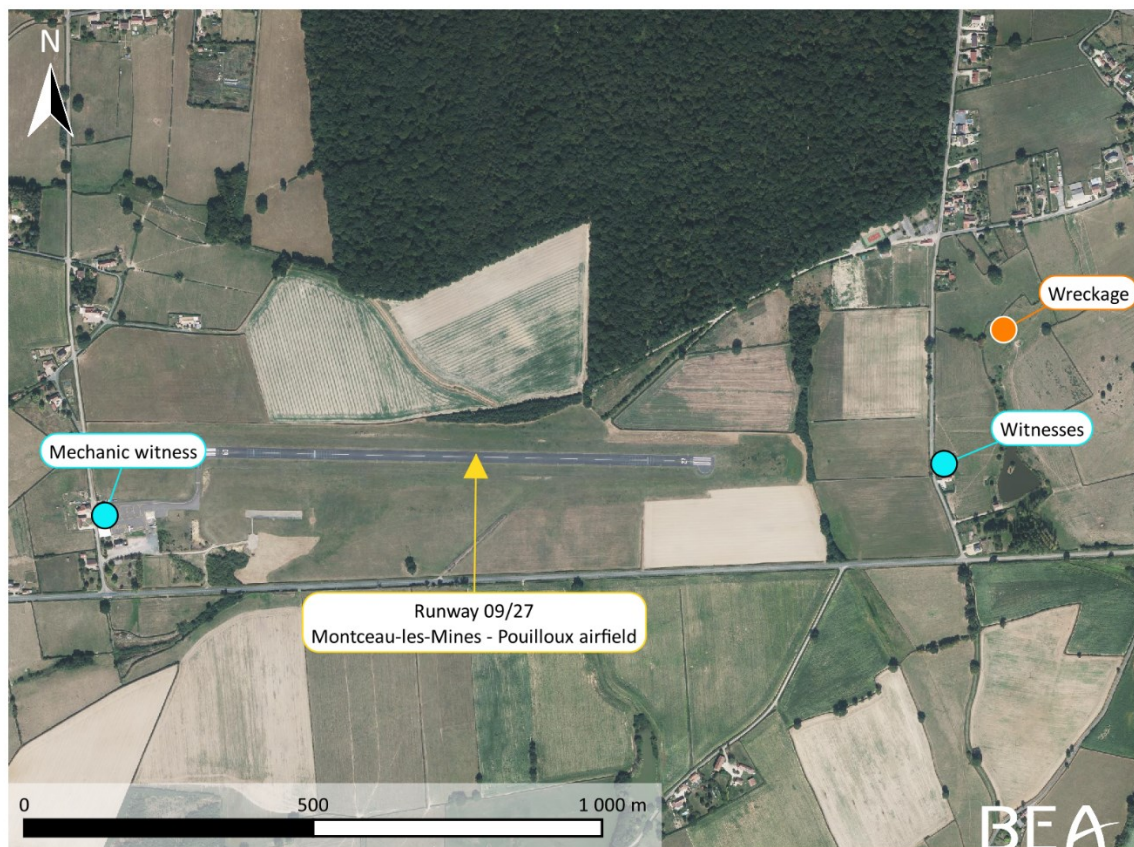
Figure 2: satellite view of the accident site (source: Géoportail, annotations BEA)

The wreckage was situated in a field to the north-east of Montceau-les-Mines aerodrome, at 555 m from the end of runway 09. There were no marks in the vegetation around the wreckage in connection with the accident.

The various verifications carried out on the wreckage found that the microlight had a very high nose-down attitude (nearly vertical) and high energy on its impact with the ground.

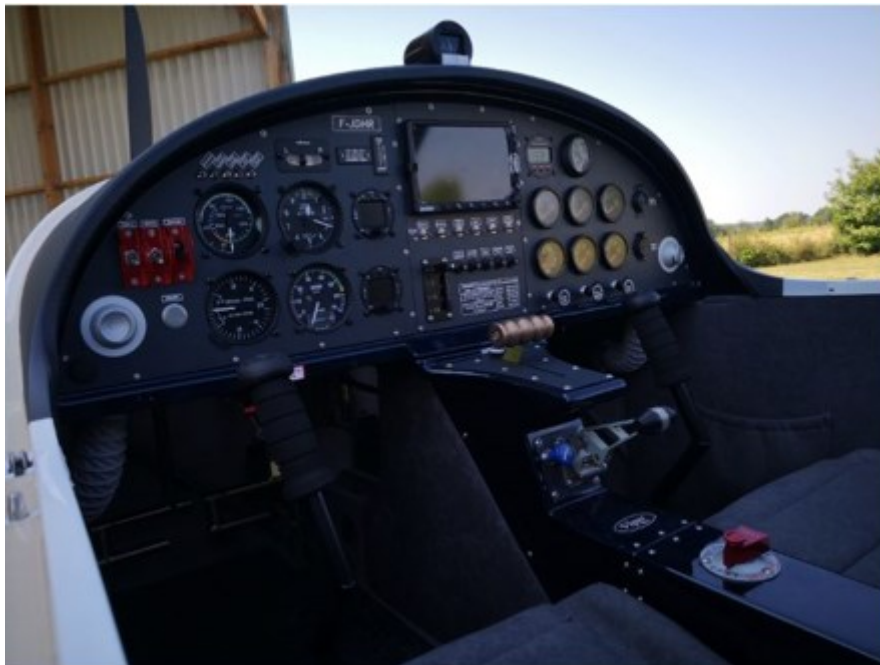
*Figure 3: view of fuel selector in Viper SD4 cockpit in "left" position
(source: Aquilair Aircraft)*

The fuel selector was found in the "OFF" position. It was mechanically functional and it is not likely that the impact could have modified its position (see paragraph 2.4).

To select the fuel tank(s), the pilot just has to turn the selector to the desired position. However, to set the selector to OFF, a vertical pin has to be raised before being able to turn the selector. Two actions are therefore necessary to set the selector to OFF.

The fuel selector was found in the "OFF" position. This position does not seem to be consistent with the decision to return to the aerodrome; what is more, the school instructors do not teach cutting off the fuel in the event of an engine failure in initial climb. It therefore seems unlikely that the pilot modified the fuel selection during the management of the engine shutdown.

The pilot had probably set the selector to the OFF position at the end of the previous flight and then forgot to open the fuel supply during the before-flight actions. In the absence of a warning, the pilot probably took off with the fuel supply closed and the engine shut down after using the remaining quantity of fuel contained in the system.
