**Accident** to the TECNAM - P92 ECHO CLUB  
identified **73TH**  
on 28 July 2022  
on Val Thorens mountain airstrip

**Missed approach in mountains, collision with terrain  
during attempted break-away**

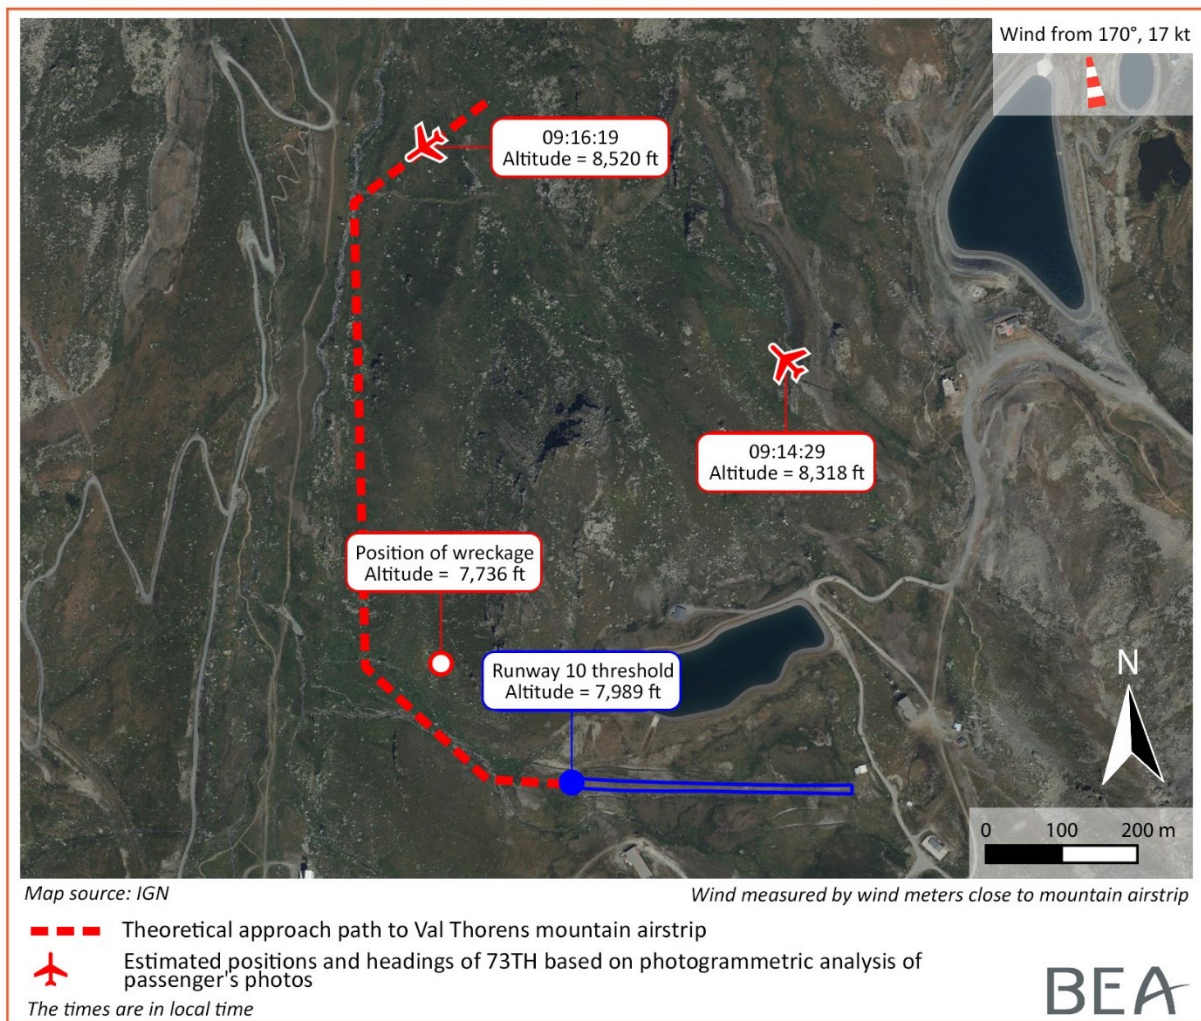
Figure 1: theoretical approach path and estimated positions of microlight based on photos taken by passenger

The pilot took off from Albertville where there was a light south-westerly to westerly wind, for a flight bound for Val Thorens mountain airstrip. There was a strong southerly wind in the mountains. Such a wind can cause violent downdrafts and turbulence on the lee side of the terrain. The pilot probably encountered these phenomena during the final approach to the airstrip and was forced to fly a missed approach. The microlight then collided with the terrain before the runway when the pilot tried to break away to the left facing the terrain.

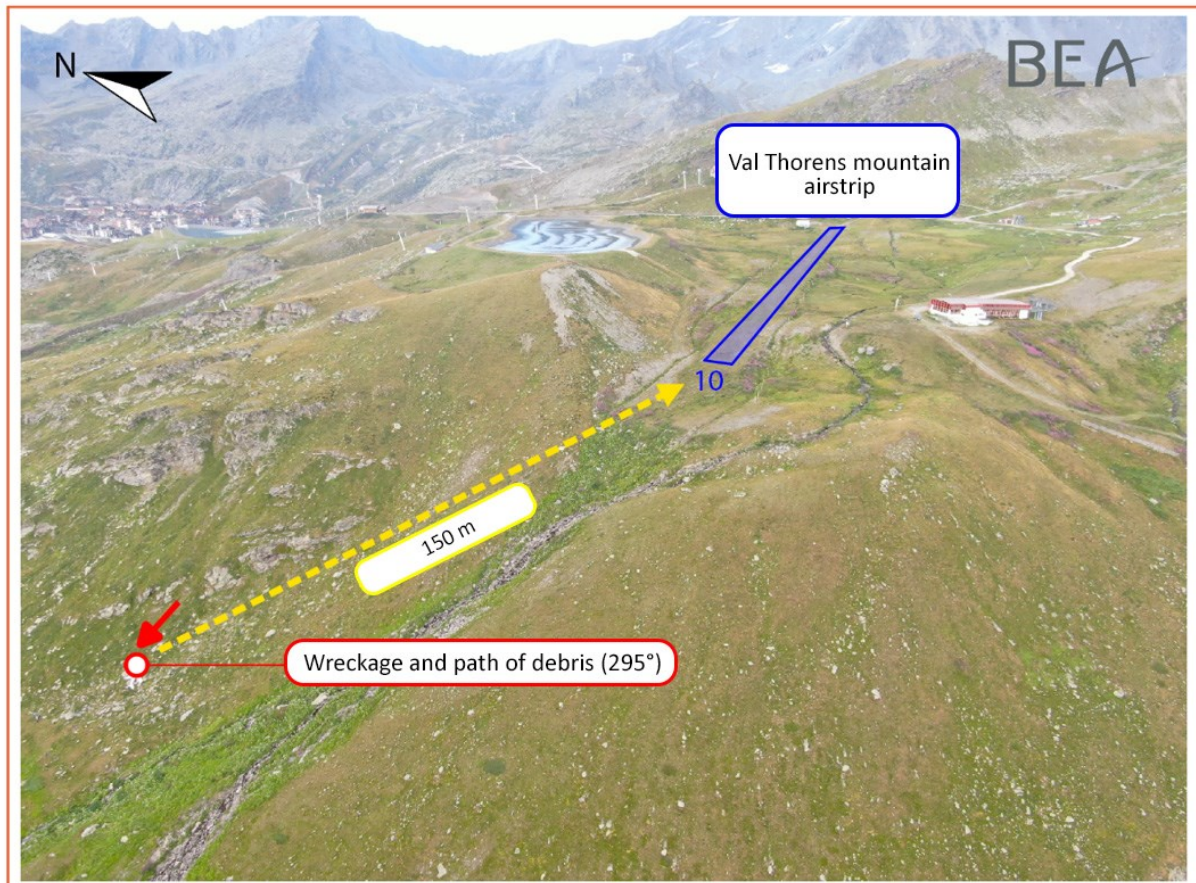
The microlight wreckage, which was complete, was situated on a mountain slope at an altitude of around 7,700 ft, with a gradient of approximately 15%, roughly 80 m below and 150 m from the threshold of runway 10 of the mountain airstrip.

The examination of the wreckage showed that the microlight collided with the ground on a westerly flight path, in the opposite direction to landing and probably with a high nose-down attitude and left bank. Debris was found over around 20 m upstream from the wreckage, all oriented on a 295° axis. The grass had been burnt by petrol on this axis. After the impact, the microlight slid down the slope and struck a rock making it nose over before coming to rest on its back.

Figure 2: aerial view of the accident site (source: GTA)
