**Accident** to the Guerin G1  
identified **760X**  
on Thursday 6 October 2022  
at Lurcy-Lévis aerodrome

**Loss of control, collision with the ground after take-off,  
fire, in instruction**

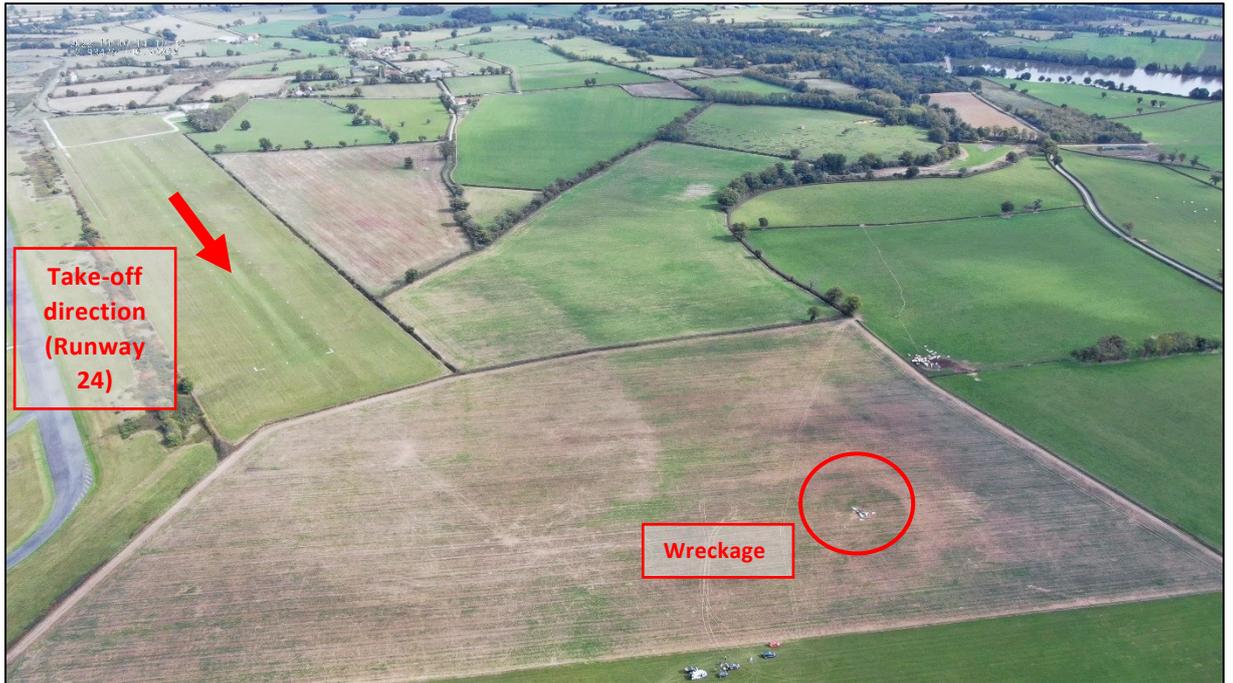
The wreckage of the microlight was found 300 m after the end of runway 24, offset to the left of the take-off axis.

Figure 1 : aerial view of the accident site (Source: BGTA, BEA annotations)

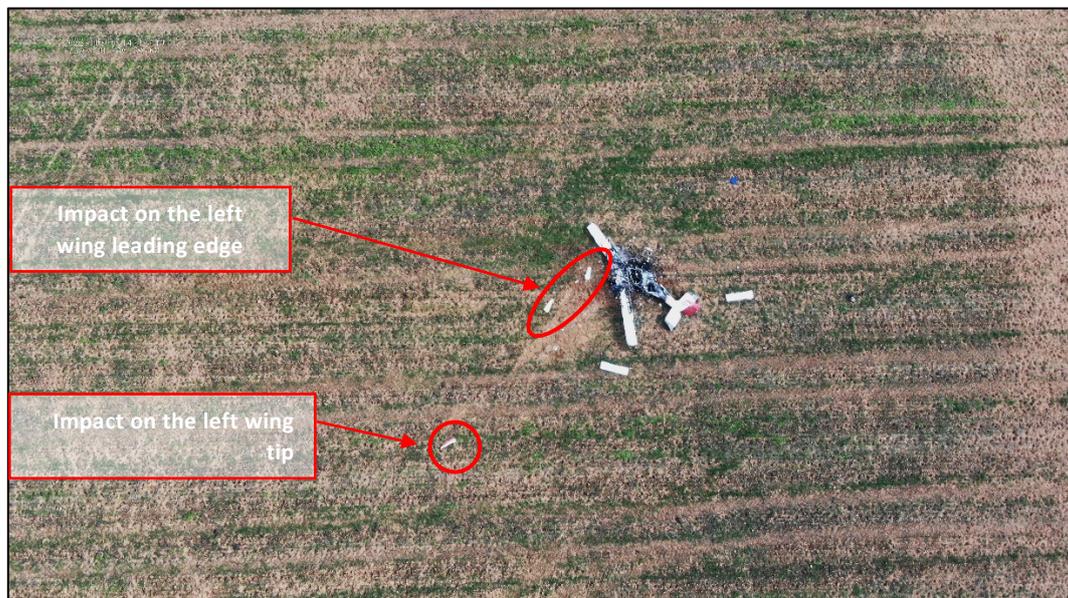
The microlight collided with the ground with the left wing tip, then it spun to the left before catching fire (see **Figure 2**).

Figure 2: aerial view of the wreckage (Source: BGTA, BEA annotations)

The examination of the wreckage was limited due to the damage caused by the fire. The continuity of the flight control linkages could not be checked and it was not possible to determine the position of the flaps or establish whether the engine was delivering power at the time of impact.

No particular anomaly which could explain the accident was identified during the examination of the wreckage.

The microlight's airframe parachute deployed upon impact.
