Accident to the Ekolot JK-05L Junior
identified **76PV**
on 14 July 2022
at Saint-Valéry - Vittefleur

This is a courtesy translation by the BEA of the Final Report on the Safety Investigation. As accurate as the translation may be, the original text in French is the work of reference.

Loss of control after take-off, collision with ground

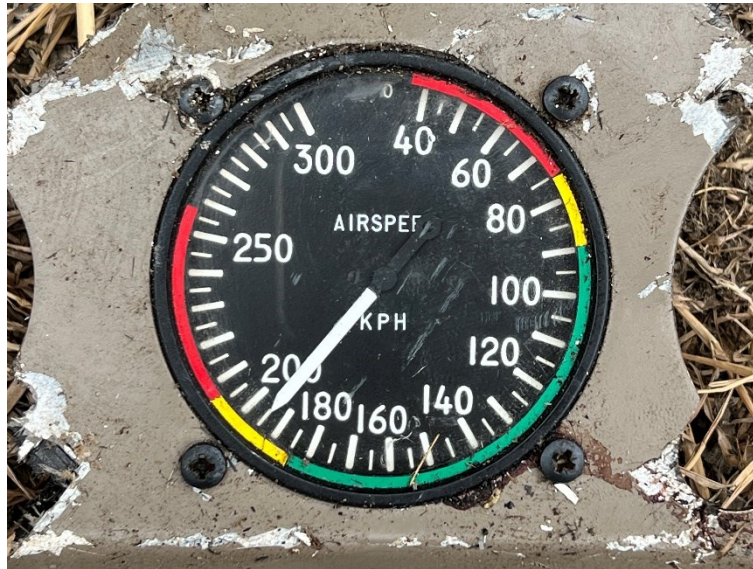
The airspeed indicator needle was blocked and indicated an airspeed of 195 km/h².

² The colour marks of the airspeed indicator were not consistent with those of the microlight's flight manual: in particular, the Velocity Never Exceed (VNE) is 180 km/h in the flight manual and 205 km/h on the instrument.

Figure 1: airspeed indicator blocked at 195 km/h (source: BEA)

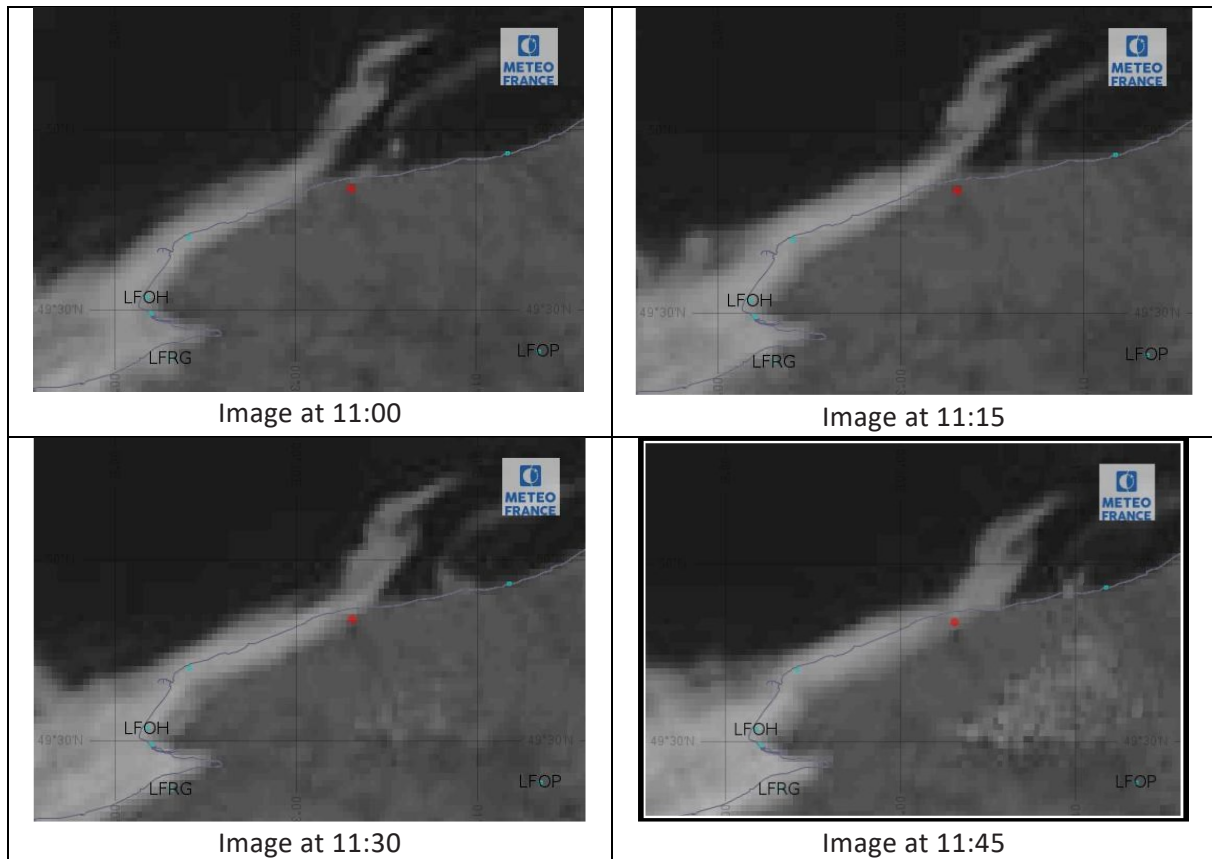
Satellite images of the visible spectrum showed the presence and evolution of sea mist in the area of the accident.

Figure 2: visible satellite images (source: Météo-France)
 (The red dot shows Saint-Valéry – Vittefleur aerodrome)
