Accident to the ZT 610
identified **77AUM**
on Friday 6 September 2024
at Frestoy-Vaux

Time	Around 18:20 ¹
Operator	Private
Type of flight	Practical exam
Persons on board	Pilot in training and instructor
Consequences and damage	Pilot in training and instructor fatally injured, microlight destroyed
This is a courtesy translation by the BEA of the Final Report on the Safety Investigation. As accurate as the translation may be, the original text in French is the work of reference.

**In-flight opening of canopy, collision with ground,
fire, check flight**

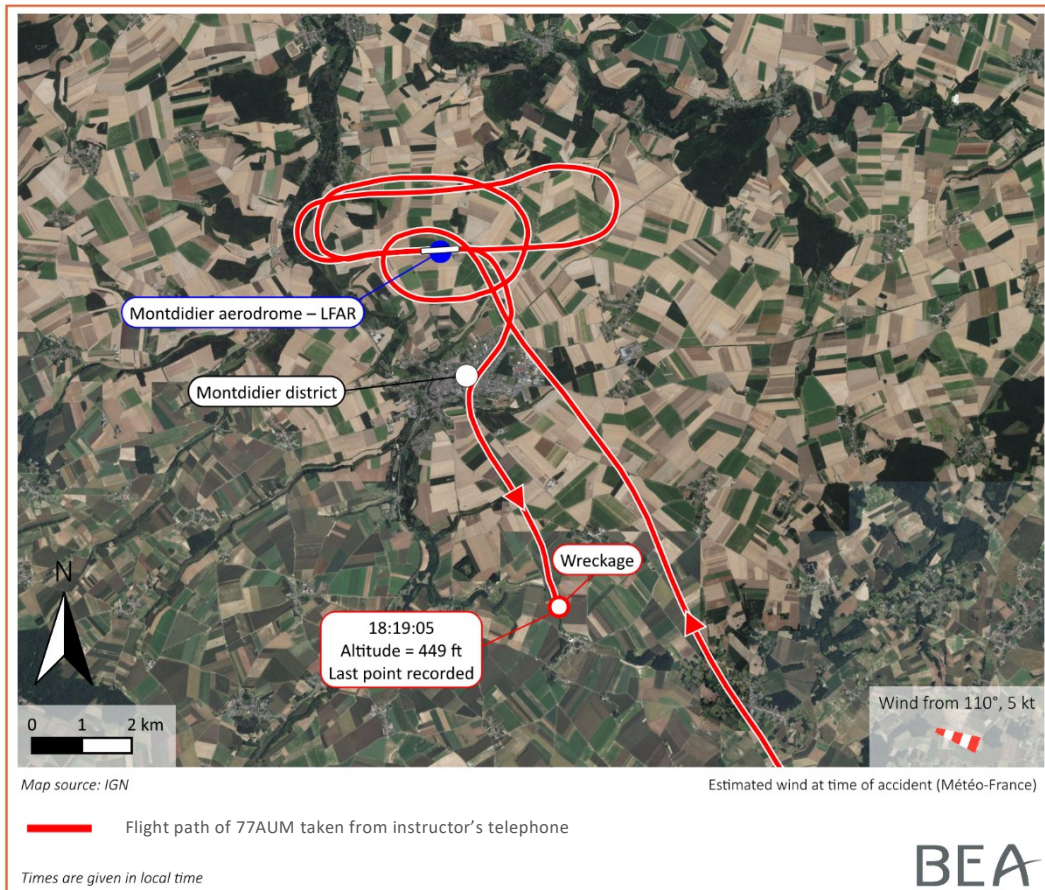
Figure 1: flight path downloaded from instructor's telephone

The recorded flight path showed that at 18:19, when the microlight was in level flight at an altitude of around 1,600 ft, i.e. a height of around 1,300 ft, it suddenly started descending and then collided with the ground.

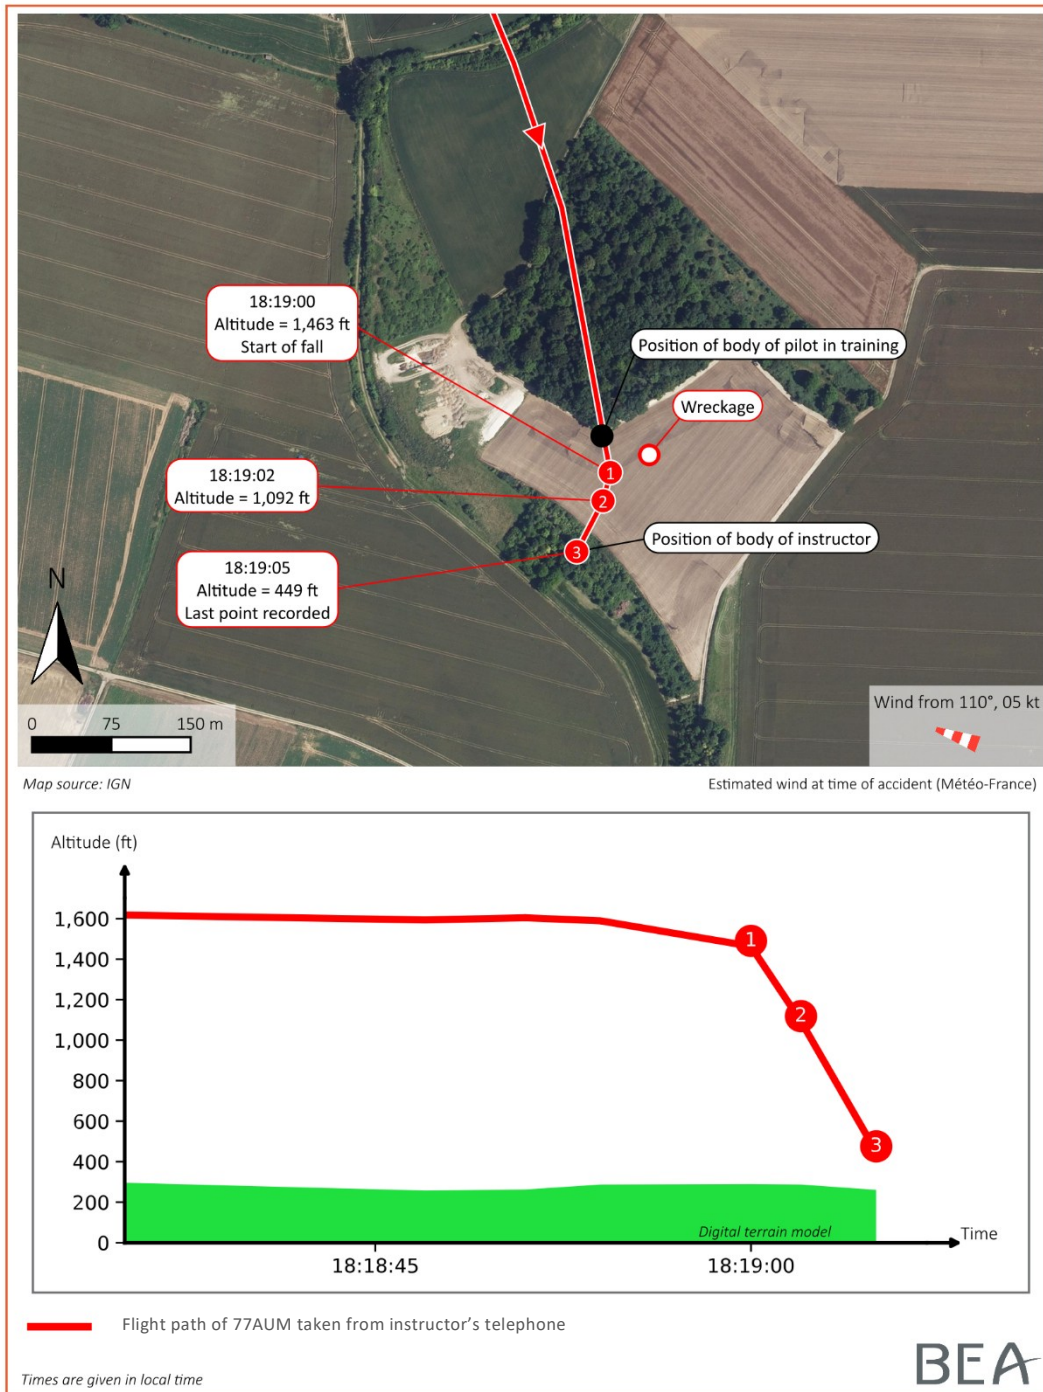
Figure 2: flight path downloaded from instructor's telephone

Points ①, ② and ③ correspond to the last three positions recorded by the instructor's telephone. This telephone was found near the instructor.

The investigation was not able to determine at what point the instructor was ejected from the microlight and as a consequence, up to what point the path corresponded to that of 77AUM.

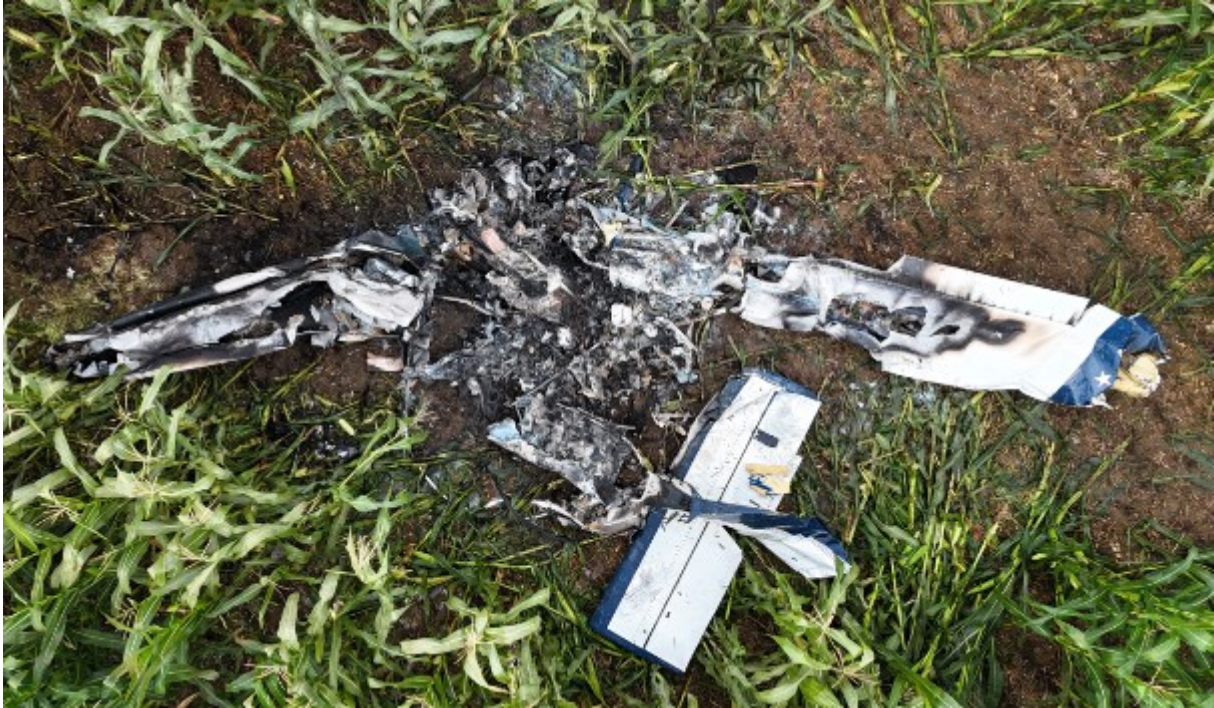
Figure 5: view of wreckage (source: BEA)

The global examination of the wreckage determined that it was complete and grouped together. The microlight had collided with the ground with a near-vertical pitch attitude. The flight controls were continuous before the impact.

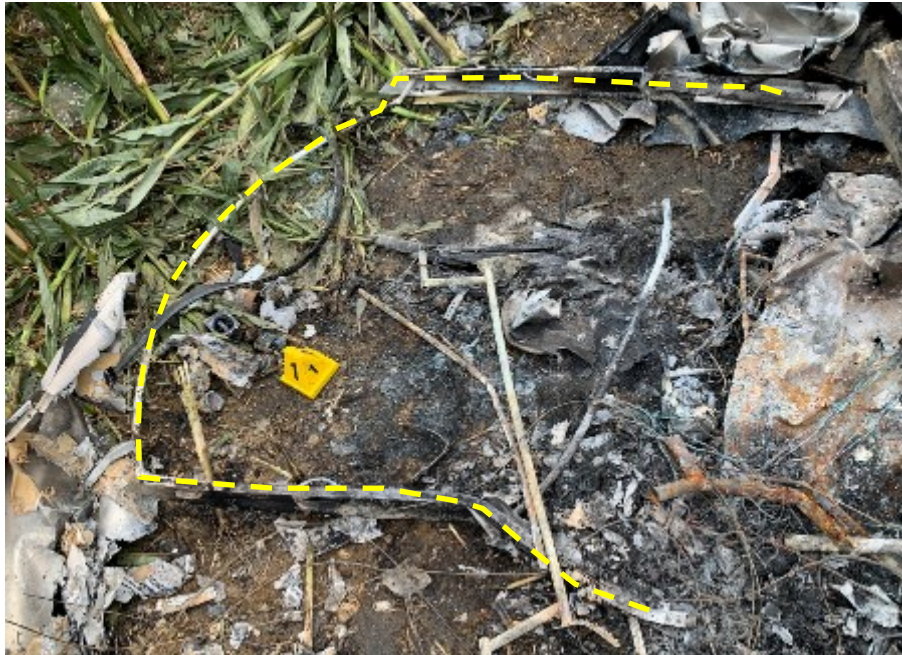
Figure 6: canopy frame (source: BEA)

The canopy closing system was composed of two hooks that were integral with the fuselage (one on the right side and one on the left side of the cabin) and connected by a cable so that their movements were symmetrical. The left hook was connected to a handle. When the handle was moved forward towards the nose of the microlight, these hooks positioned themselves over the top of two fittings on the canopy frame, thus preventing it from opening.

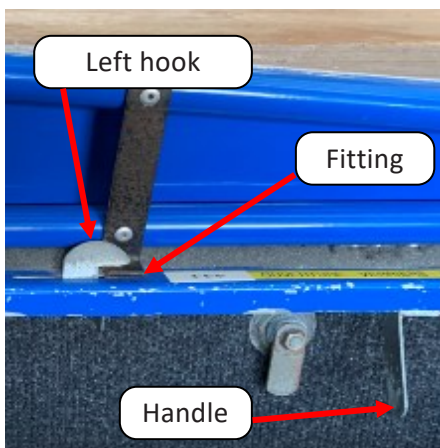
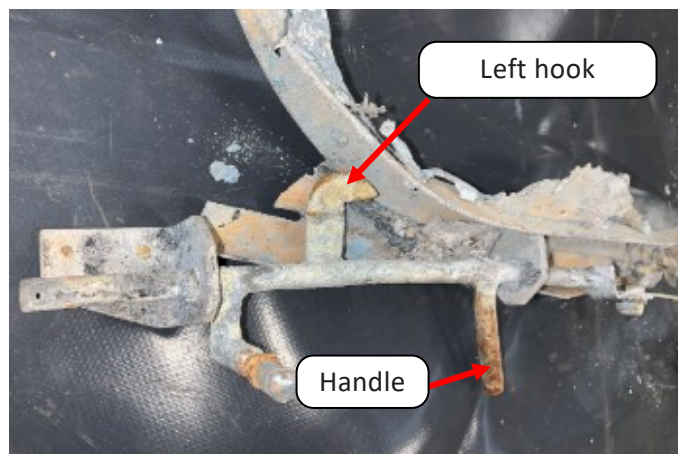
Figure 7: handle to close canopy on an equivalent microlight (source: BEA)

Figure 8: handle to close canopy on 77AUM (source: BEA)

On 77AUM as on the equivalent type microlight, no locking system to prevent untimely opening was observed.

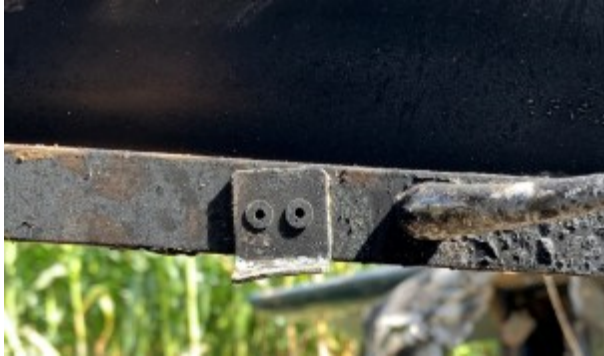
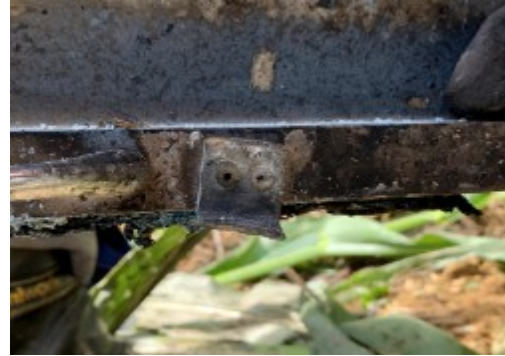
It was observed that the two canopy fittings of 77AUM were deformed in a downwards direction (see **Figure 9** and **Figure 10**).

*Figure 9: left-hand canopy fitting
(source: BEA)*

*Figure 10: right-hand canopy fitting:
(source: BEA)*

It was not possible to determine if these deformations were the result of wear prior to the flight or if they were the consequence of the canopy opening during the occurrence flight.

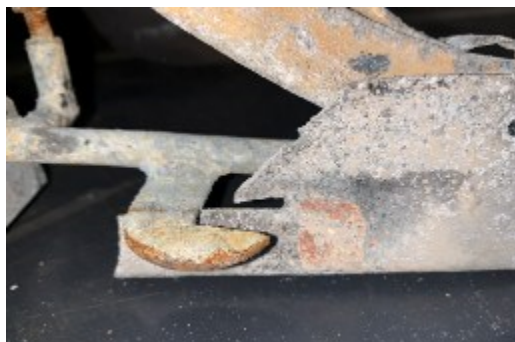
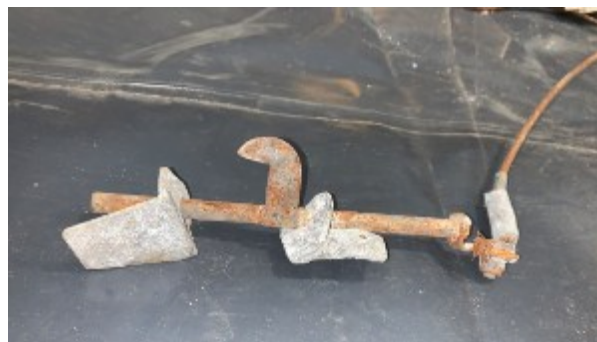
Furthermore, the left-hand and right-hand hooks were deformed in an upwards direction; this was consistent with the downward deformations seen on the fittings (see **Figure 11** and **Figure 12**).

Figure 11: detail of left-hand hook

Figure 12: detail of right-hand hook
