Accident to the DTA Dynamic Feeling 912UL Diva
identified **77BIQ**
on 20 August 2022
at Meaux-Esbly (Seine-et-Marne)

Loss of control during initial climb, tumbling, collision with ground, during a local revenue flight

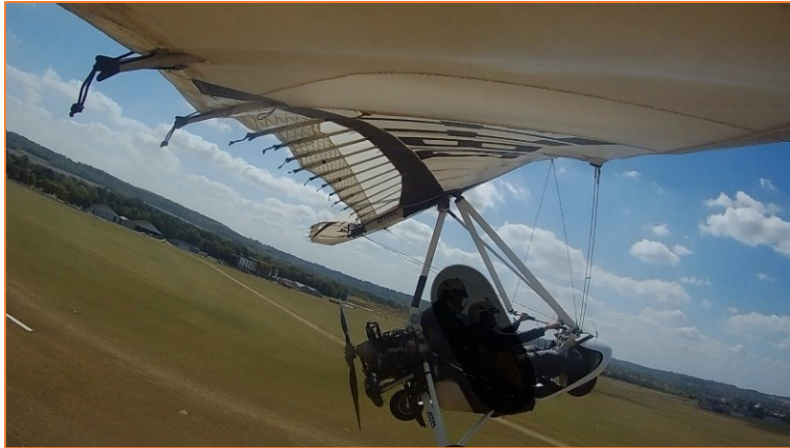
Figure 1: field of view recorded by the camera

Examination of the flight camera recording of the accident flight did not reveal any technical malfunction on the flex-wing. Spectral analysis of the audio recorded by this camera led to the conclusion that the engine was running continuously up to the loss of control.

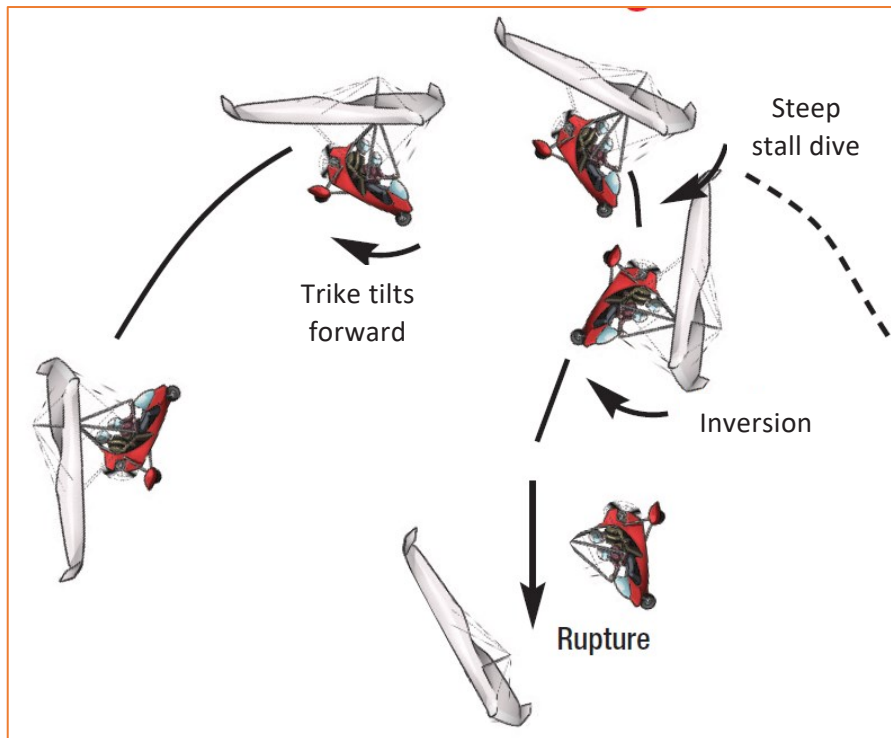
Tumbling is a phenomenon specific to flex-wing microlights with a delta wing. It is defined in the microlight pilot's handbook as the microlight tumbling around its pitch axis.

According to the document "[Mémo sécurité du pilote ULM](#)" (Microlight pilot safety memo), this forward tilt can occur in the event of a stall on a climb path, a pull-up manoeuvre or a climb at steep pitch attitude. It is uncontrollable.

Figure 2: tumbling (Source: FFPLUM, annotated by the BEA)⁴

The microlight pilot's handbook indicates that the aircraft rotates very quickly after the dive. It is rare for the wing structure to withstand the stresses.

⁴ Contrary to this illustration taken from the 6th edition of the "Mémo sécurité du pilote ULM" document, during the accident to 77BIQ, there was no detachment of the wing during the fall of the flex-wing.
