Accident to paramotor MACFLY 185, wing Dudek Universal 1.1
identified **78ASI**
on 1 July 2022
at Broué (Eure-et-Loir)

Time	09:10 ¹
Operator	Uranus Paramoteur
Type of flight	Instruction
Persons on board	Student pilot
Consequences and damage	Student pilot fatally injured, paramotor destroyed
This is a courtesy translation by the BEA of the Final Report on the Safety Investigation. As accurate as the translation may be, the original text in French is the work of reference.

**Entry into uncontrolled sharp turn, collision with ground,
in instruction**

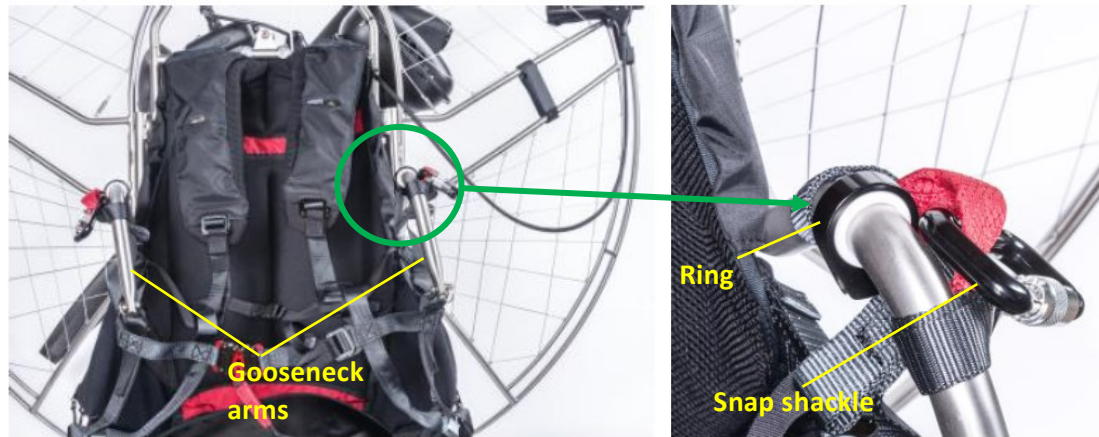
The riser attachment points on the paramotor "gooseneck" movable arms are asymmetrical by design. In the case of a counter-clockwise rotating propeller - as was the case for 78ASI - the ring on the right-hand movable arm is moved forward to cancel the torque that tends to cause the paramotor to pull to the right. In addition, the movable arms have a slight torsion on the right to shift the centre of gravity of the pilot/paramotor assembly to the left in relation to the wing attachment points, thus countering the propeller torque in level flight. These settings are optimised for cruising: at higher power levels, the wing will roll to the right; at lower power levels, the wing will roll to the left.

Figure 1: “gooseneck” movable arms with rings holding snap shackles
(source: Macfly user manual, March 2022 edition, modification⁷ and annotations BEA)

The examinations carried out by the BEA found that the trims were symmetrically set to the take-off position. The rings to position the riser snap shackles on the movable arms were close to or in the factory setting, compatible with the weight of the student pilot. The height setting of the brake control grips complied with the manufacturer’s specifications. The measurement of the risers, and the wing setting and symmetry did not reveal any anomaly. The wing was recent and in good condition before the accident; all the damage observed was the result of the risers and then the wing rolling around the propeller, after the collision with the ground, when the engine accelerated.
