Accident to the Air Création
GTE Trek 700E / Fun 450
identified **79HX**
on 09 August 2020
at Aslonnes

**Approach with tailwind, turbulence on short final,
go-around, insufficient control of path, collision with a tree
then the ground, fire**

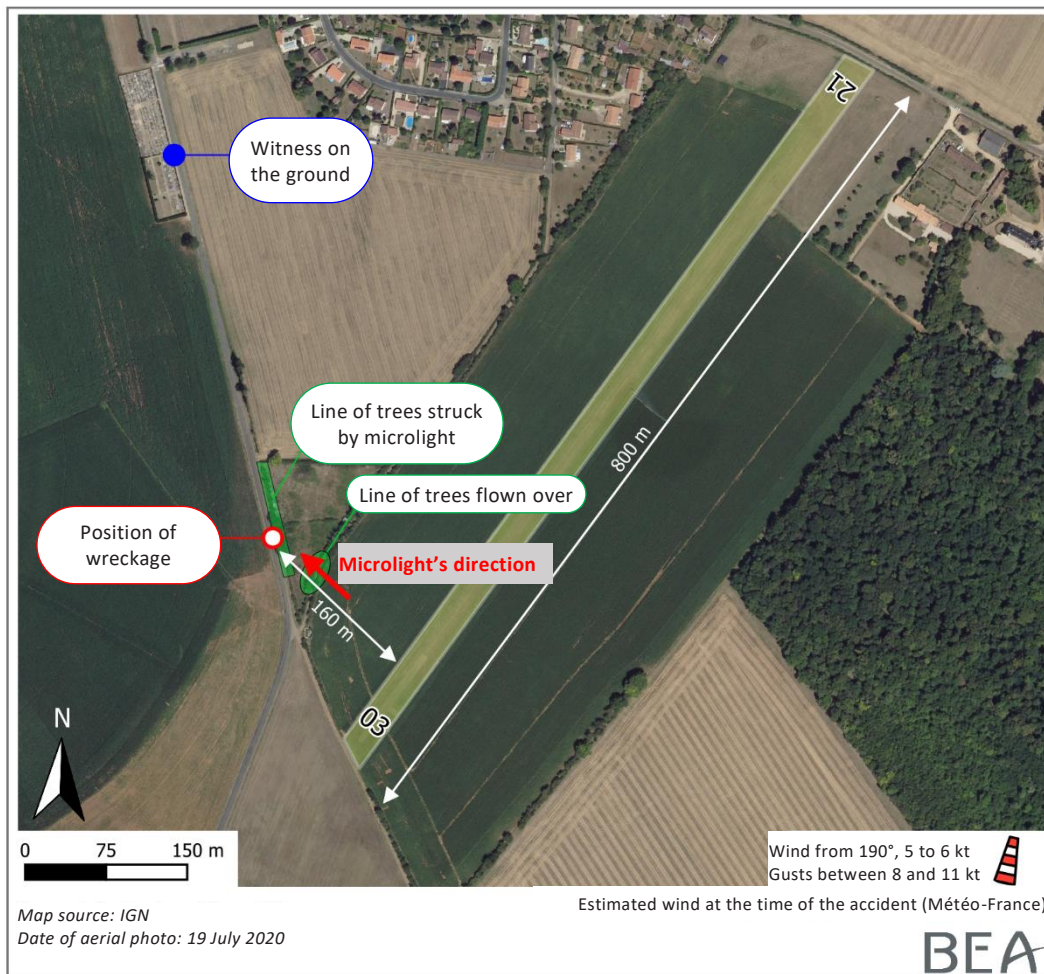
After 35 minutes of flight, he flew overhead the microlight strip at an altitude of 1,500 ft (i.e. at a height of approximately 1,000 ft) to conduct a reconnaissance of its facilities, before joining the start of the downwind leg for a right-hand circuit to runway 03. At the end of the base leg, he encountered turbulence and the microlight sank slightly. On short final, he encountered more turbulence, this time stronger. The microlight sank again and the passenger suggested to the pilot that he perform a go around. The pilot applied full power, the microlight deviated to the left of the runway axis, collided with a tree and then with the ground.

Figure 1: end of flight path of 79HX

The wreckage was located at the bottom of a line of trees about 10 m tall. Several severed branches were found on the ground around the wreckage. The first marks were found in the upper part of one of the trees.
