Accident to the JMB AIRCRAFT VL3
identified **88PP**
on 16 October 2021
at Beaune-Challanges aerodrome

Time	Around 18:15 ¹
Operator	Private
Type of flight	Local
Persons on board	Pilot, passenger
Consequences and damage	Pilot and passenger fatally injured, microlight destroyed
This is a courtesy translation by the BEA of the Final Report on the Safety Investigation. As accurate as the translation may be, the original text in French is the work of reference.

Loss of control in initial climb, collision with ground

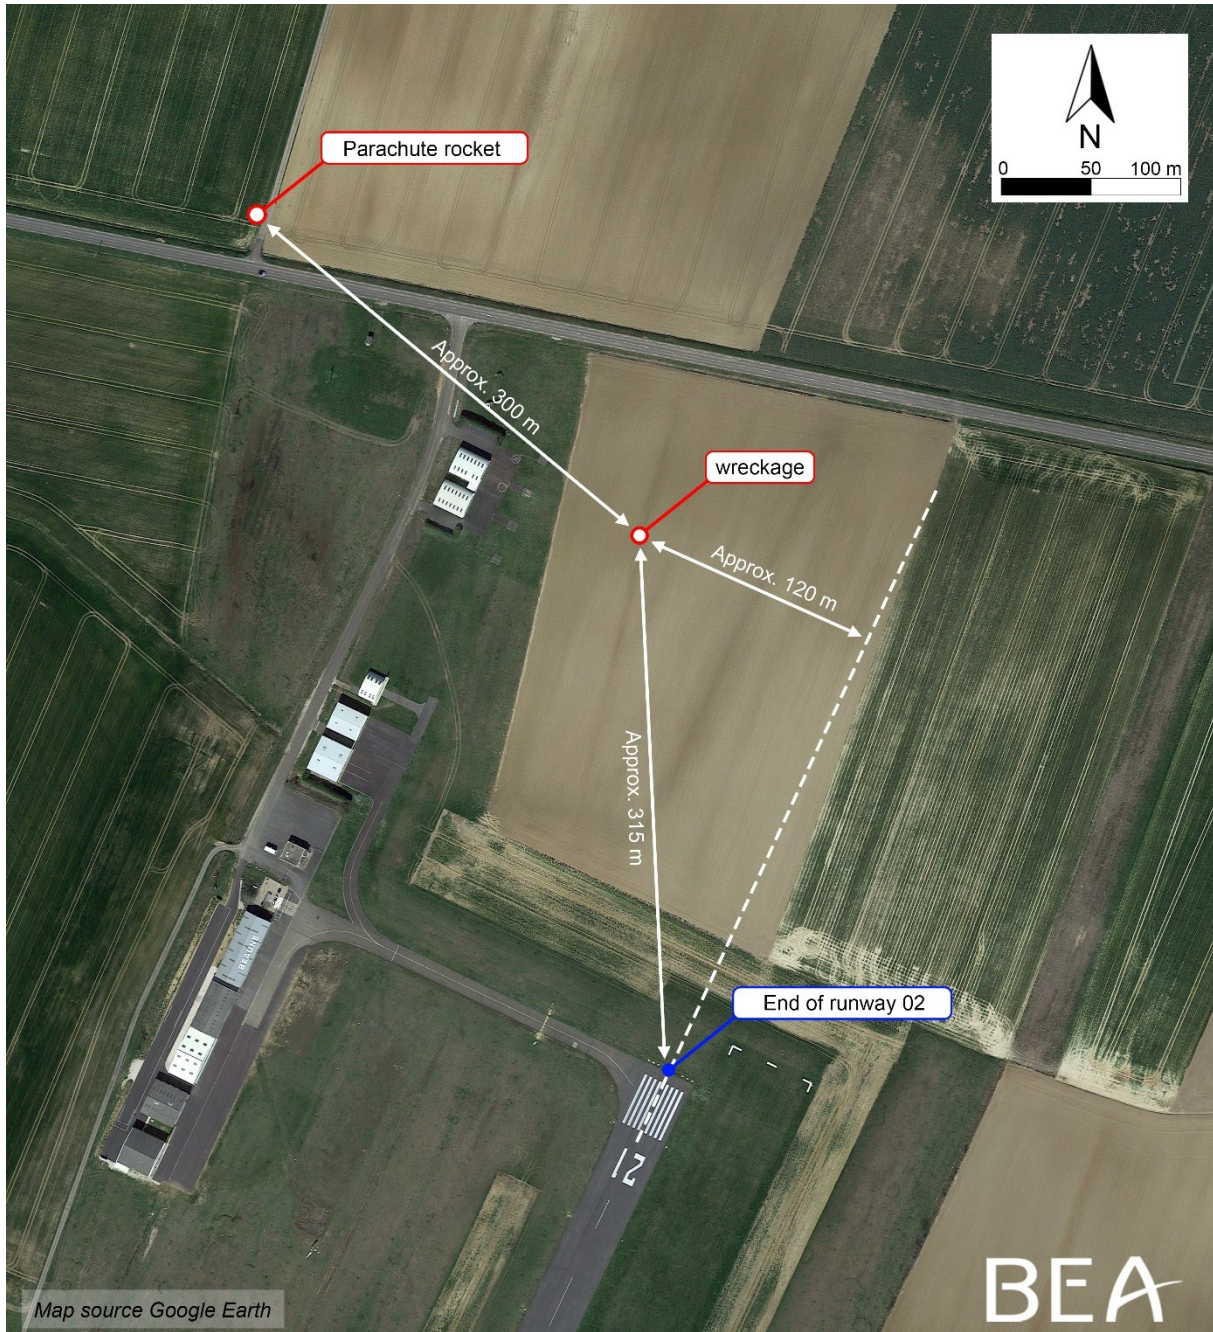
Figure 1: overview of site

The wreckage was located in a field of low crops located on the axis of runway 02³ of Beaune-Challenges aerodrome. It was around 315 m from the end of runway 02, offset to the left of the runway centreline by around 120 m (see **Figure 1**).

The wreckage of the microlight was complete and grouped together. It was lying on its belly on a 073° heading. It was almost completely consumed by the post-impact fire.

The examination of the site and the deformations of the wreckage made it possible to conclude that the underside of the microlight struck the ground almost flat, and that the microlight did not bounce. The landing gear and flaps were retracted and the engine was operating at the time of the collision with the ground. Despite the fire, the continuity of the controls of the three axes of the microlight could be confirmed.

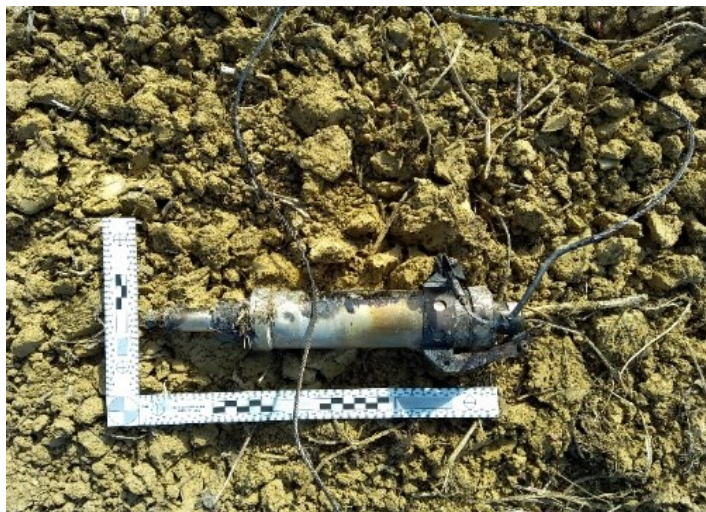
Figure 2: photo of parachute rocket (source: BEA)

The airframe parachute rocket was found at around 300 m north-west of the wreckage. The parachute activation handle was still in its housing. The activation of the rocket was the result of the fire and not a deliberate action by the pilot or passenger.

This accident highlights the risk of an additional accident due to the untimely activation of an airframe parachute. This risk is increased if there is a post-impact fire or if the wreckage is handled. The uncontrolled firing of an airframe parachute rocket can cause serious or fatal injuries to people in the vicinity of the wreckage.
