Accident to the APCO Aviation THRUST M identified 95-WG on 6 September 2021 at Trébrivan (Côtes-d'Armor)

Time	Around 19:45 ¹
Operator	Private
Type of flight	Local
Persons on board	Pilot
Consequences and damage	Pilot fatally injured

Loss of motor power, loss of control, collision with the ground

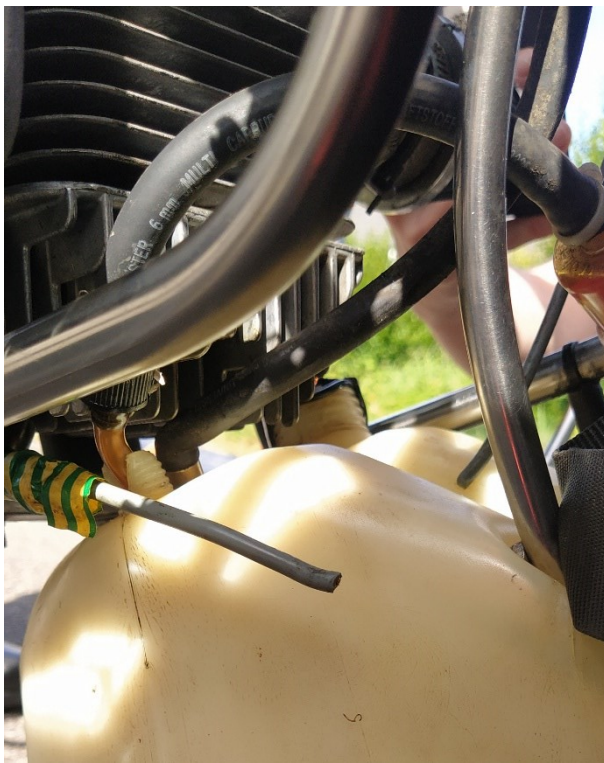
The wing was not torn. The rigging lines and controls were continuous. The upper lines were entangled with the wing. The fuel tank was punctured by a motor component when the motor moved during the collision with the ground. The power cable of the motor spark plug was cut. The spark plug was wrapped in insulating tape (see Figure 1).

Figure 1: spark plug wrapped in insulating tape, cut power cable
(Source: BEA)

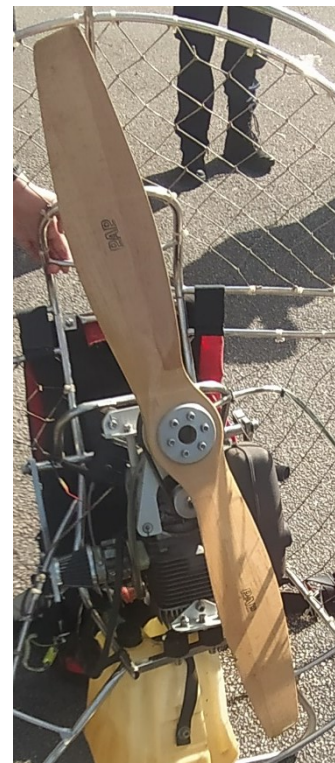
The propeller was intact, a consistent but inconclusive sign of a decrease in motor power (see Figure 2).

Figure 2: propeller
(Source: BEA)
