Accident to the Dudek Warp 2
identified **95AKI**
on 10 May 2024
at Auvers-sur-Oise

In-flight loss of control, collision with ground

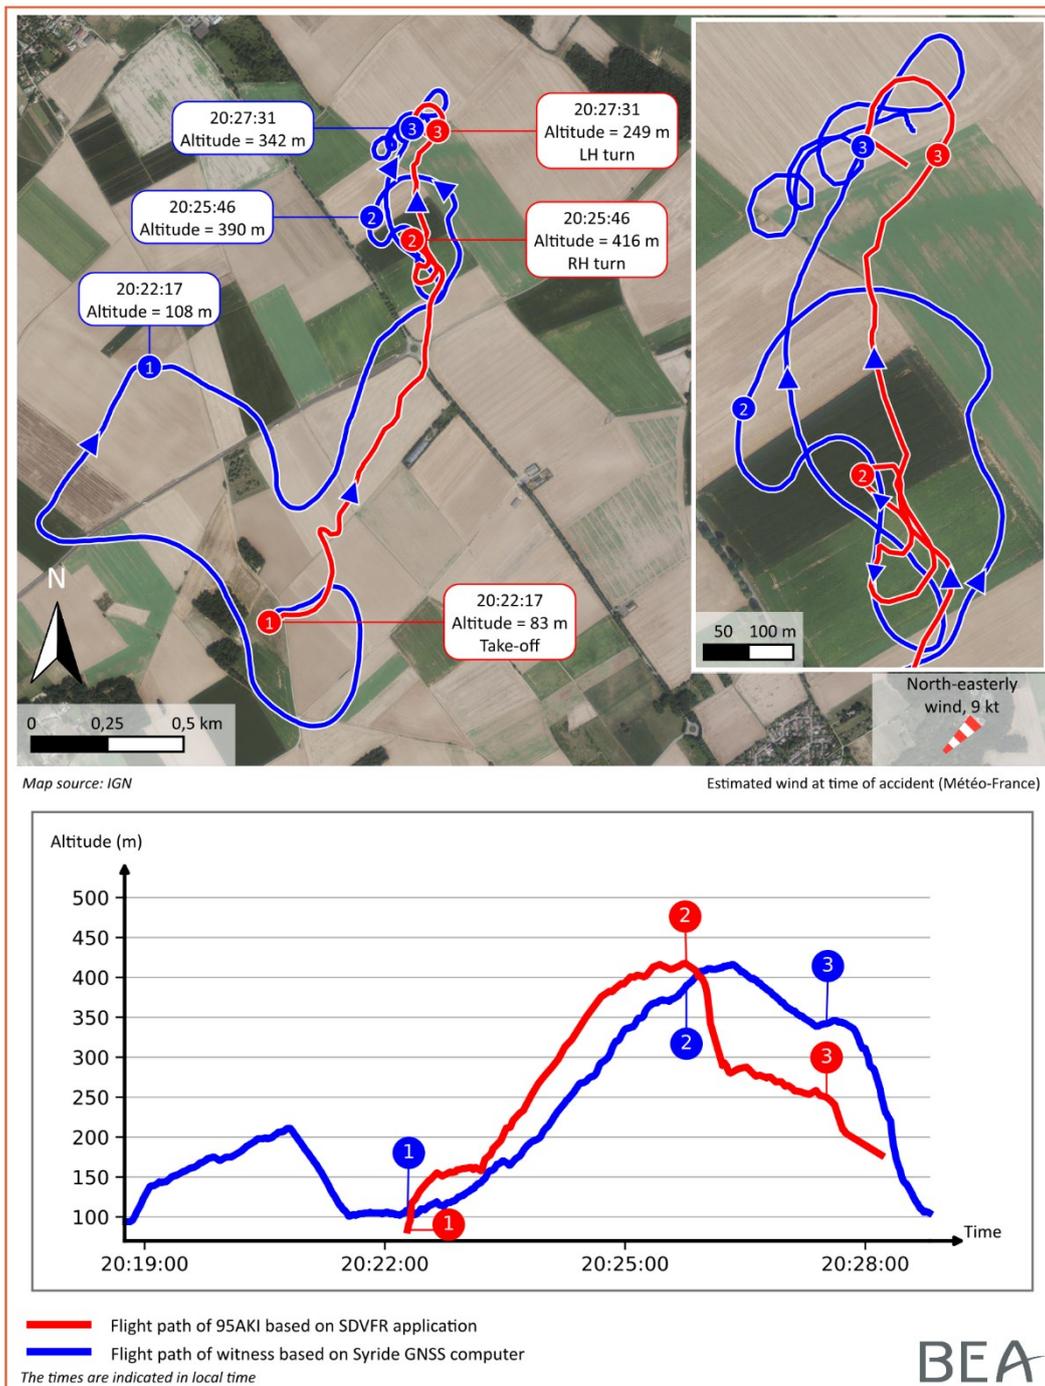
The pilot inflated the wing twice to check the suspension lines and correctly position it for take-off, carried out the engine tests and then started to take off. He rejected his first take-off as the wing had not correctly inflated and folded during the manoeuvre. The second take-off was at 20:22 (see **Figure 1**, point **1**). Once the two paramotors were in flight (point **2**), the pilot carried out a figure of eight by making a right-hand and then a left-hand turn. During this manoeuvre, the microlight descended around 140 m in roughly 50 s to finish at an altitude of 280 m.

A few minutes later, the accompanying pilot looked behind him to check the position of the pilot and saw him rapidly descending in a steep left-hand turn (point **3**), until he struck the ground. After landing as quickly as possible, he rapidly removed the paramotor battery which was melting and producing white smoke before providing assistance to the pilot. The engine was no longer operating at this time.

Figure 1: flight paths and vertical manoeuvres of the two paramotors

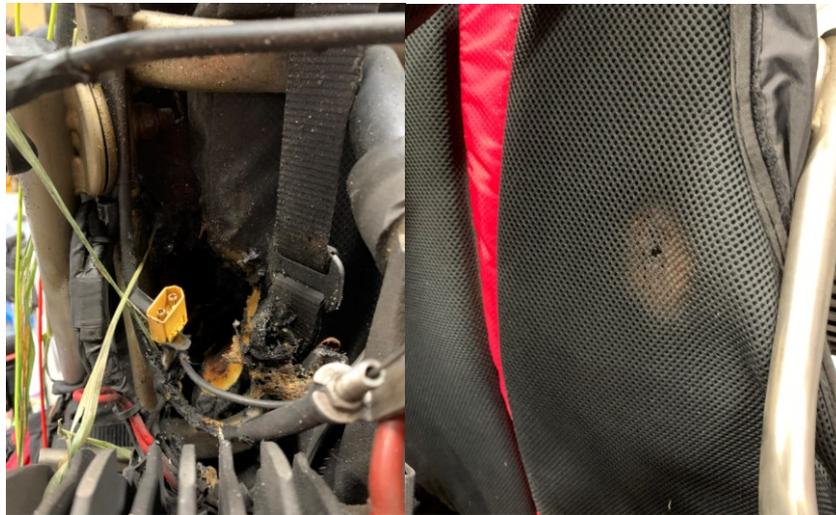
Heat damage was observed in the battery area. The heat emitted was intense enough to penetrate the harness backrest and melt the cable sheaths in that area. Three of the six battery cells were found intact, the other three had very probably melted. The battery connector on the chassis side showed no signs of internal overheating.

Figure 2: front and rear view of the paramotor seat (source: BEA)

The deformations of the chassis suggest a frontal impact with the ground, with the right-hand side striking the ground first. The cage structure was severely damaged on the left-hand side, near the area where the battery was attached.

The thermal runaway of the battery was very probably caused by the microlight hitting the ground.
