Accident to the TL-ULTRALIGHT SRO - Sting Carbon
identified **95SN**
on 4 September 2021
at Woignarue (Somme)

Time	09:50 ¹
Operator	Private
Type of flight	Local
Persons on board	Pilot and passenger
Consequences and damage	Pilot and passenger fatally injured, microlight destroyed
This is a courtesy translation by the BEA of the Final Report on the Safety Investigation published in September 2022. As accurate as the translation may be, the original text in French is the work of reference.

Stall in adverse weather conditions, collision with ground

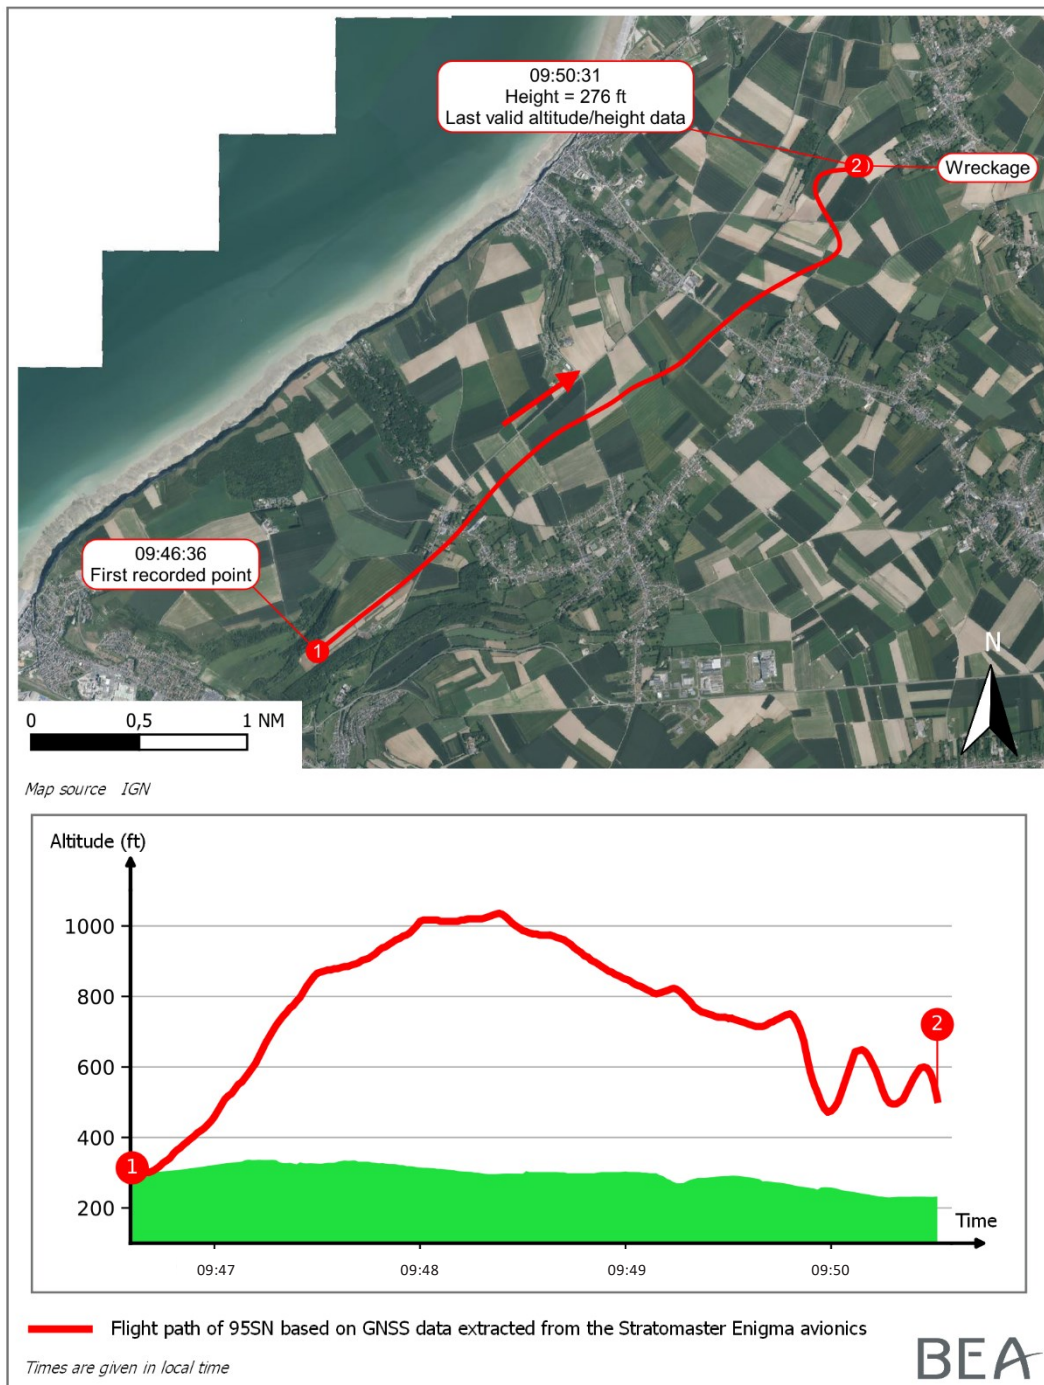
At 09:50, 95SN collided with the ground in a field, 5.8 km north-east of the aerodrome. The farmer who owned the field discovered the wreckage about 45 min after the accident and alerted the emergency services.

Figure 1: flight path of 95SN

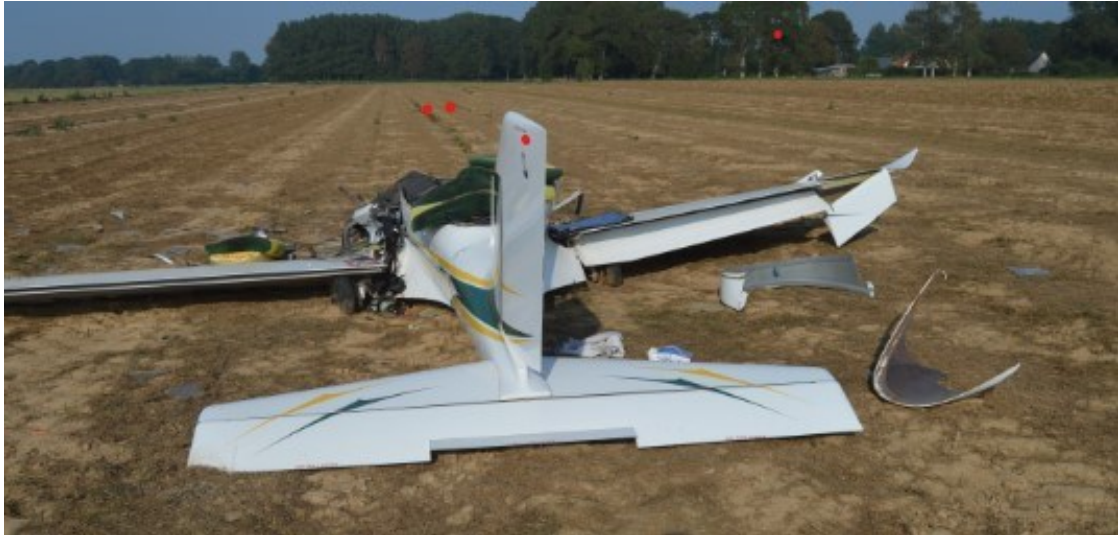
The accident site was a field free of any obstacles. The general condition of the wreckage revealed that the microlight had hit the ground with a slight nose-down attitude and a small left bank angle. The landing gear struts were ruptured.

The aileron, flap, elevator and rudder controls were continuous prior to the impact with the ground. The examination of the flap and elevator trim controls indicated that they were positioned for landing prior to the collision with the ground.

The examination of the propulsion system did not reveal any failure that could explain a reduction in power or an engine shut-down.

Figure 2: wreckage of 95SN (source BEA)

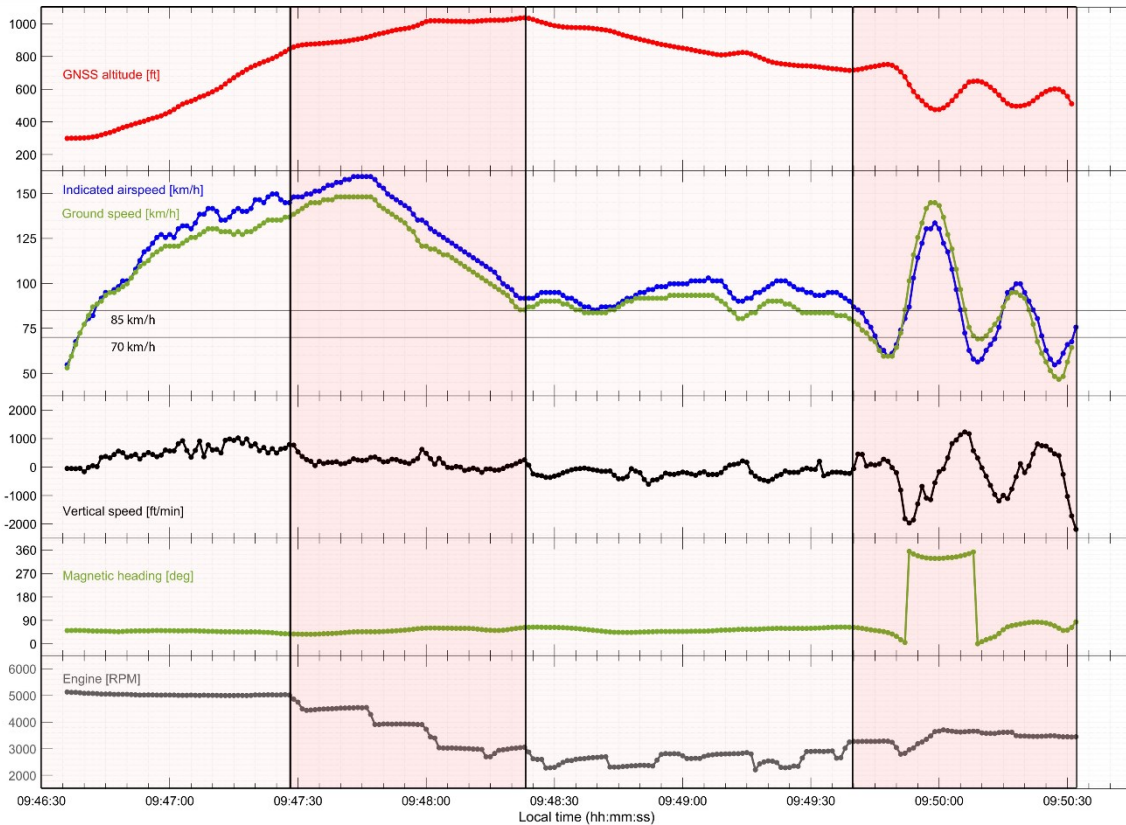
Figure 3: analysis of the 95SN flight parameters (source BEA)

The first phase, which lasted approximately 50 s, included take-off and a stable increase in engine speed to approximately 5,000 rpm, up to an altitude of 850 ft. The indicated airspeed increased to 140 km/h.

During the second flight phase, the flight data indicated a step-down decrease in engine speed, from 5,000 rpm to approximately 3,000 rpm. The microlight continued to climb with a lower vertical speed and reached the maximum altitude of 1,037 ft. The indicated airspeed decreased to 90 km/h.

During the third phase, the microlight gradually descended to approximately 700 ft with a reduced engine speed (between 2,200 and 3,250 rpm) and an indicated airspeed that fluctuated between 90 and 105 km/h.

During the last flight phase, the microlight made a turn of approximately 90° to the left, and then 115° to the right. During the turn, the engine speed increased in steps until it reached 3,700 rpm. Large fluctuations in altitude and speed were recorded. The indicated airspeed fell below 60 km/h three times. These variations in altitude, indicated airspeed and vertical speed revealed that the microlight had stalled three times before colliding with the ground.

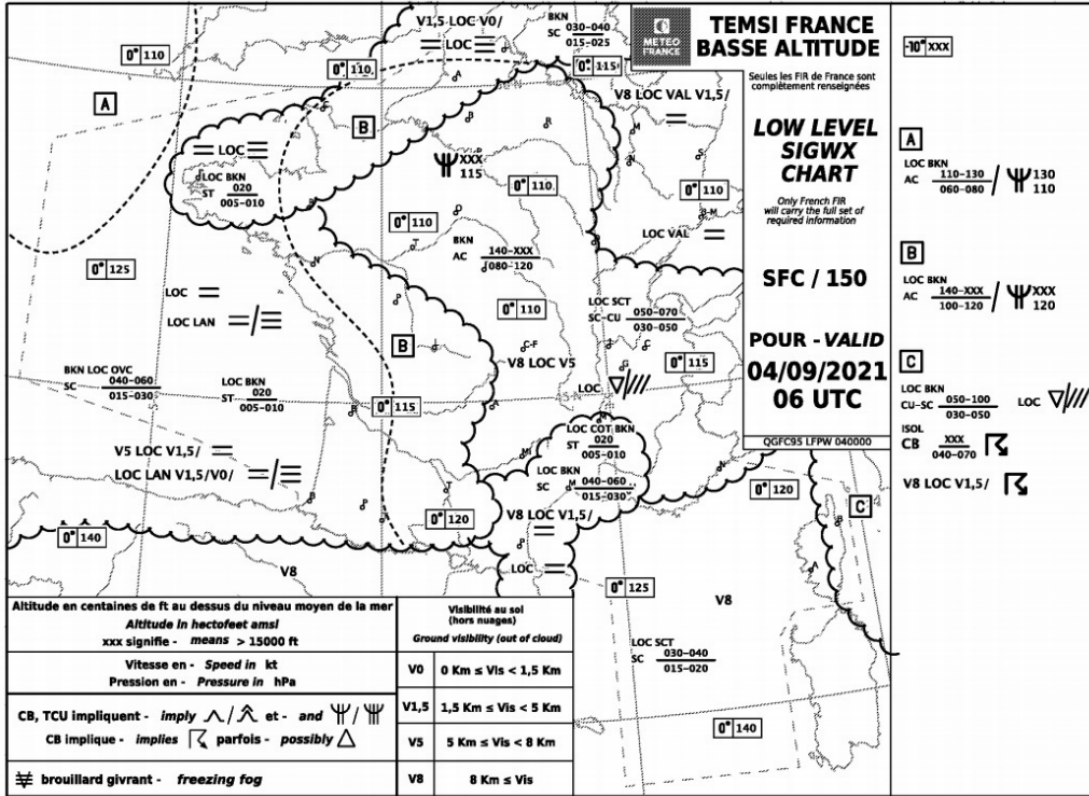
The low level SIGWX chart for France at 08:00 indicated the presence of mist and fog locally in the coastal area with visibility locally less than 1.5 km.

Figure 4: low level SIGWX chart for France at 08:00 (source Météo-France)
